SWRBD CFRAM Study

Flood Risk Review Report

February 2012
Office of Public Works

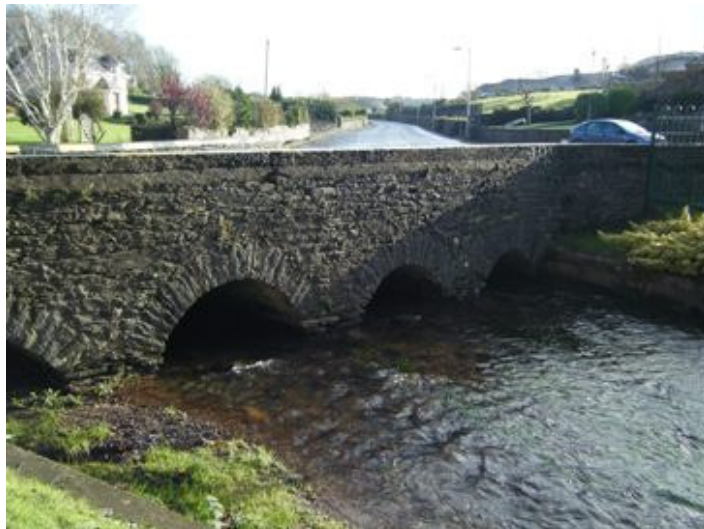
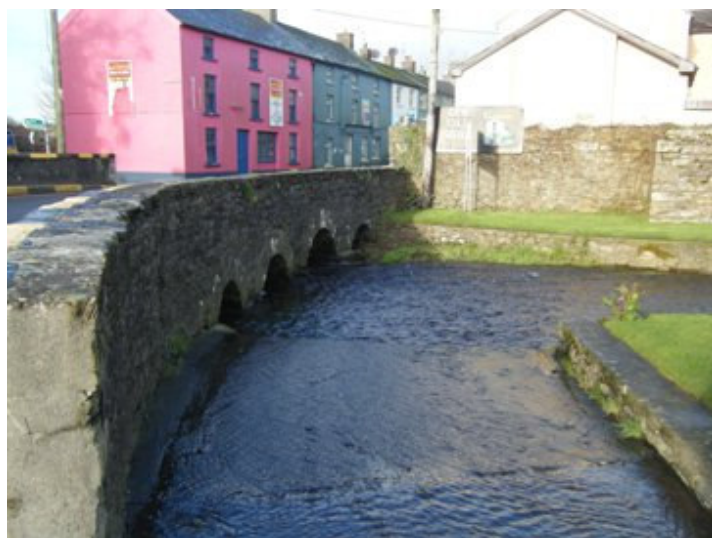
Clashmore Bridge - R671 Regional Road

The Local Authority also confirmed that fluvial flooding occurs at the location of the Clashmore Bridge in the village of Clashmore. If floods occur at this location then the adjacent properties are affected. WCC personnel recalled flooding along the main road and the recalls the bridge impassable to cars following flooding in 2010. It was noted during the site visit that the 4 number eyes of the bridge are quite low which may result in over spilling to the adjacent area in times of high flow.

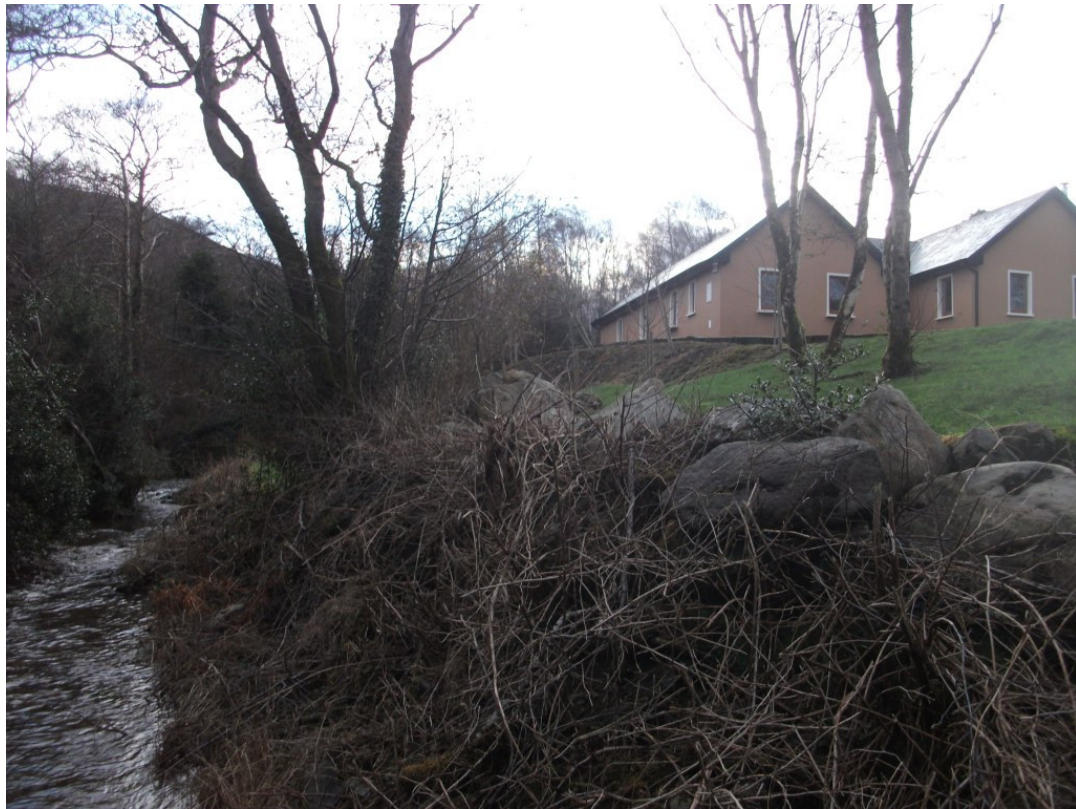
From the site visit, it is thought that the school is the only receptor at risk in this RR area. Properties east of the stream channel are not thought to be low enough to be affected by the River Behy while the property south of the school is well above the level of the stream as shown in the photograph below:

Instead, it is recommended that works are carried out to either improve the stream channel capacity or construct defences to protect the school from future flood events.

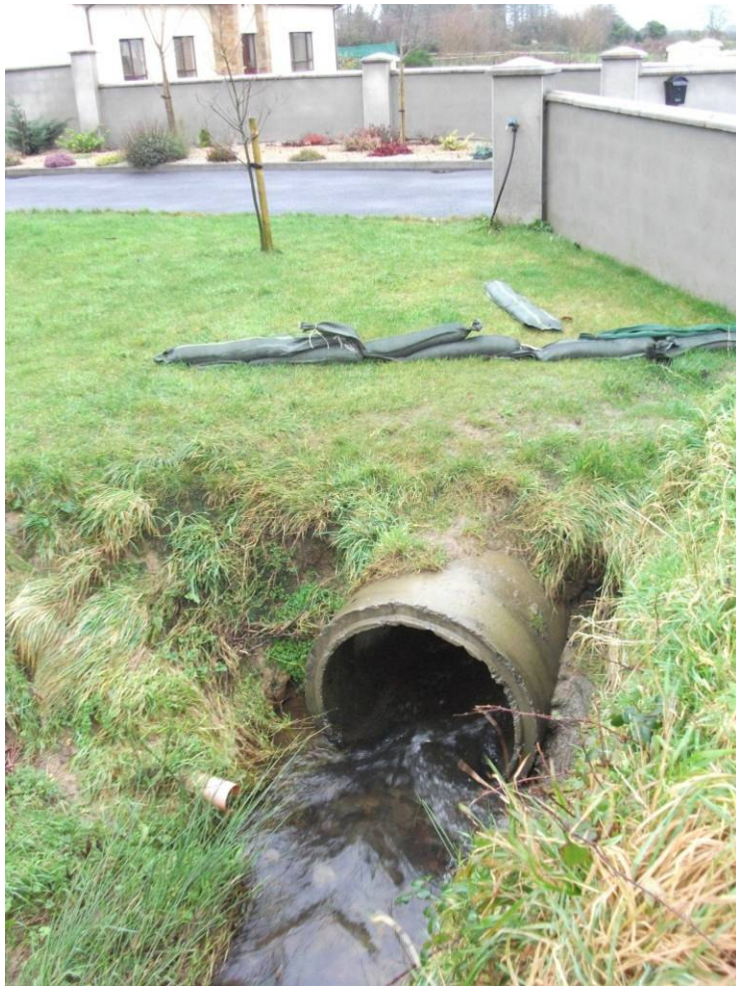
Example of minor drain/stream in Cordal RR area

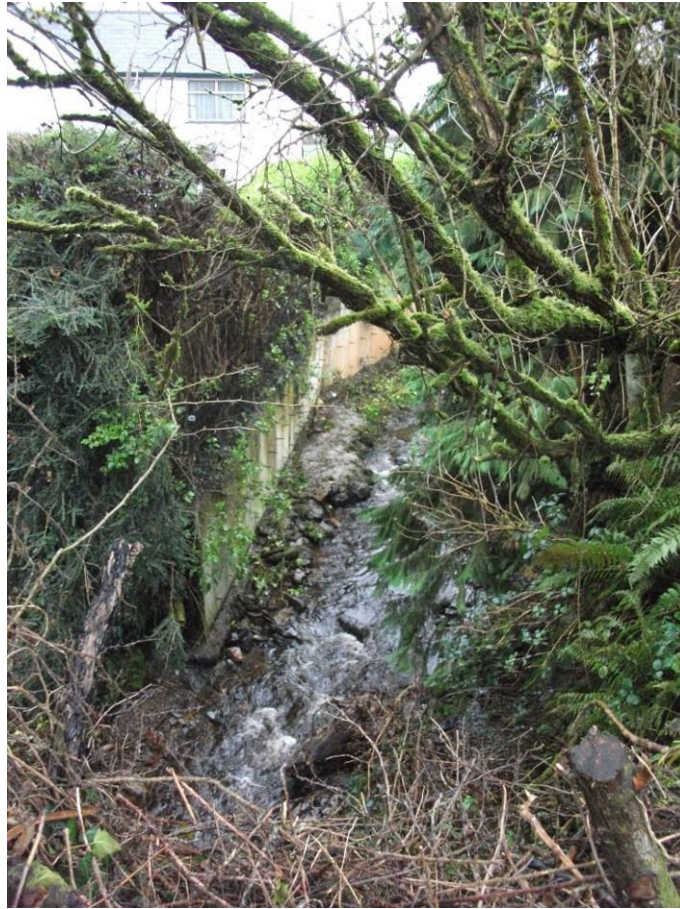
Example of property excluded from Cordal flood risk boundary due to elevation

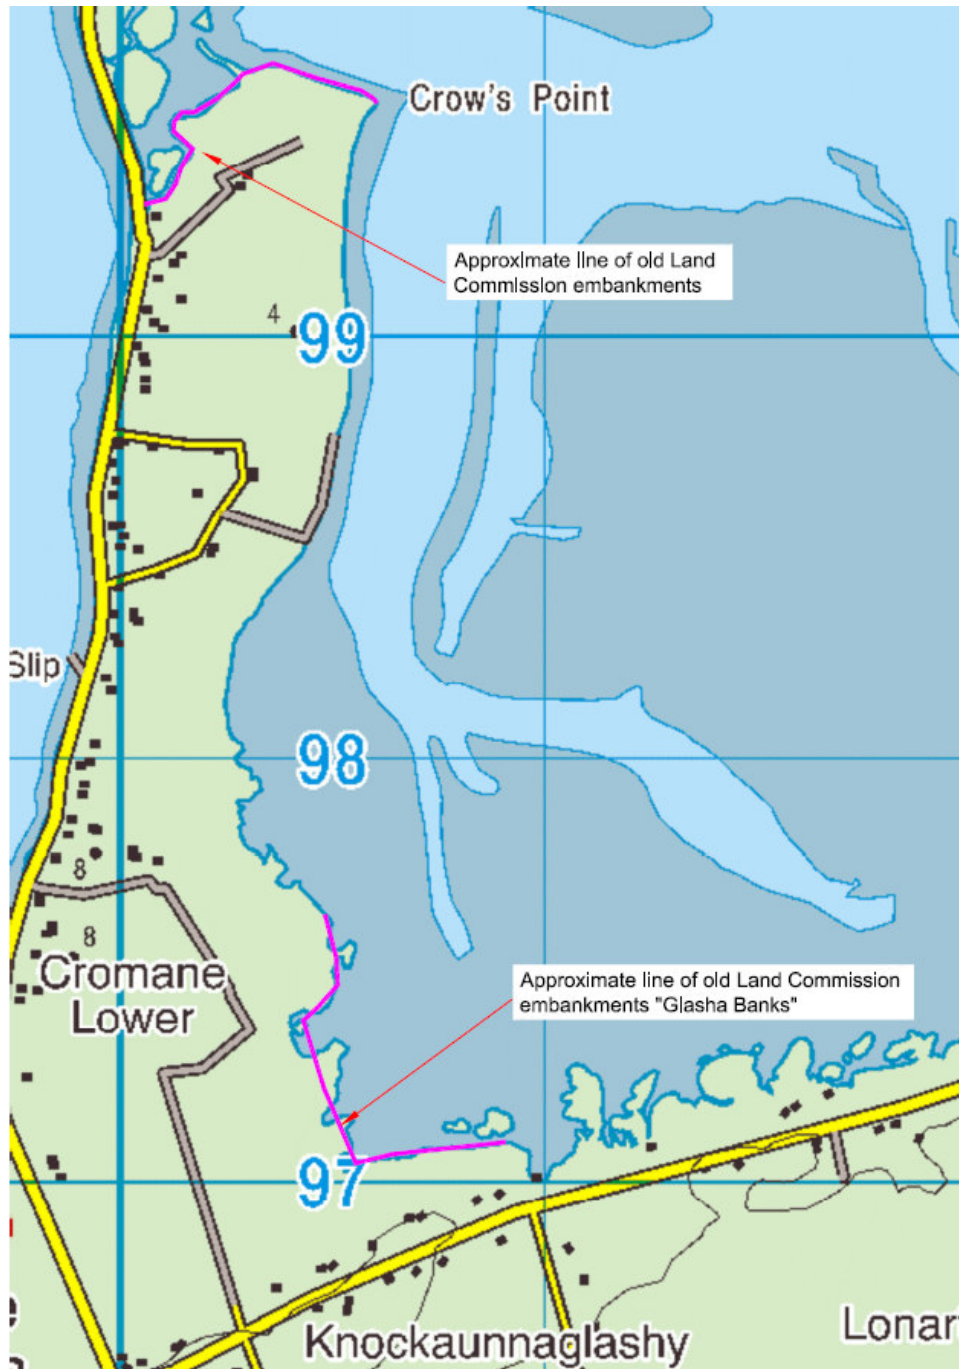
With regard to the Glasha Banks, the LA advised the main purpose of these was to protect agricultural lands but that due to lack of maintenance and possibly to rising sea levels, these were no longer effective and the lands were no longer protected. The LA agreed that in general, most houses in the Cromane Lower area are high enough that they are not at significant risk of flooding although the access road may be affected at times due to overwashing.

The LA are concerned that the flood defences are no longer anyone's direct responsibility since the Land Commission ceased to operate and as a result, the defences are likely to continue to deteriorate as maintenance is only carried out in a reactive fashion or in some cases, not carried out at all.

Approximate location and line of old Land Commission Embankments at Cromane

Instead, it is recommended that works are carried out to rehabilitate and/or improve the existing defences and to construct new defences where none exist in order to reduce the risk from possible future flood events.

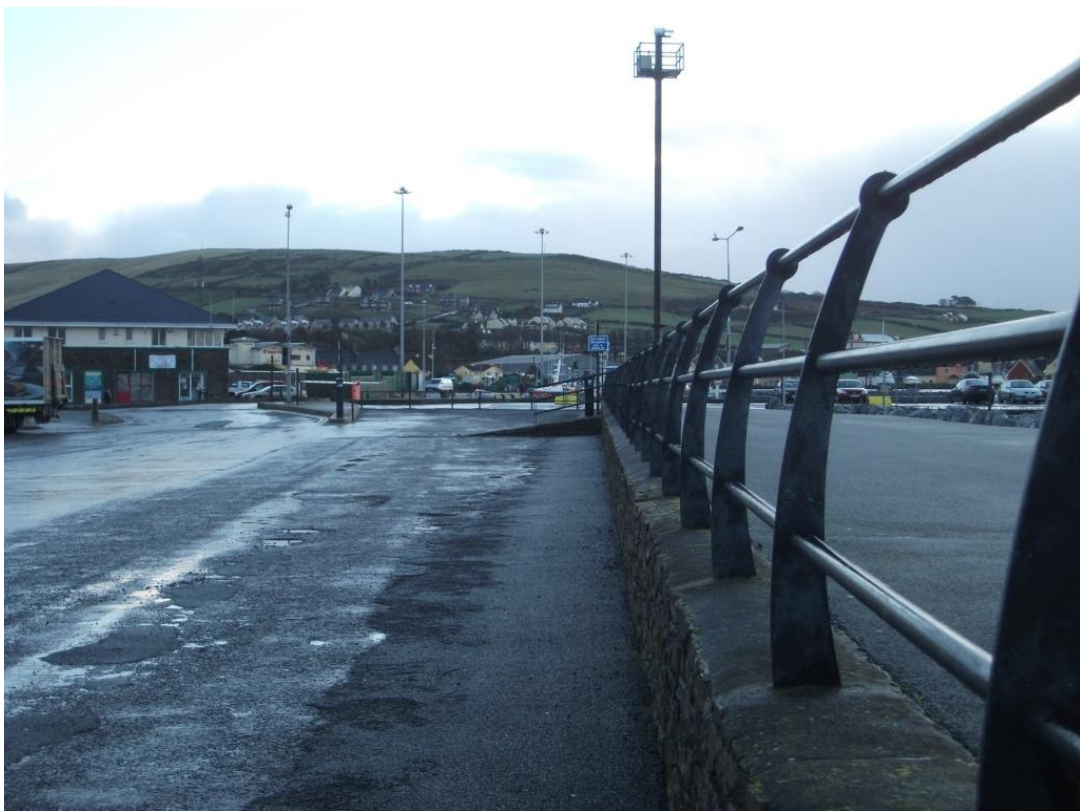
One local advised that the quay walls had once been badly damaged by high tides and when they were re-built, they were raised to a higher level and this reduced the problem. He was of the opinion that the flooding was due to overtopping due to wave action rather than tide levels in excess of defences.

Photo indicating higher level of quay area (RHS) compared to street level (towards LHS)

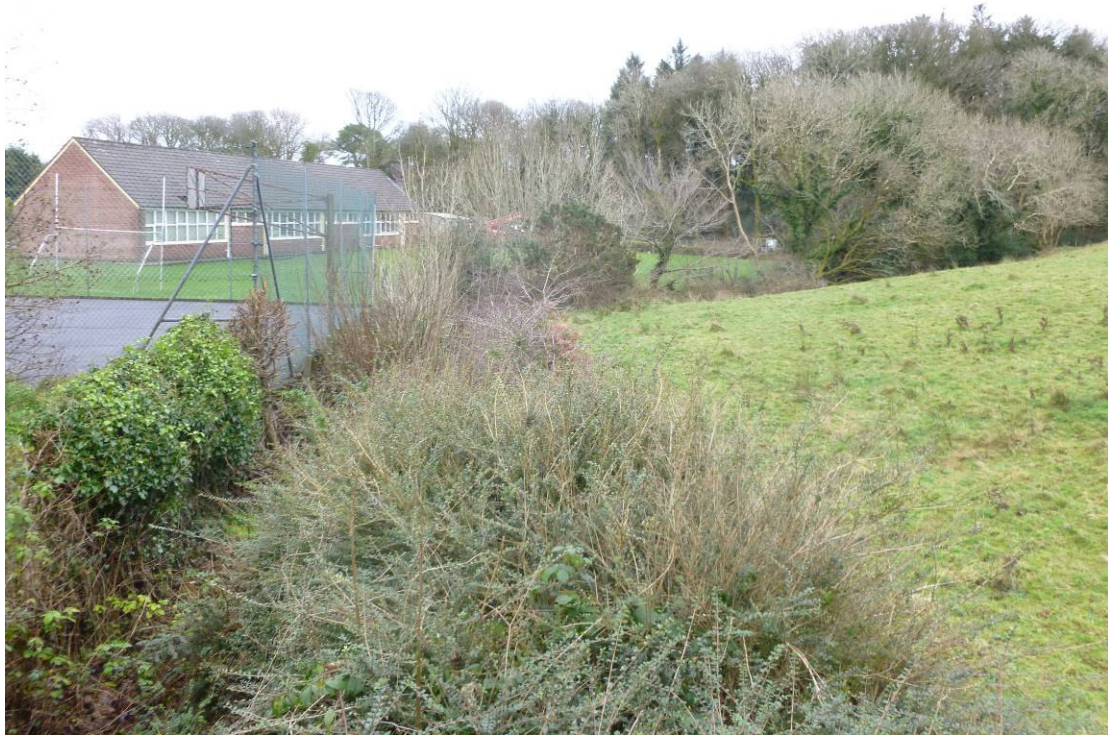
Dromore – River is under the hedging in the foreground and follows the line of the ditch. School can be seen in the background.

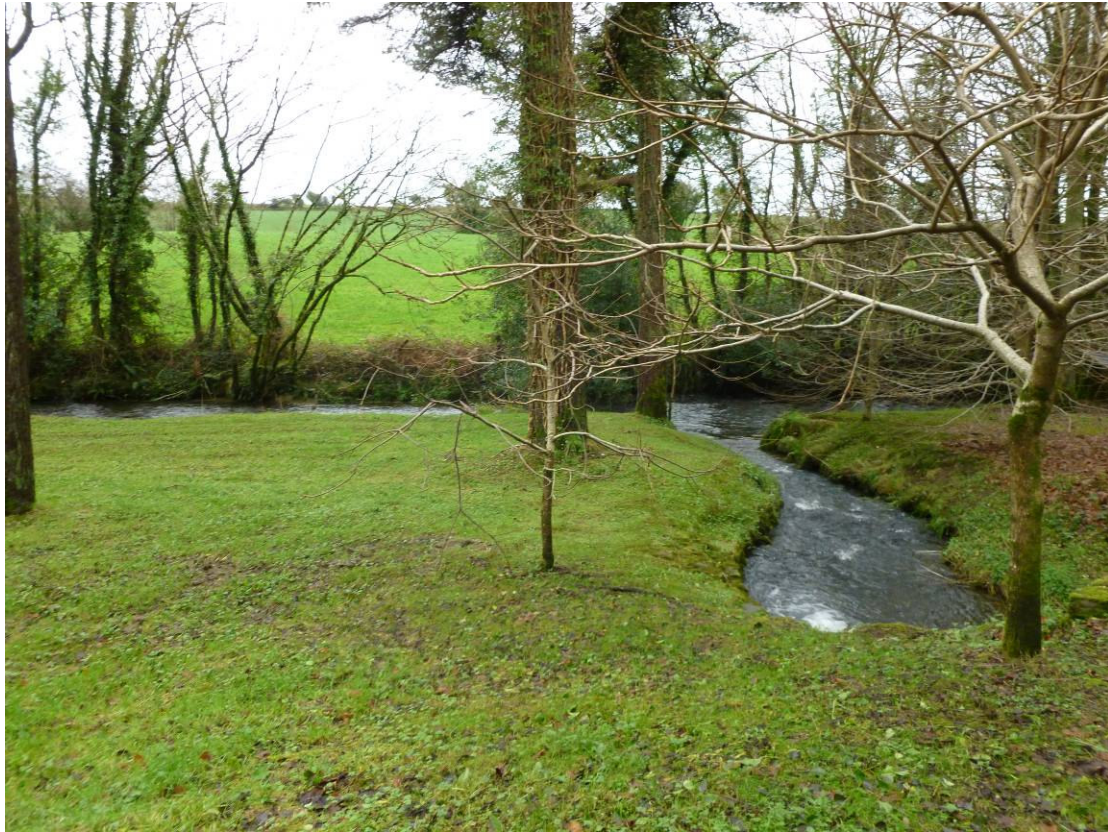
Dromore – view of River downstream from School

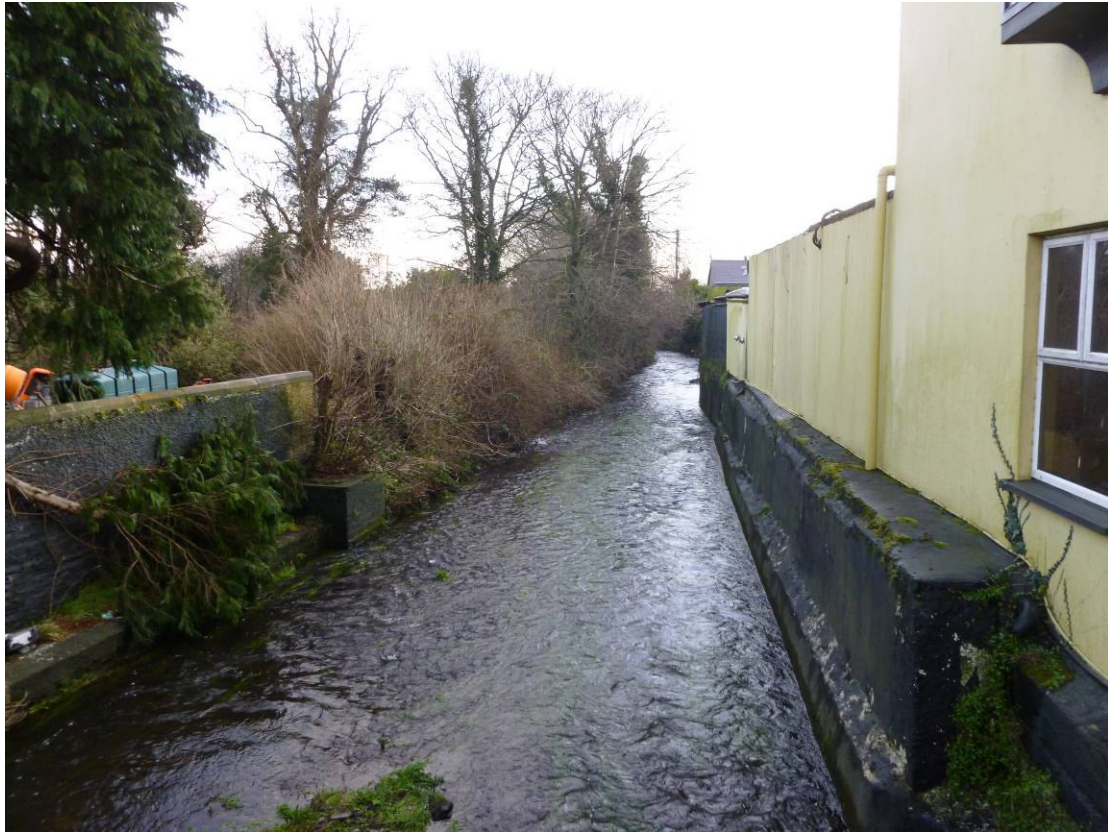
Dunmanway – river running adjacent to properties

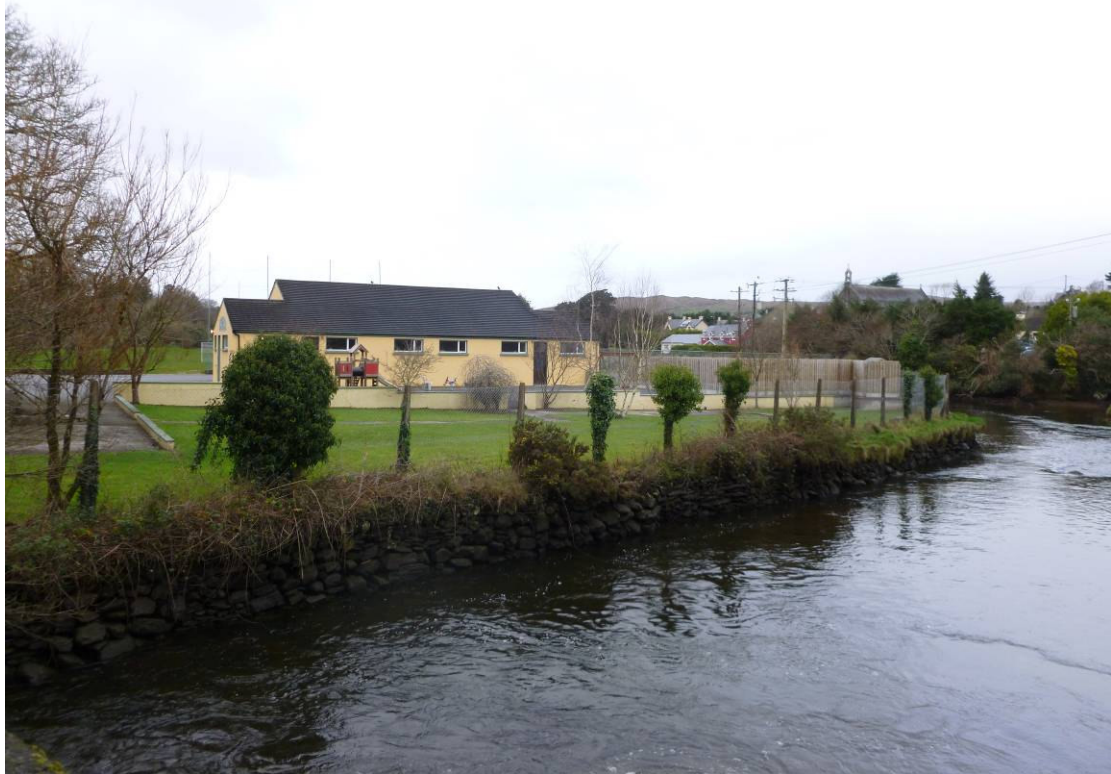
Durrus – Unknown receptor (Primary School) within the flood outline.

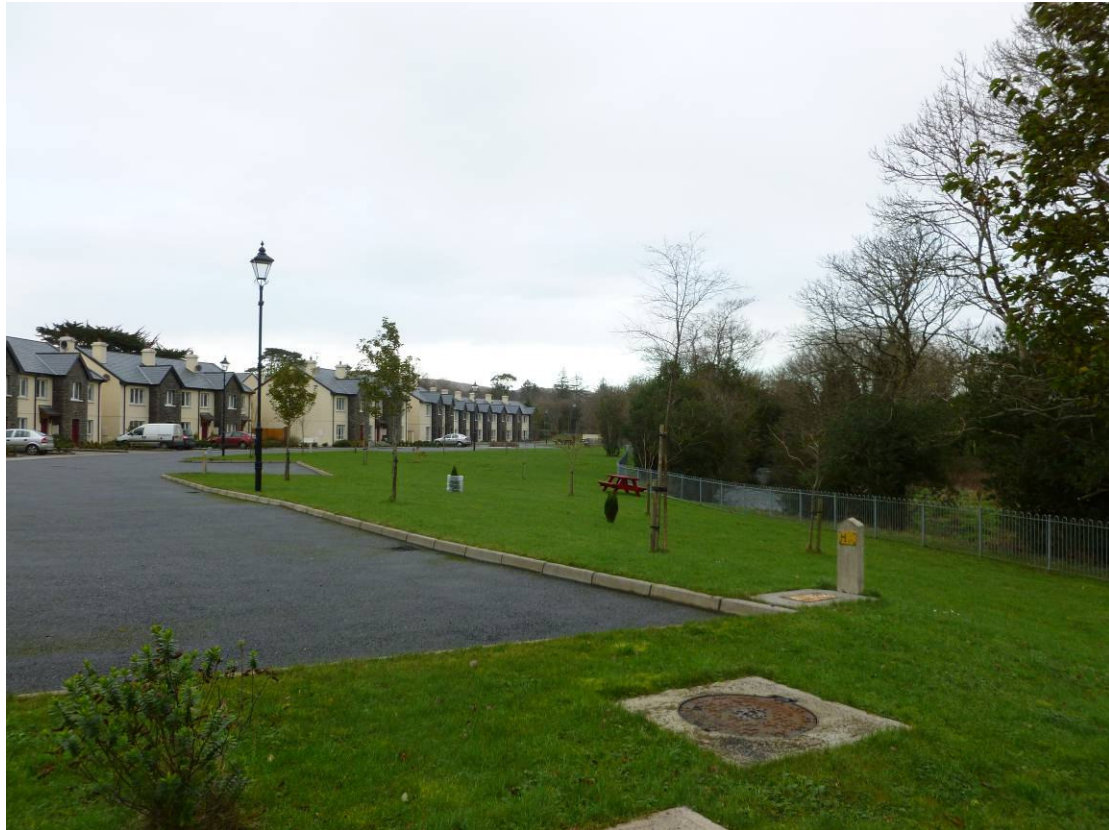
Durrus – new development susceptible to flooding.

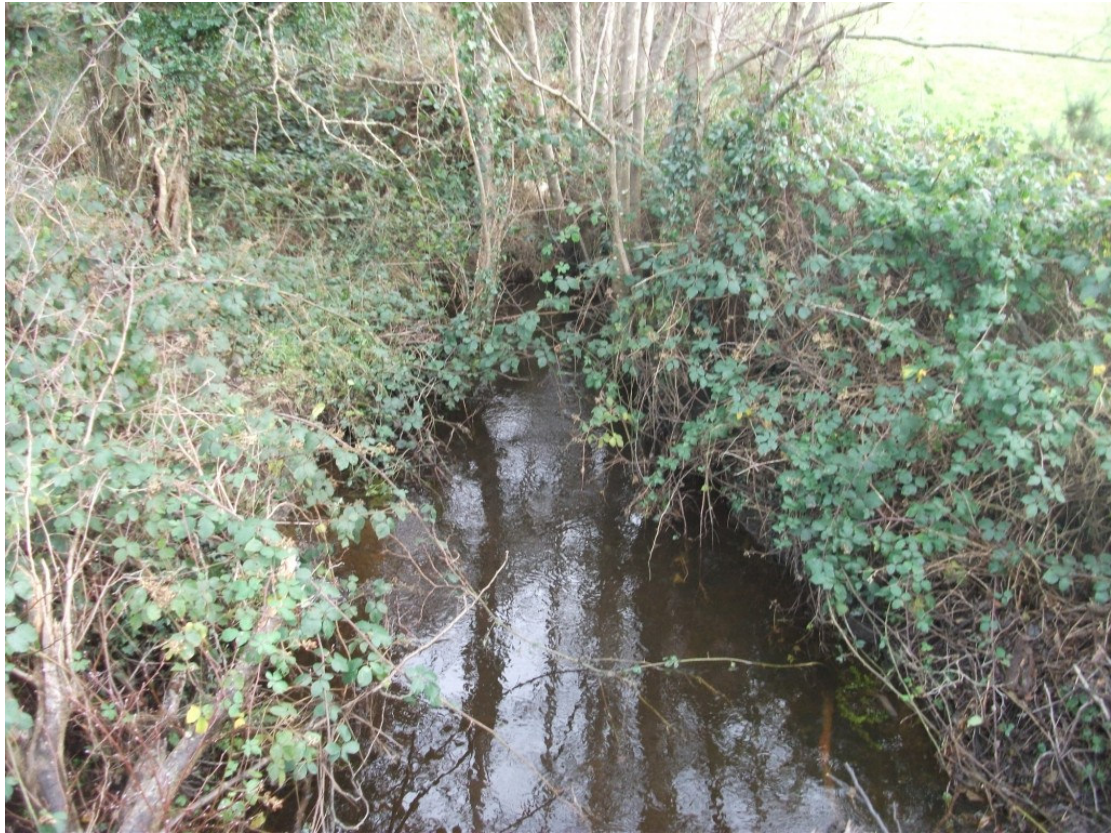
From the site visit it is clear that this is an error since the topography rises significantly in this area in addition to the source stream being comparatively small as illustrated in the photos below:

Stream channel north of school & properties

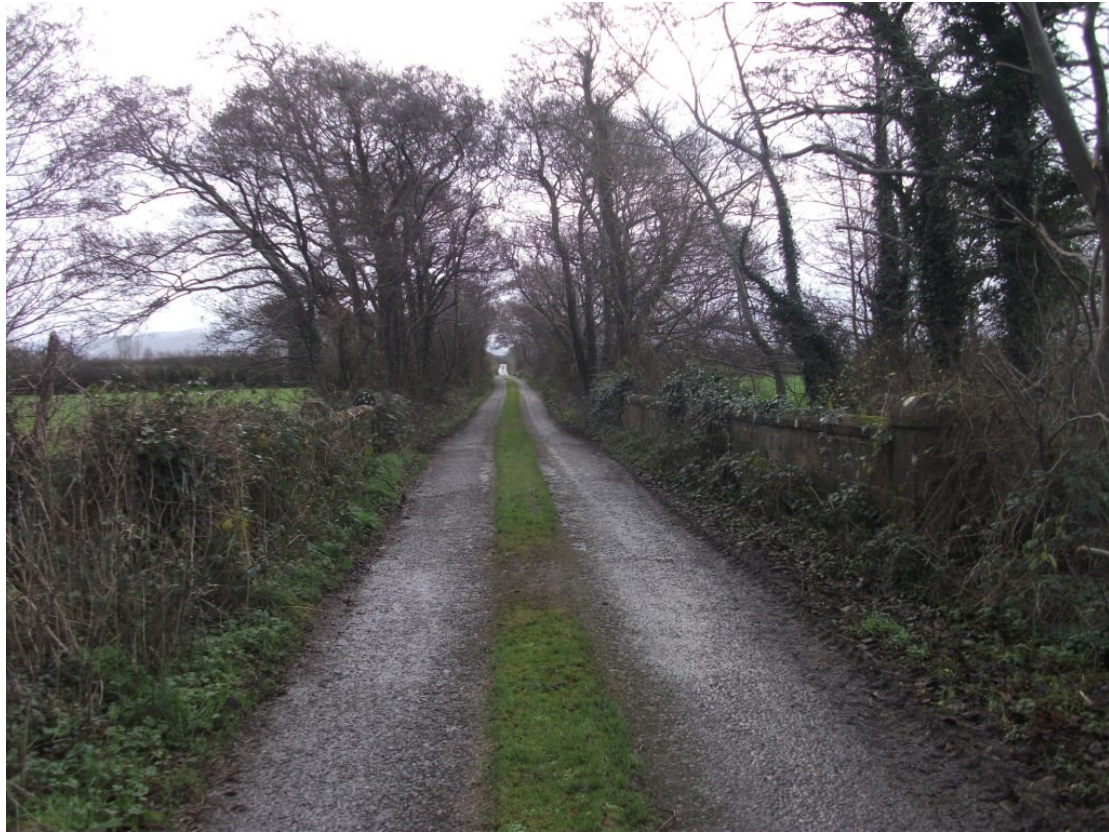
Road and land rising to south (towards school and other properties)

This wedge is over estimating the risk south of the stream channel and amendments are proposed to resolve this. The amended boundaries are indicated on the attached map.

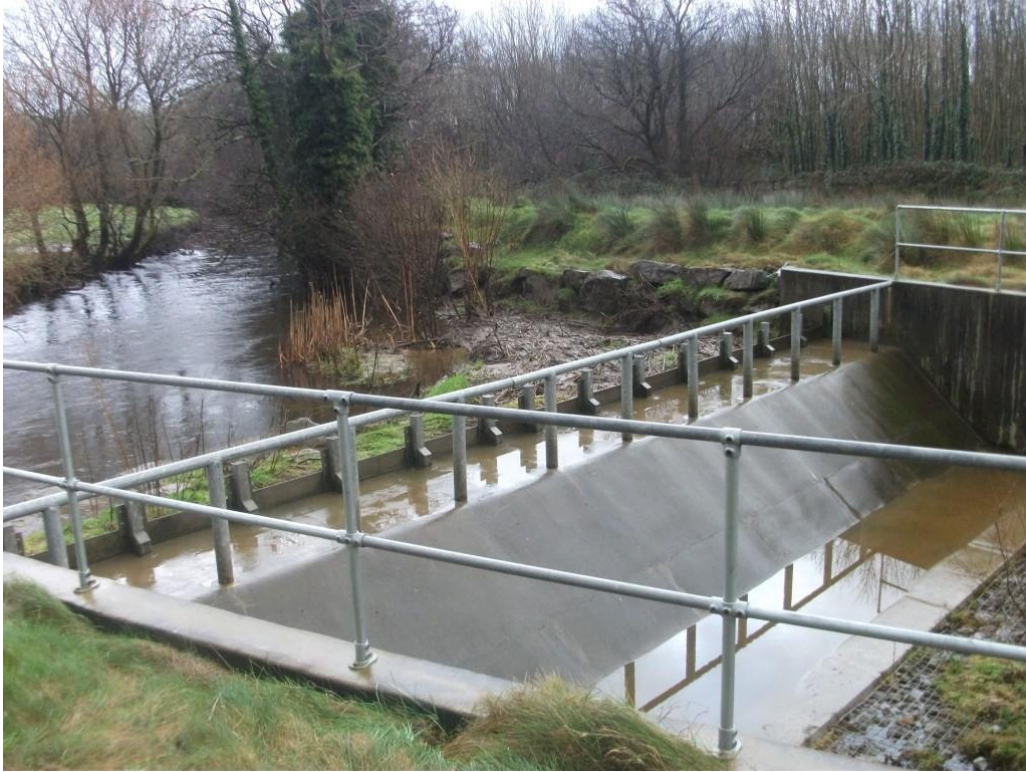
As mentioned above, a flood alleviation channel has been constructed near the meanders in the Brown Flesk River (east of N22 at garden centre) and while no water was overflowing into this during the site visit, it was evident that the channel had recently been in use.

Spillway to flood alleviation channel

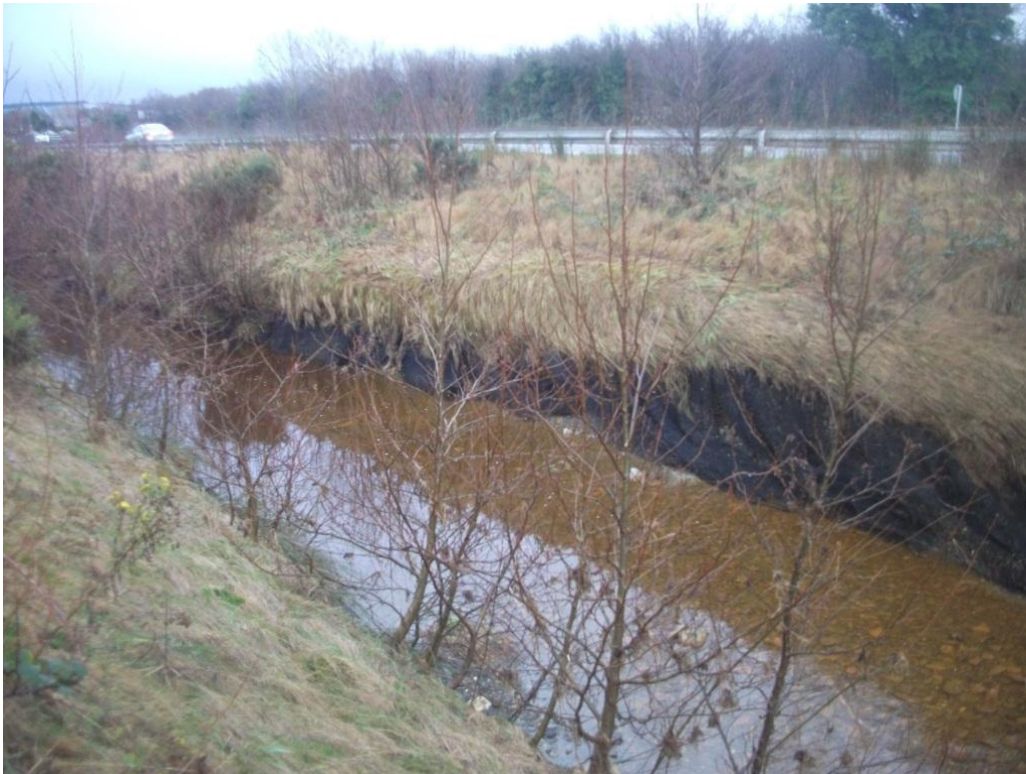
Evidence of recent high flow in flood alleviation channel (matted grass on far bank)

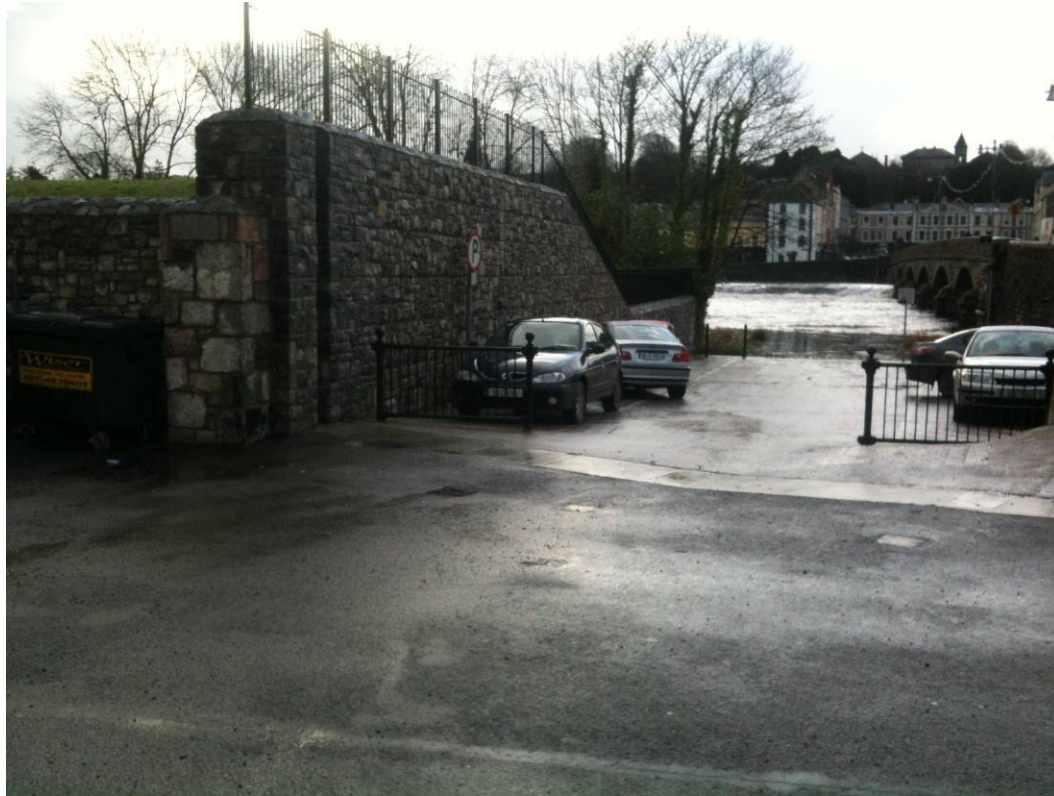
Permanent and demountable flood protection works have been installed in the town north of the river to a height of approximately 3m above the existing bank levels. Refer to the attached maps included in the Appendix to this Site Inspection Report.

Flood Protection works north of the river at the bridge

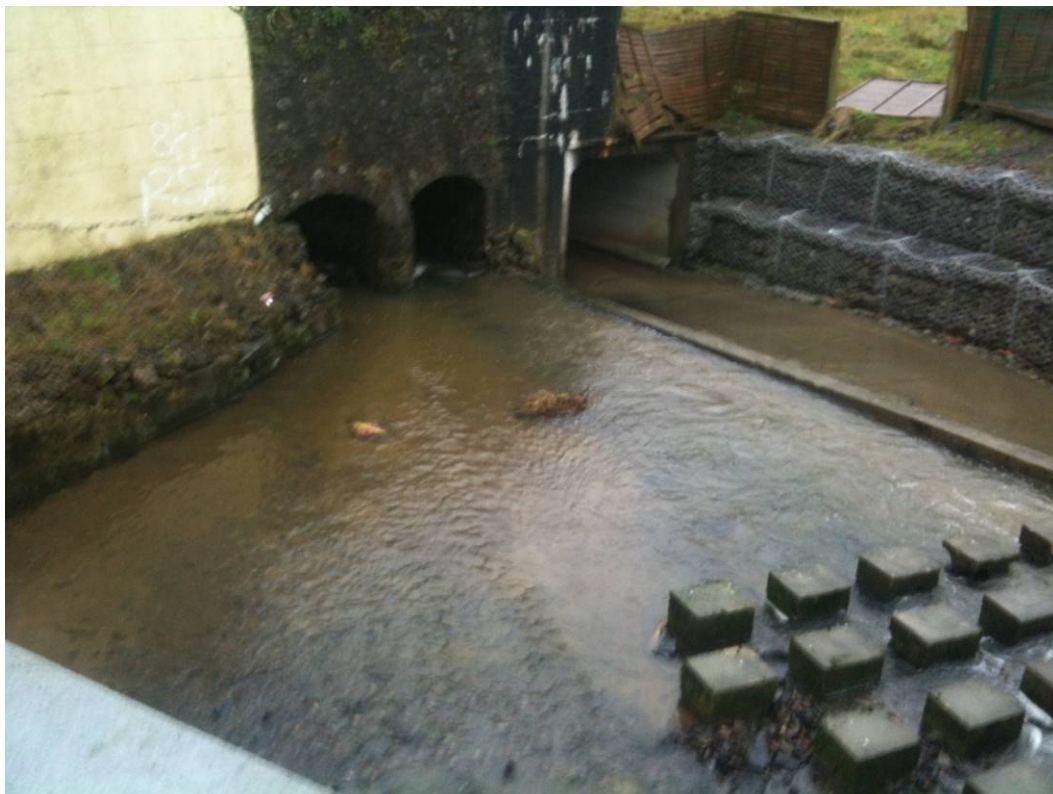
Flood overflow behind houses on west side of R578 in the village.

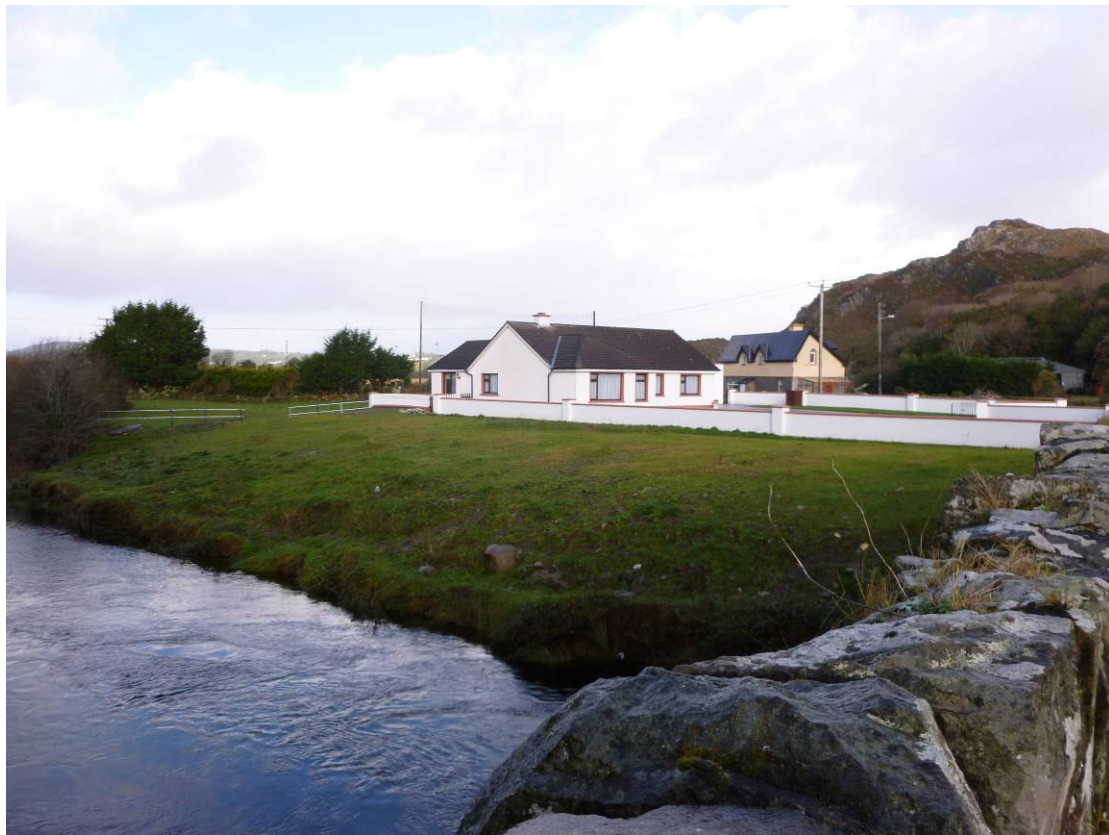
Glenflesk – property at risk.

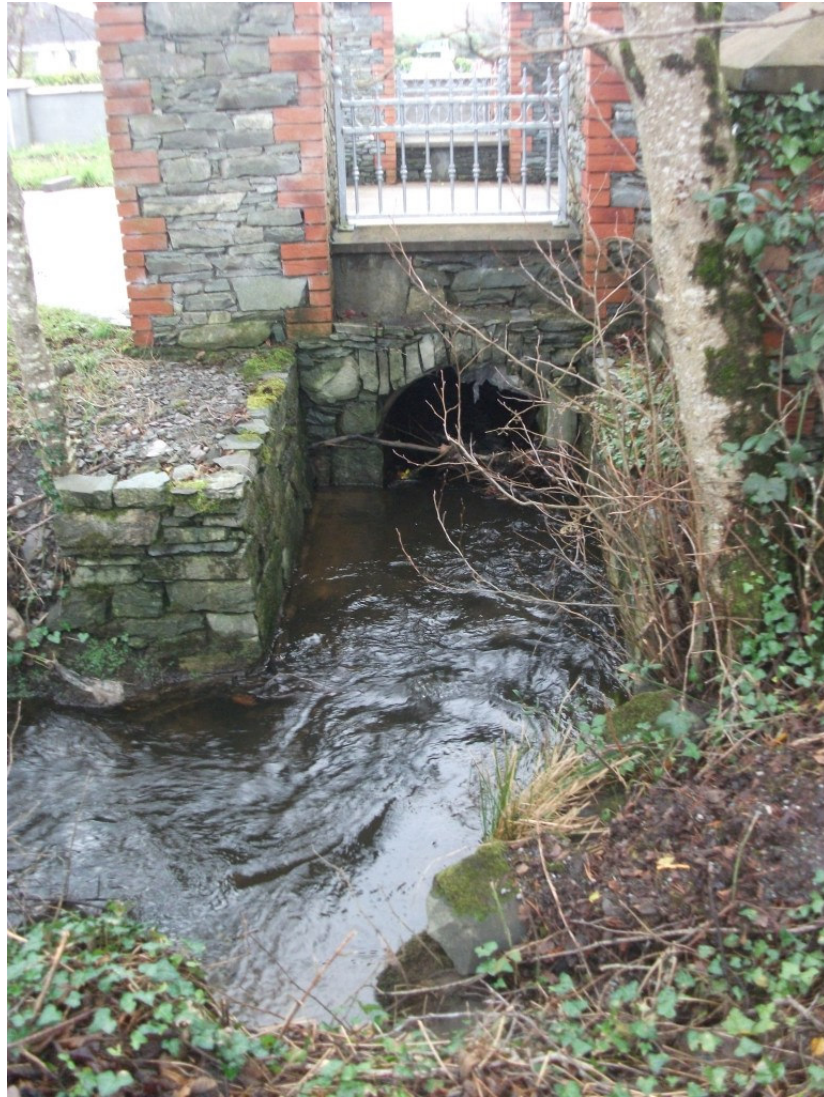
Stream culvert inlet at nursing home

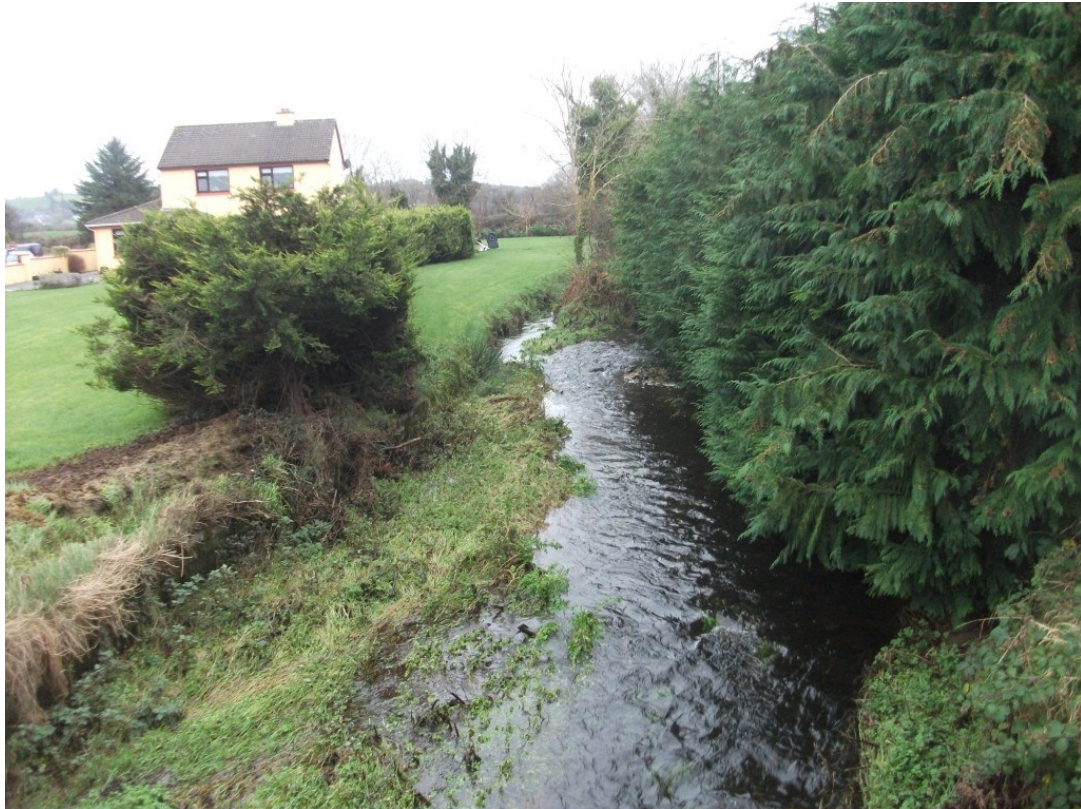
**House which is no longer affected due to culvert improvement works
(garden is still affected)**

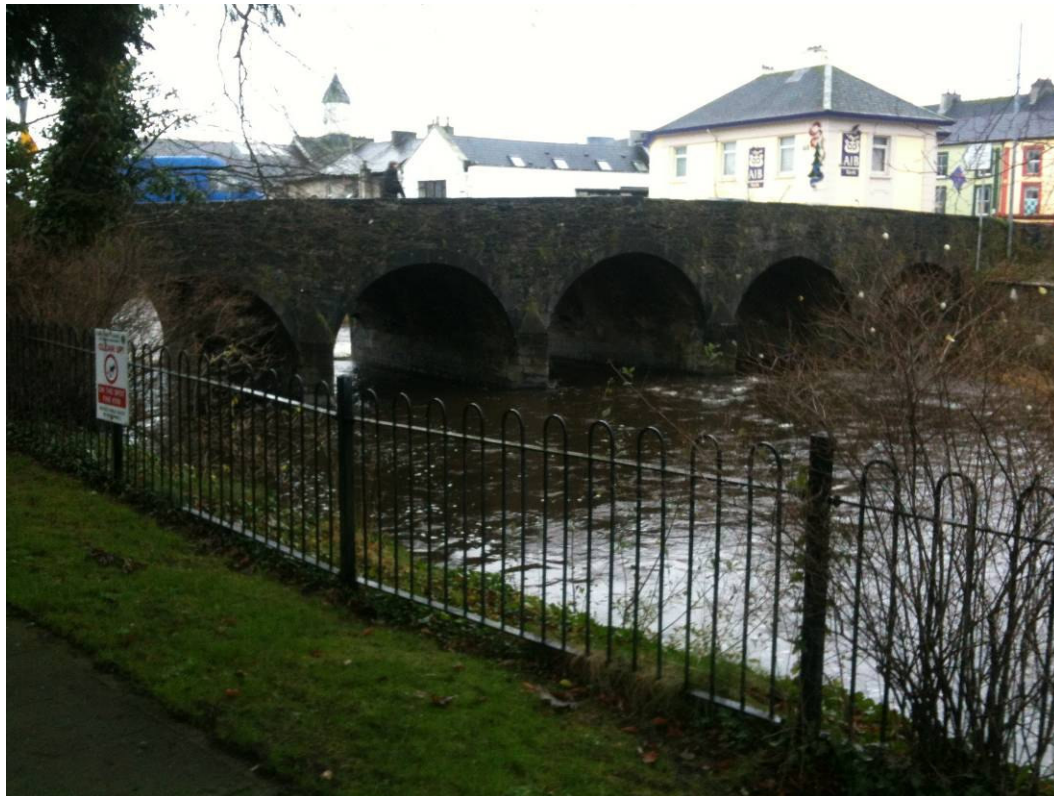
The soffit levels of the River Dalua six eyed masonry arch bridge (Main Street Bridge) in the town centre are approximately 2m higher than the approach road levels on O'Brien Street. The soffit levels of the River Allow five eyed masonry arch bridge (Greenane Bridge) in the town centre are approximately 1m higher than the Main Street Bridge soffit levels. A number of weirs have been installed on the rivers within the town. River widening works have been undertaken downstream of the town to accommodate larger downstream flows in the River Allow.

Upstream side of River Dalua Bridge (Main Street Bridge) in the town centre

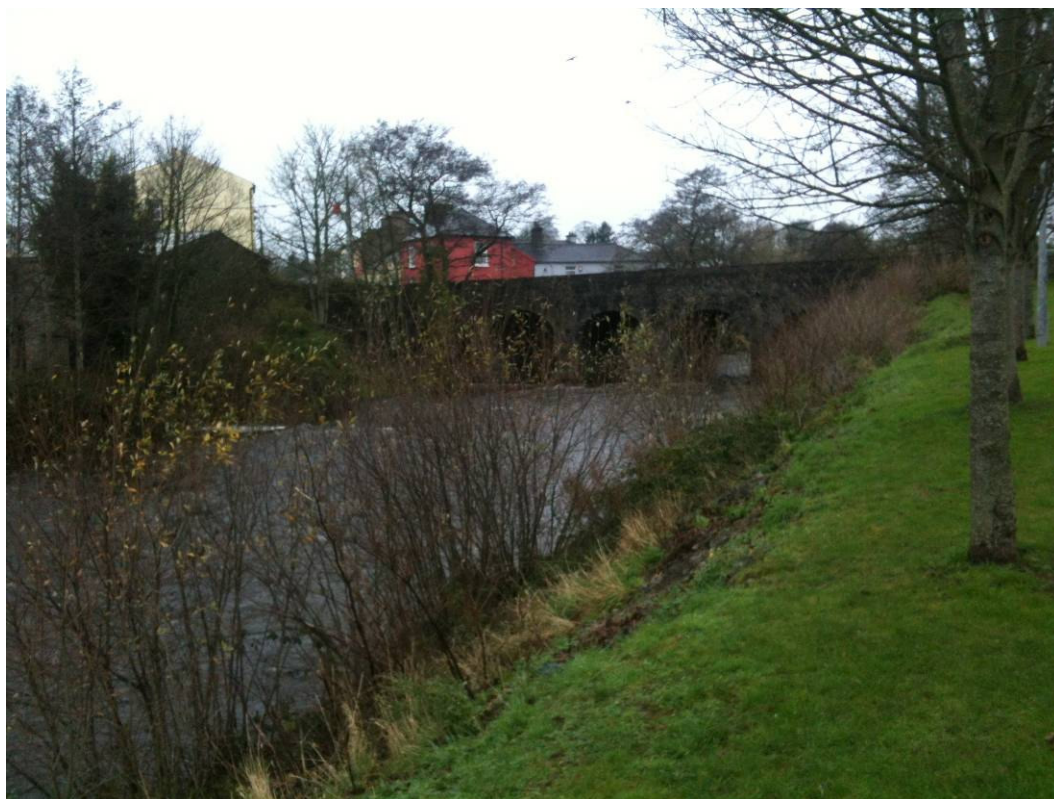
Downstream side of River Allow Bridge (Greenane Bridge) in the town centre

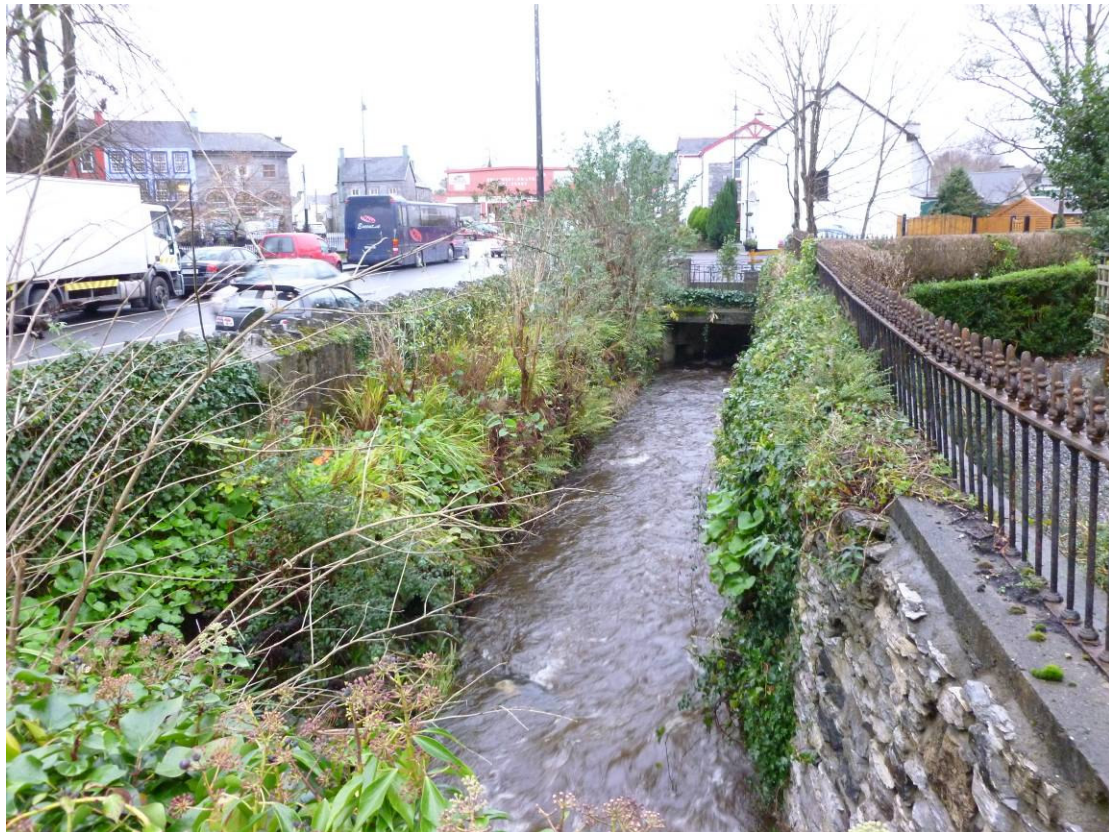
Kenmare – river runs through town adjacent to town square.

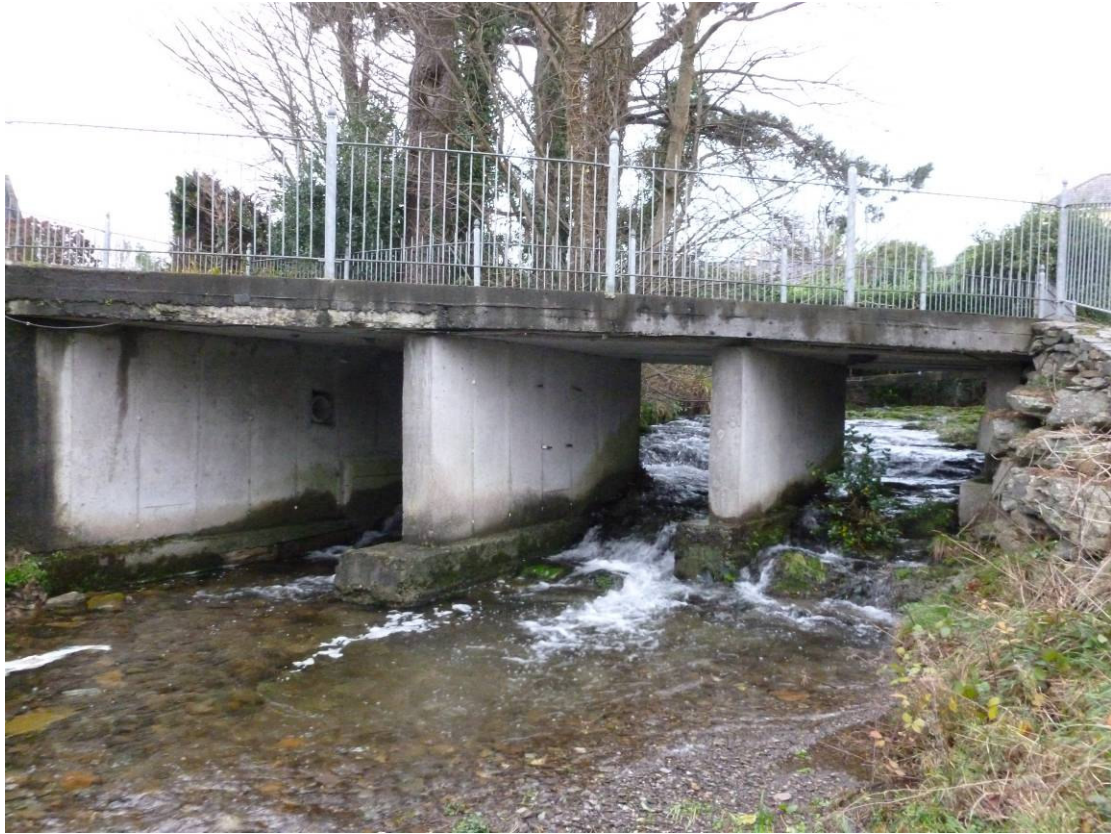
Kilcrohane – view of bridge and river adjacent to town.
