SWRBD CFRAM Study

Flood Risk Review Report

February 2012
Office of Public Works

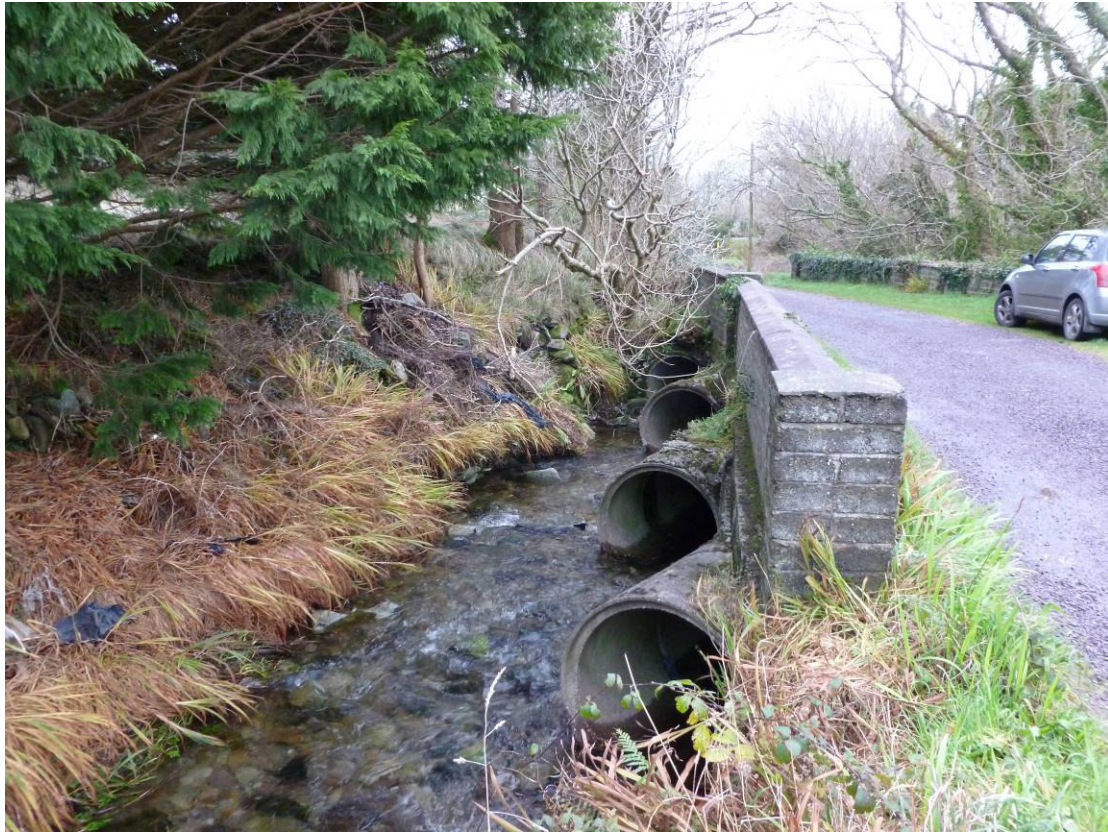
Kilcrohane – culvert downstream of village.

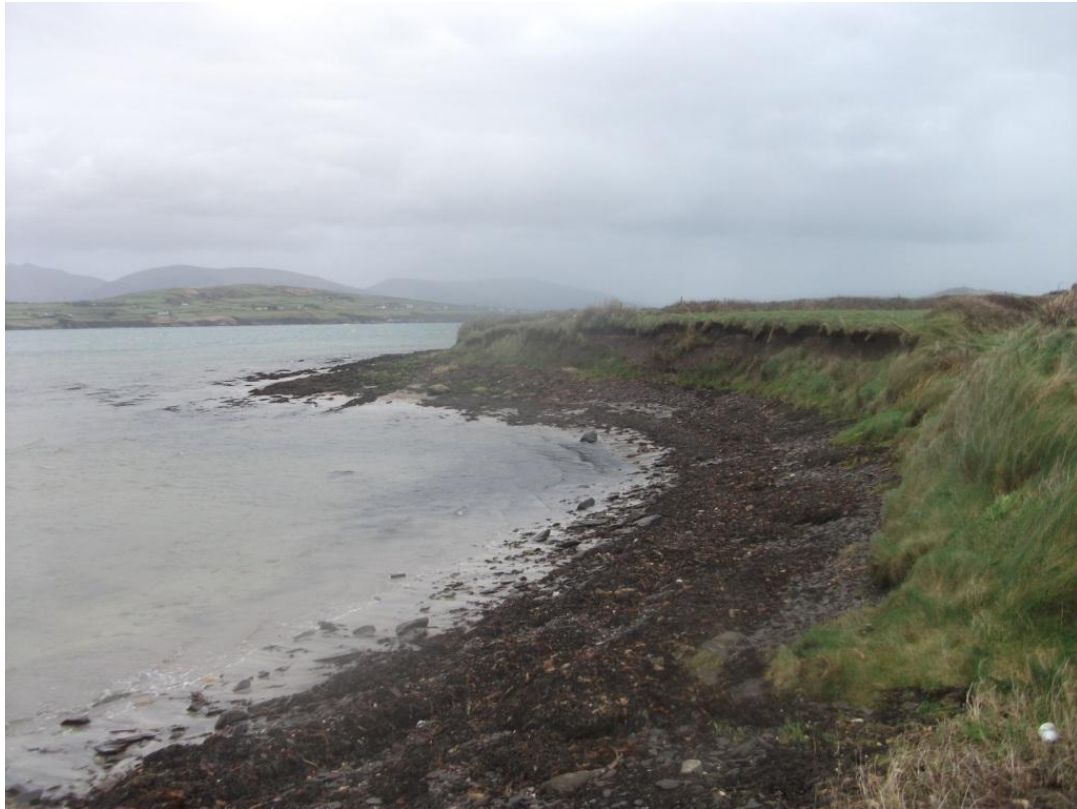
Typical difference in level along shoreline

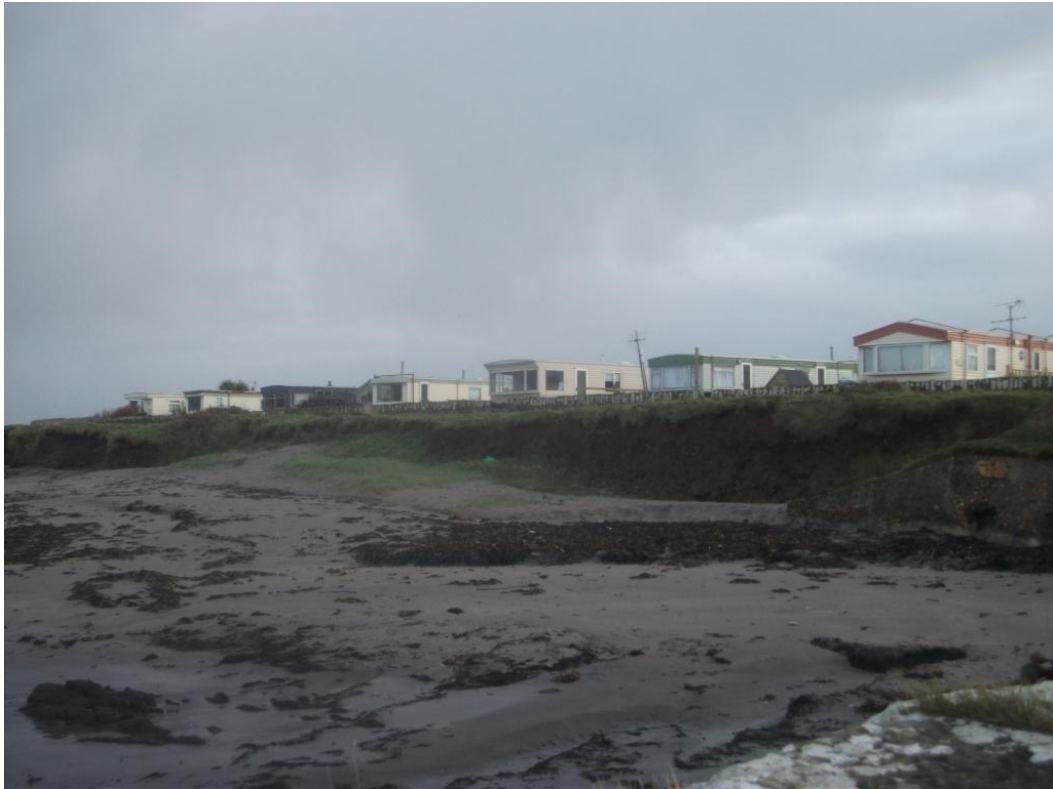
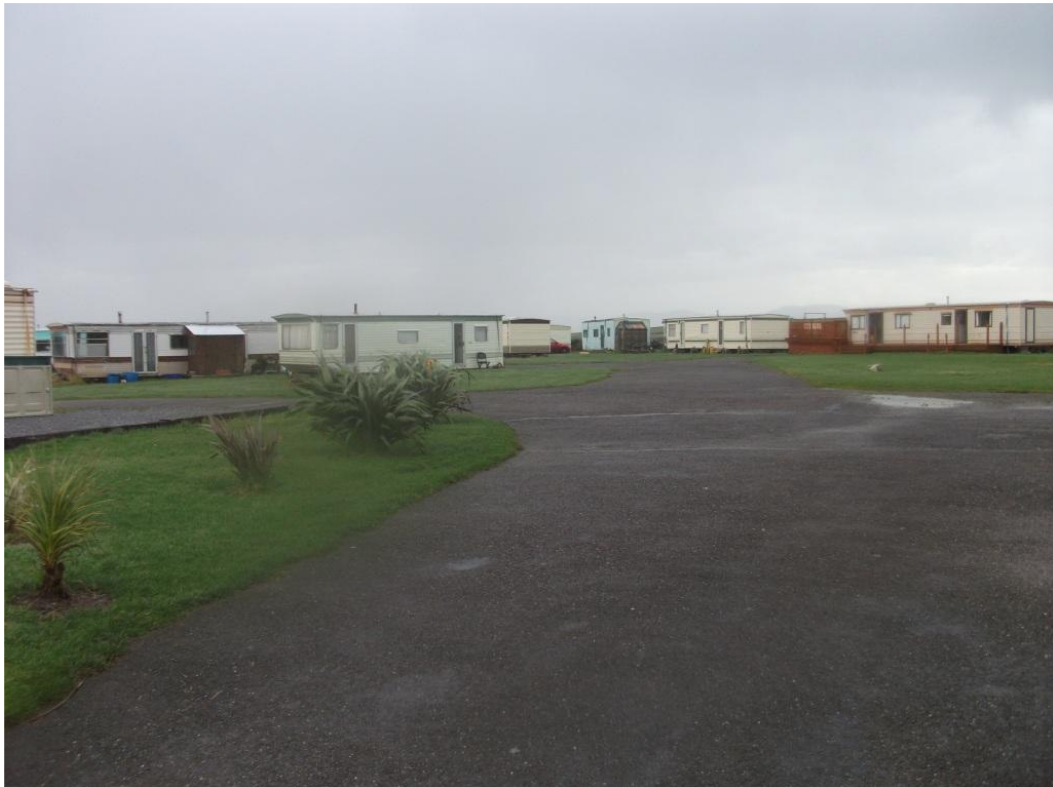
Approximately 70 mobile/holiday homes are located in the north west corner of the Risk Review (RR) area (see photos below). These are not recorded on OSI mapping but are visible on ortho-photographs and may account for the high com/res index.

Holiday homes located at Kilfarnoge

These appear to be above outside the 10%, 1% and 0.1% flood outlines and it is recommended that the index is reduced to reflect this.

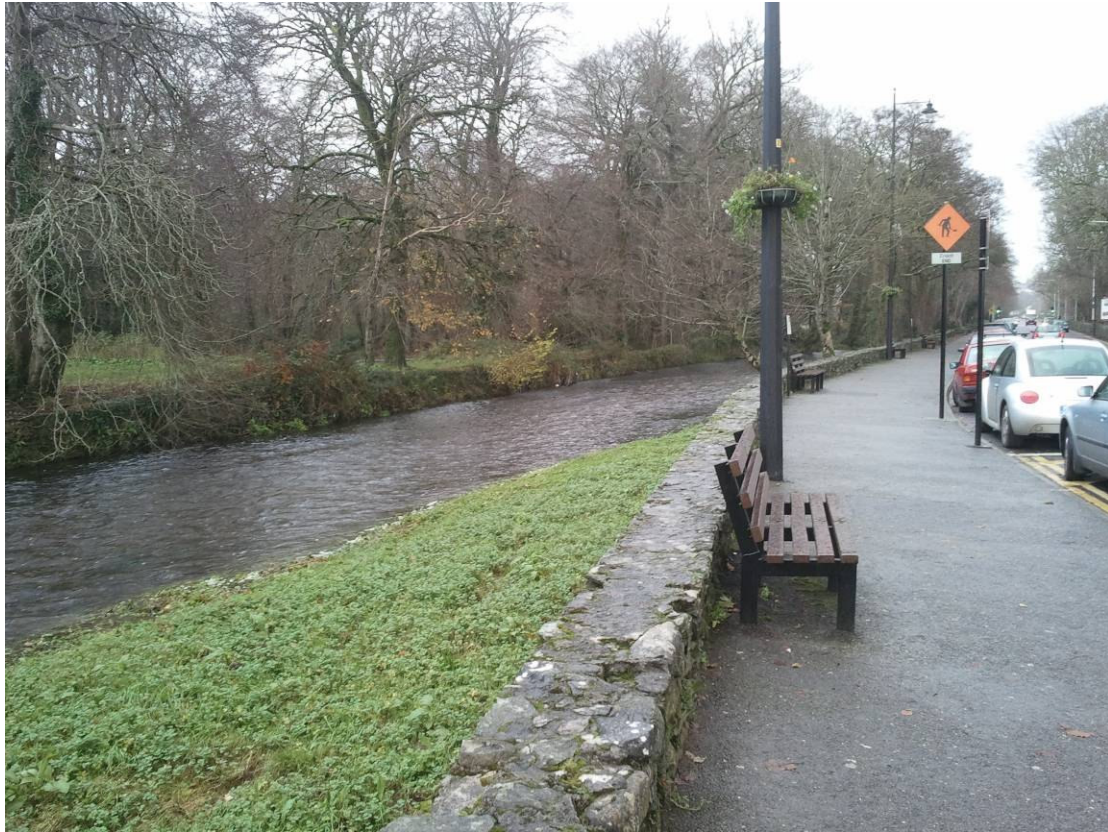
The River Deenagh next to the Port Road.

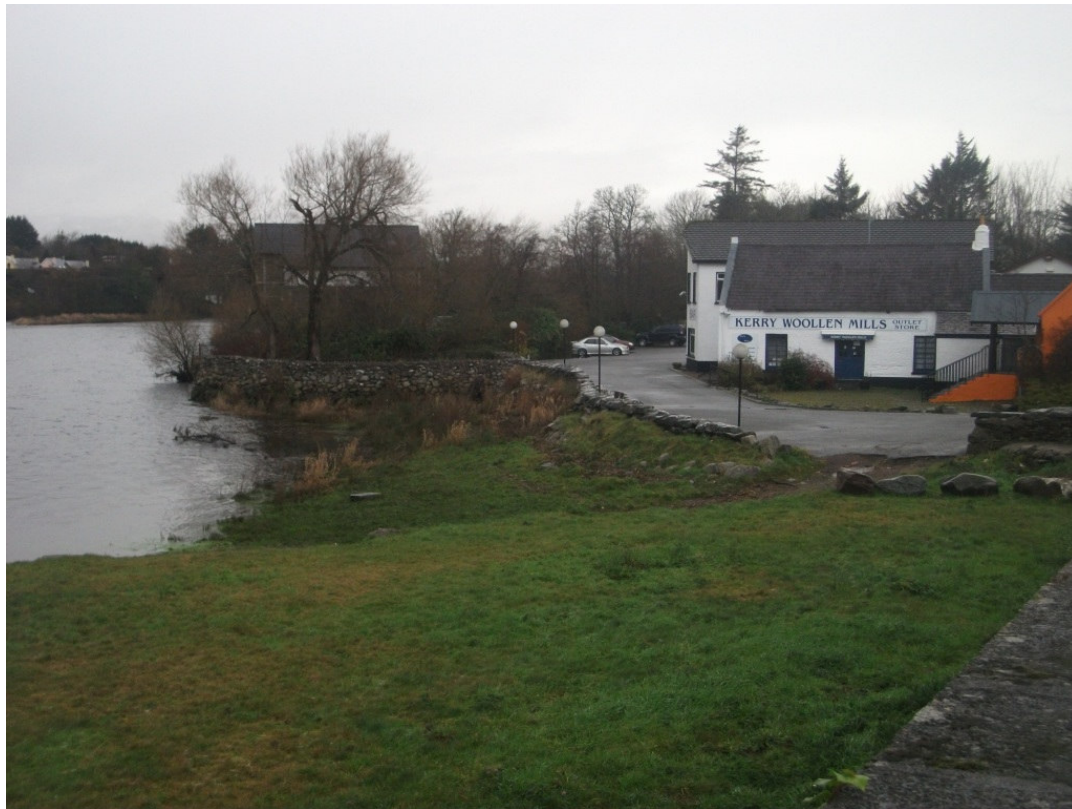
Enquiries were also made at the filling station and the fishery (near wool mill) on the east bank of the River Laune. Staff at the filling station were unaware of any flooding issues while staff at the fishery (lower level, shown in photo below) advised that the car park and building flooded occasionally during combinations of high tides and flows. The individual was of the opinion that the problem was related to a build up of material in the river channel and that maintenance works were needed.

**Woollen mill & fishery susceptible to flooding
(East bank, downstream of N70 bridge)**

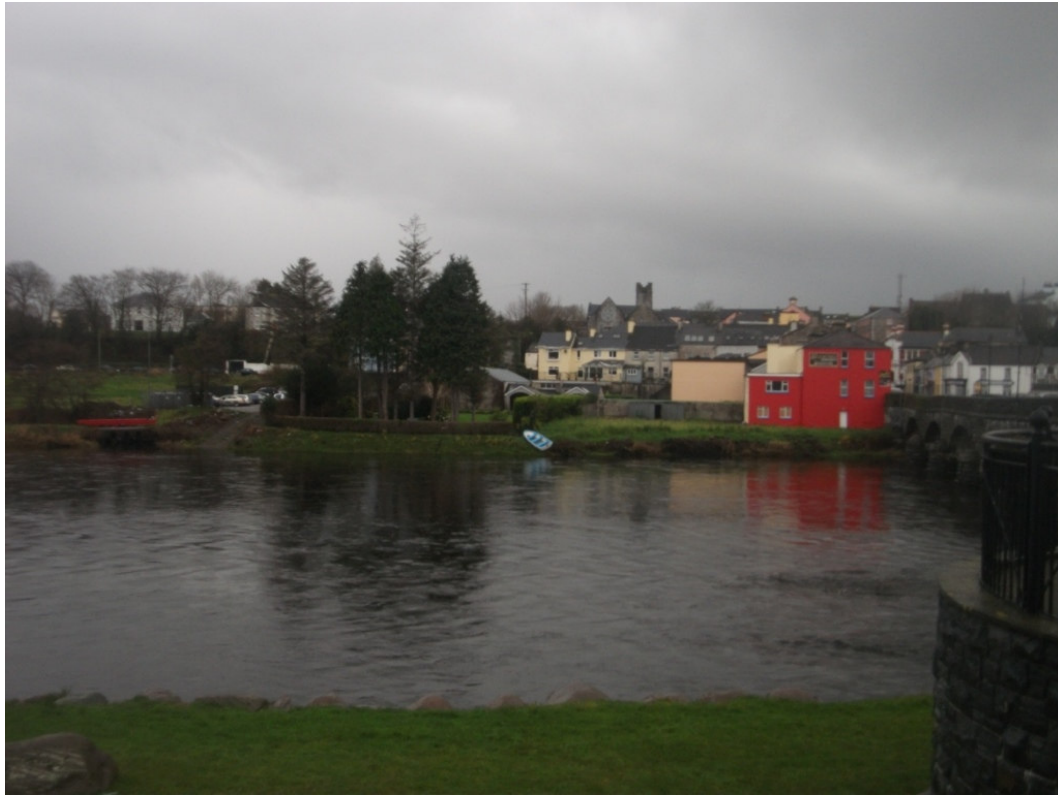
Properties upstream of bridge (west bank) which are historically susceptible to flooding

It should be noted though that some properties adjacent to the river bank near the N70 bridge do flood and these would benefit from localised defence or channel improvement works.

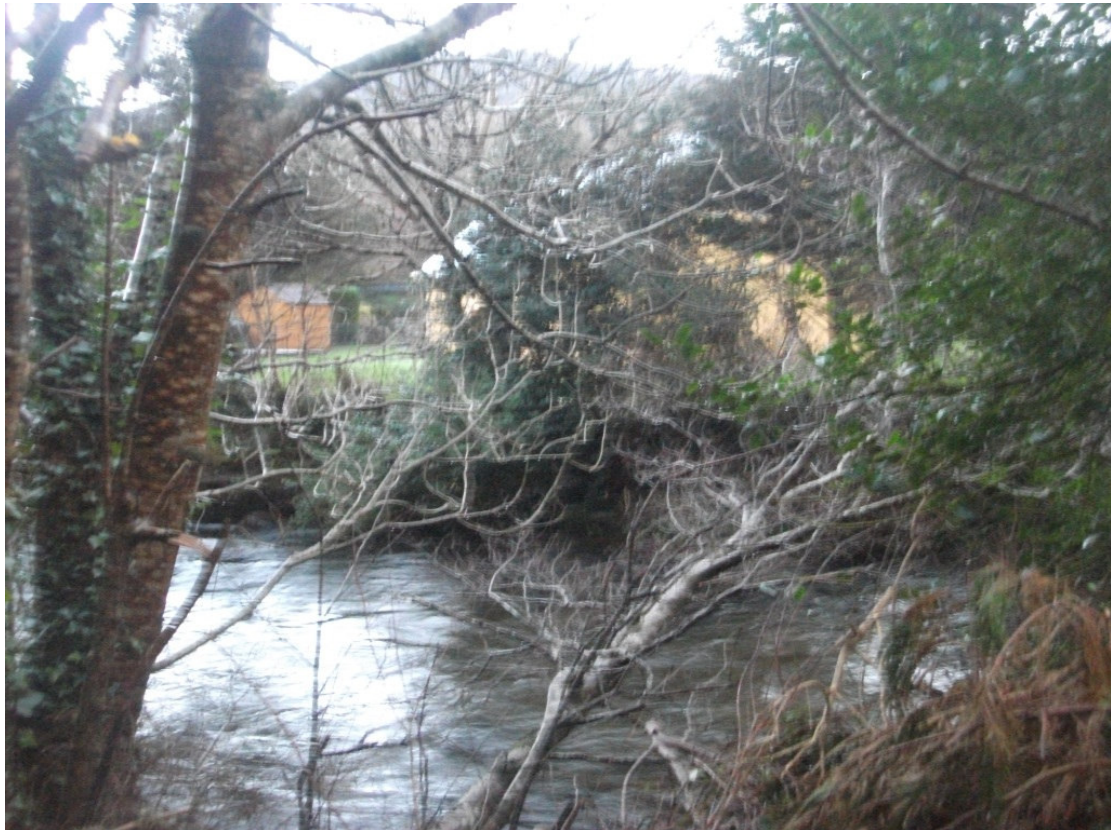
The photo below shows one of the newer houses in the area which, although located beside the river, has been constructed at an elevated level, presumably to reduce the risk of flooding:

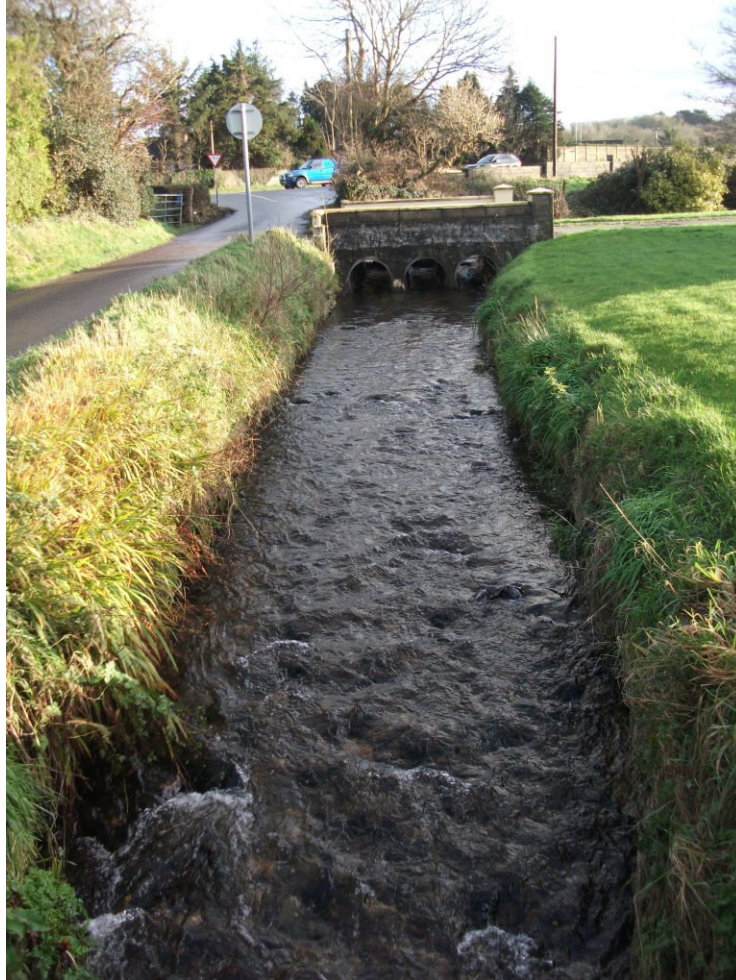
He also advised that a local farm house which is within the PFRA flood outlines was affected a few years ago and that the likely source of the problem is at a downstream bridge where the culvert pipes have less capacity than upstream (see photos below).

Three pipe culvert on Ballyoutragh stream at access point to residential property

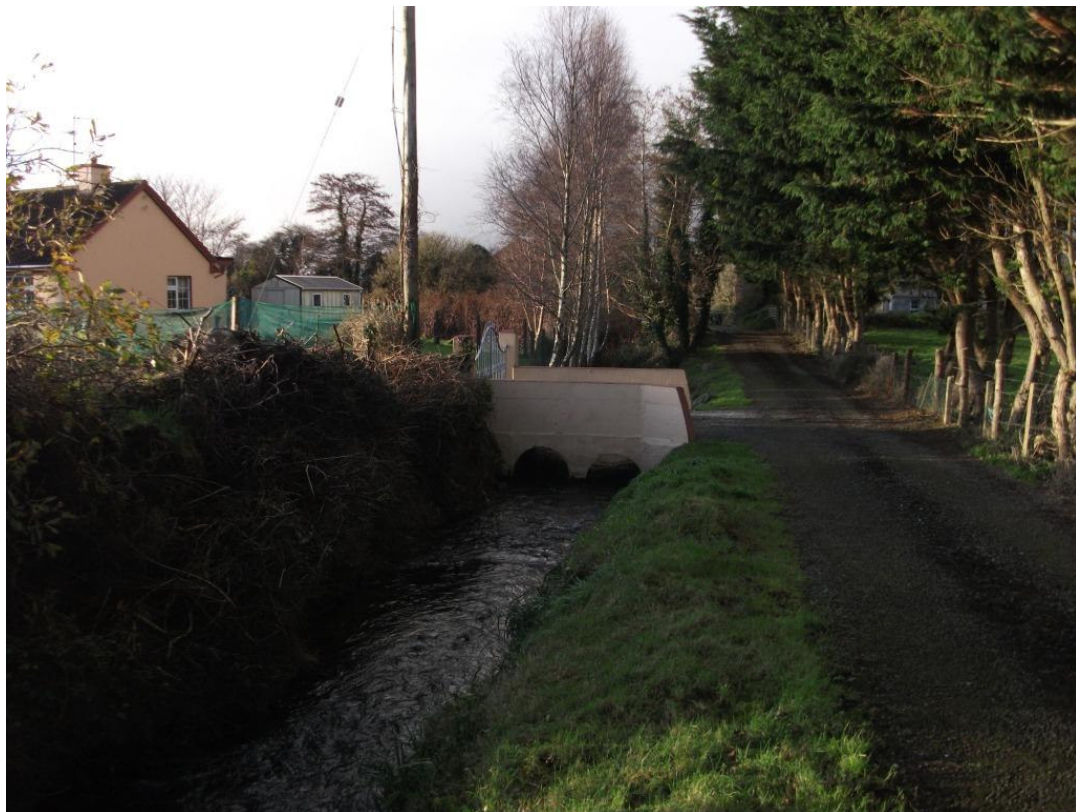
Two pipe culvert on Ballyoutragh stream at access point to residential property (downstream of first photo hence restriction at flow rates)

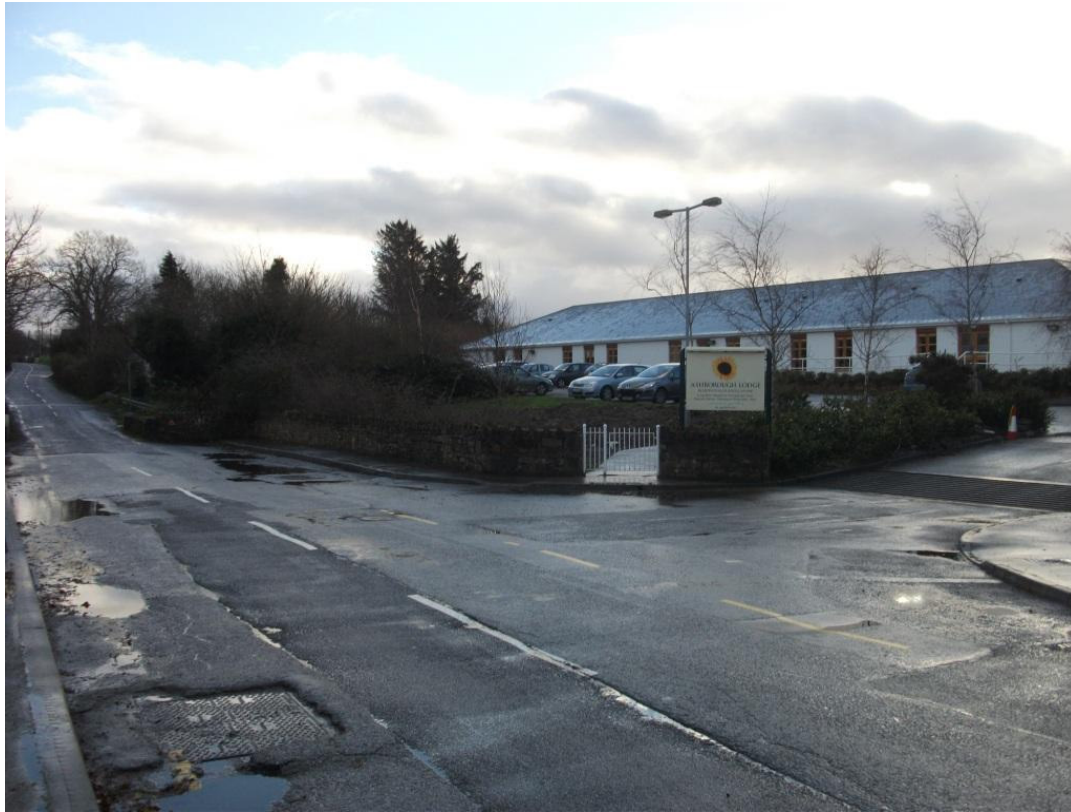
Proposed changes to the flood extent outlines will result in approximately 23 residential properties being excluded from the 10% boundary. In addition, it is proposed that the nursing home is also excluded due to its elevation relative to the nearby stream.

Nursing home (road culvert entrance for stream visible as wall extension on LHS of photo)

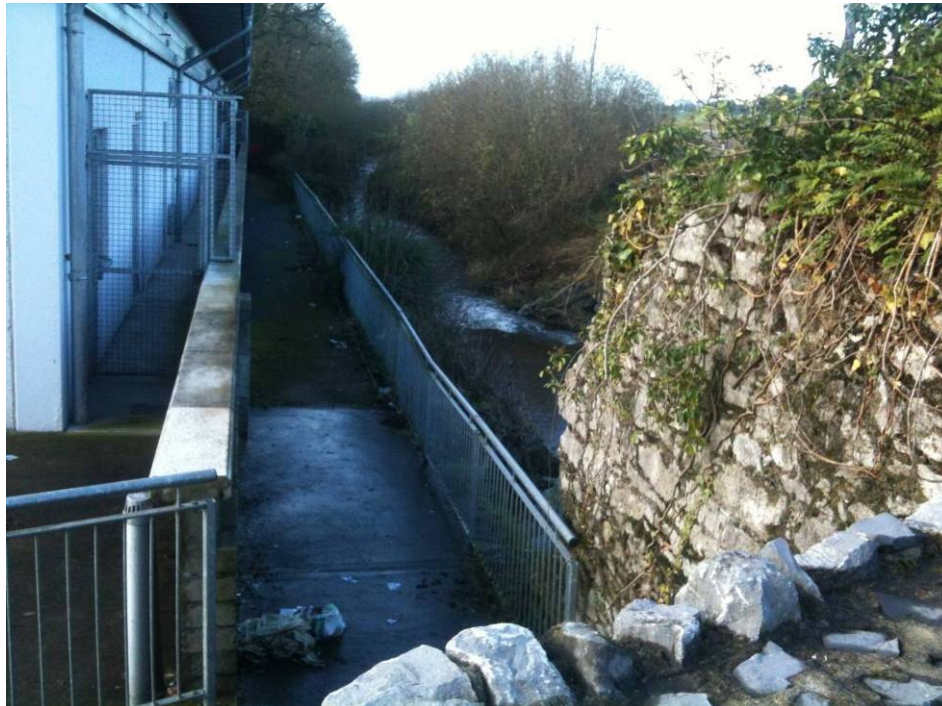
At Dublin Road North of the town, ground levels at the Aldi shop have been raised and a flood defence wall is located east of the shop.

Flood Defence wall east of Aldi shop north of the town on the Dublin Road.

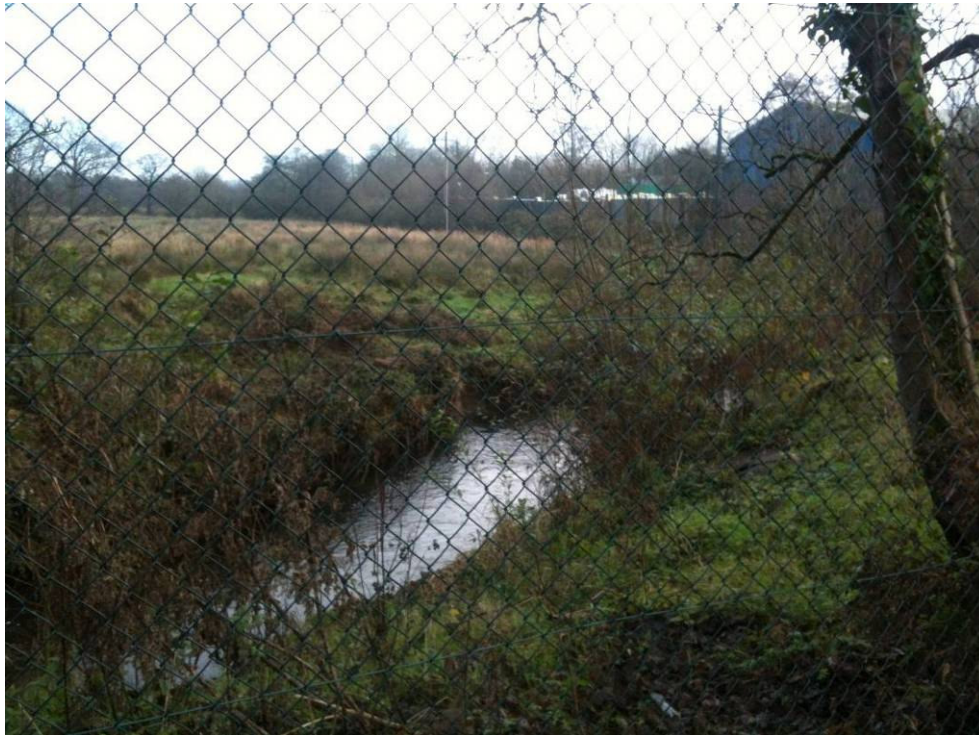
North of R665 Clonmel road north of the Dairygold yard a flood defence wall

View of flood plain and Dairygold boundary wall north of R665 Clonmel road

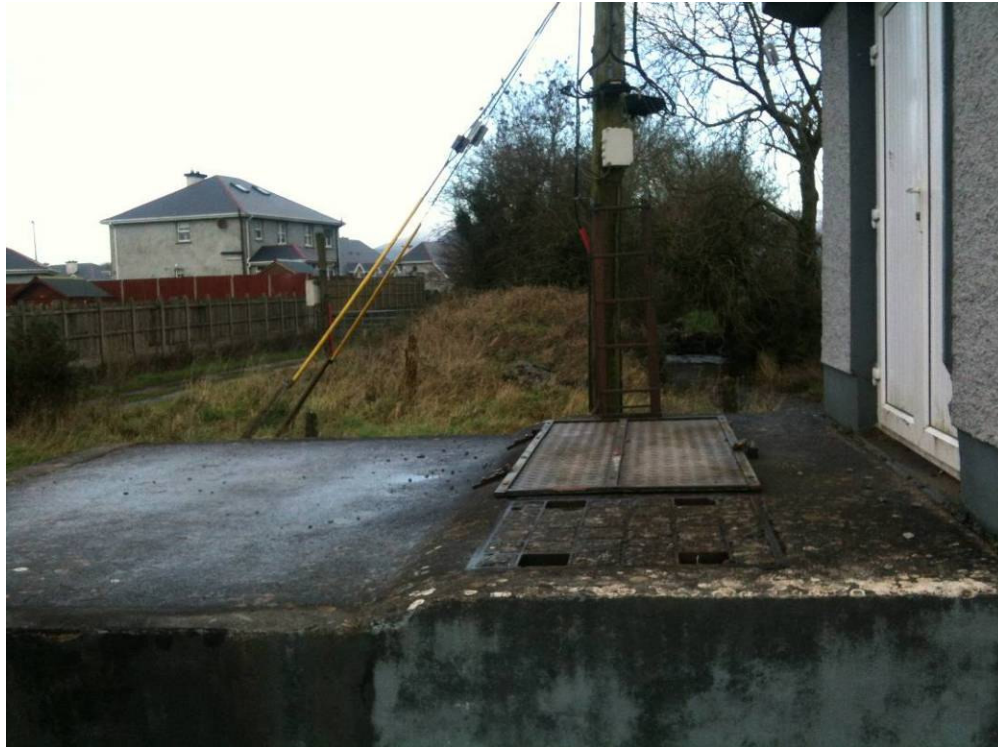
New Housing estate "Sliabh Alainn" at Ballynamona Bridge on L-1418 road with flood bund west of the river.

This site is not an AFA because flood risk in the town is low. Flood protection works currently in place at Aldi and Dairygold yard. Additional flood protection works is recommended near the Sliabh Ailainn estate at Ballynamona Bridge together with a moratorium on constructing new houses in the floodplain.

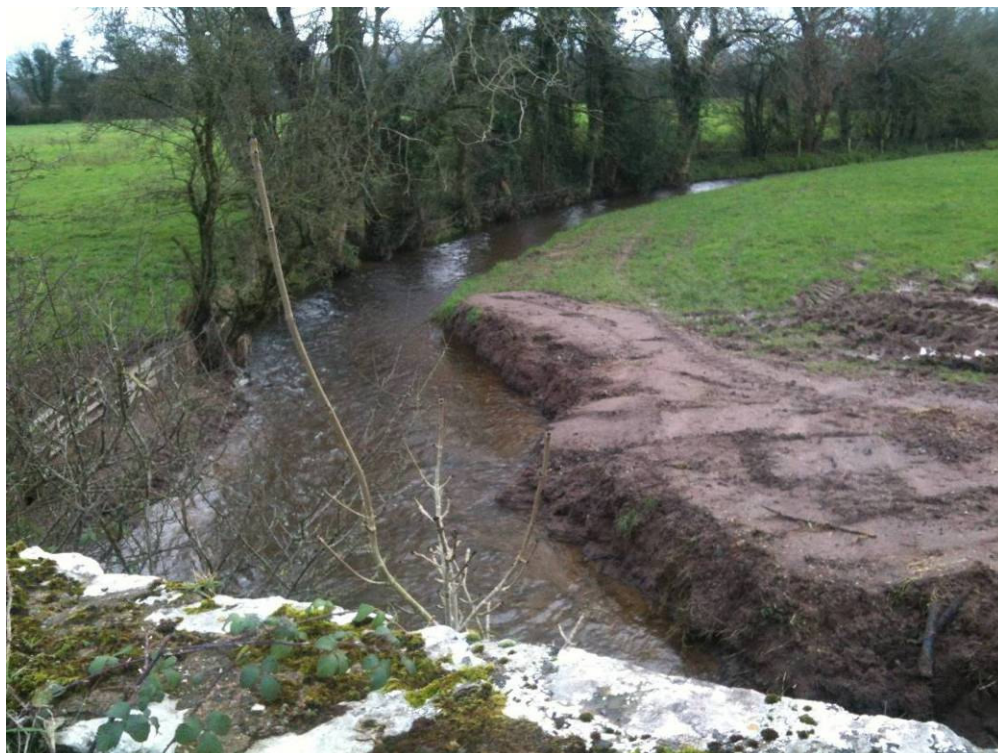
Channel widening works south of Ballynamona Bridge on L-1418 road.

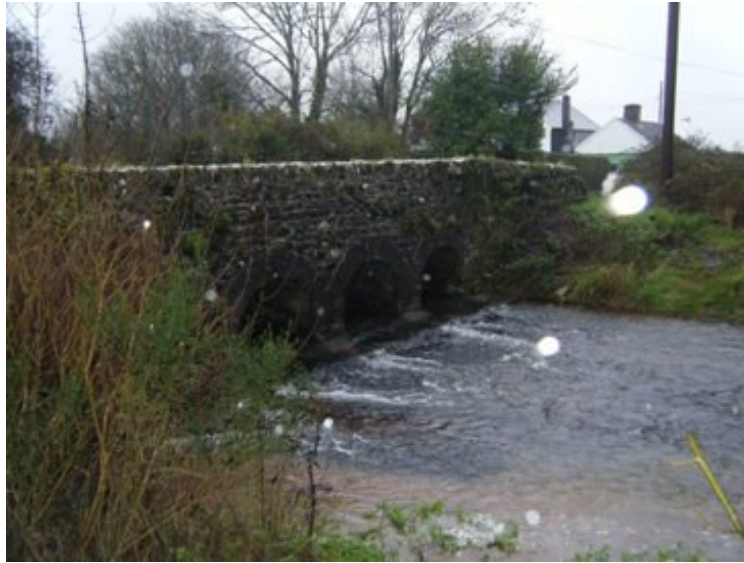
Bridge at north end of village - Kiltha River

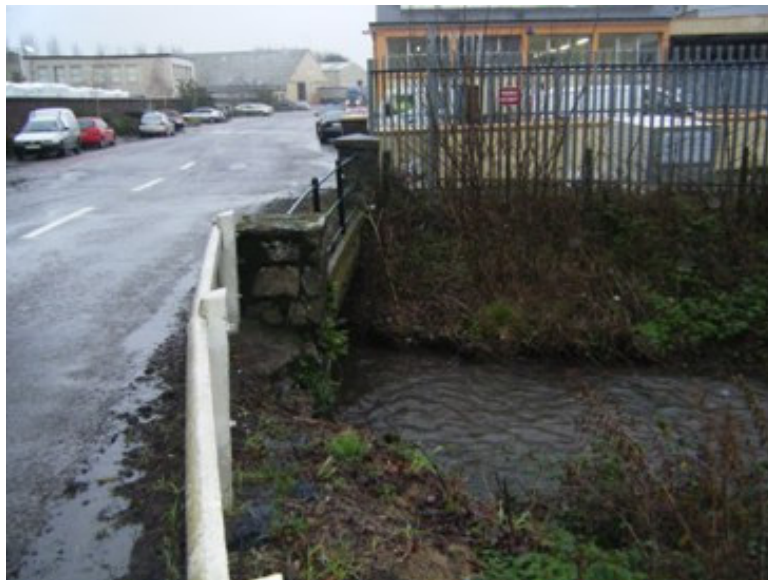
Bridge adjacent to Dairygold Creamery - Kiltha River

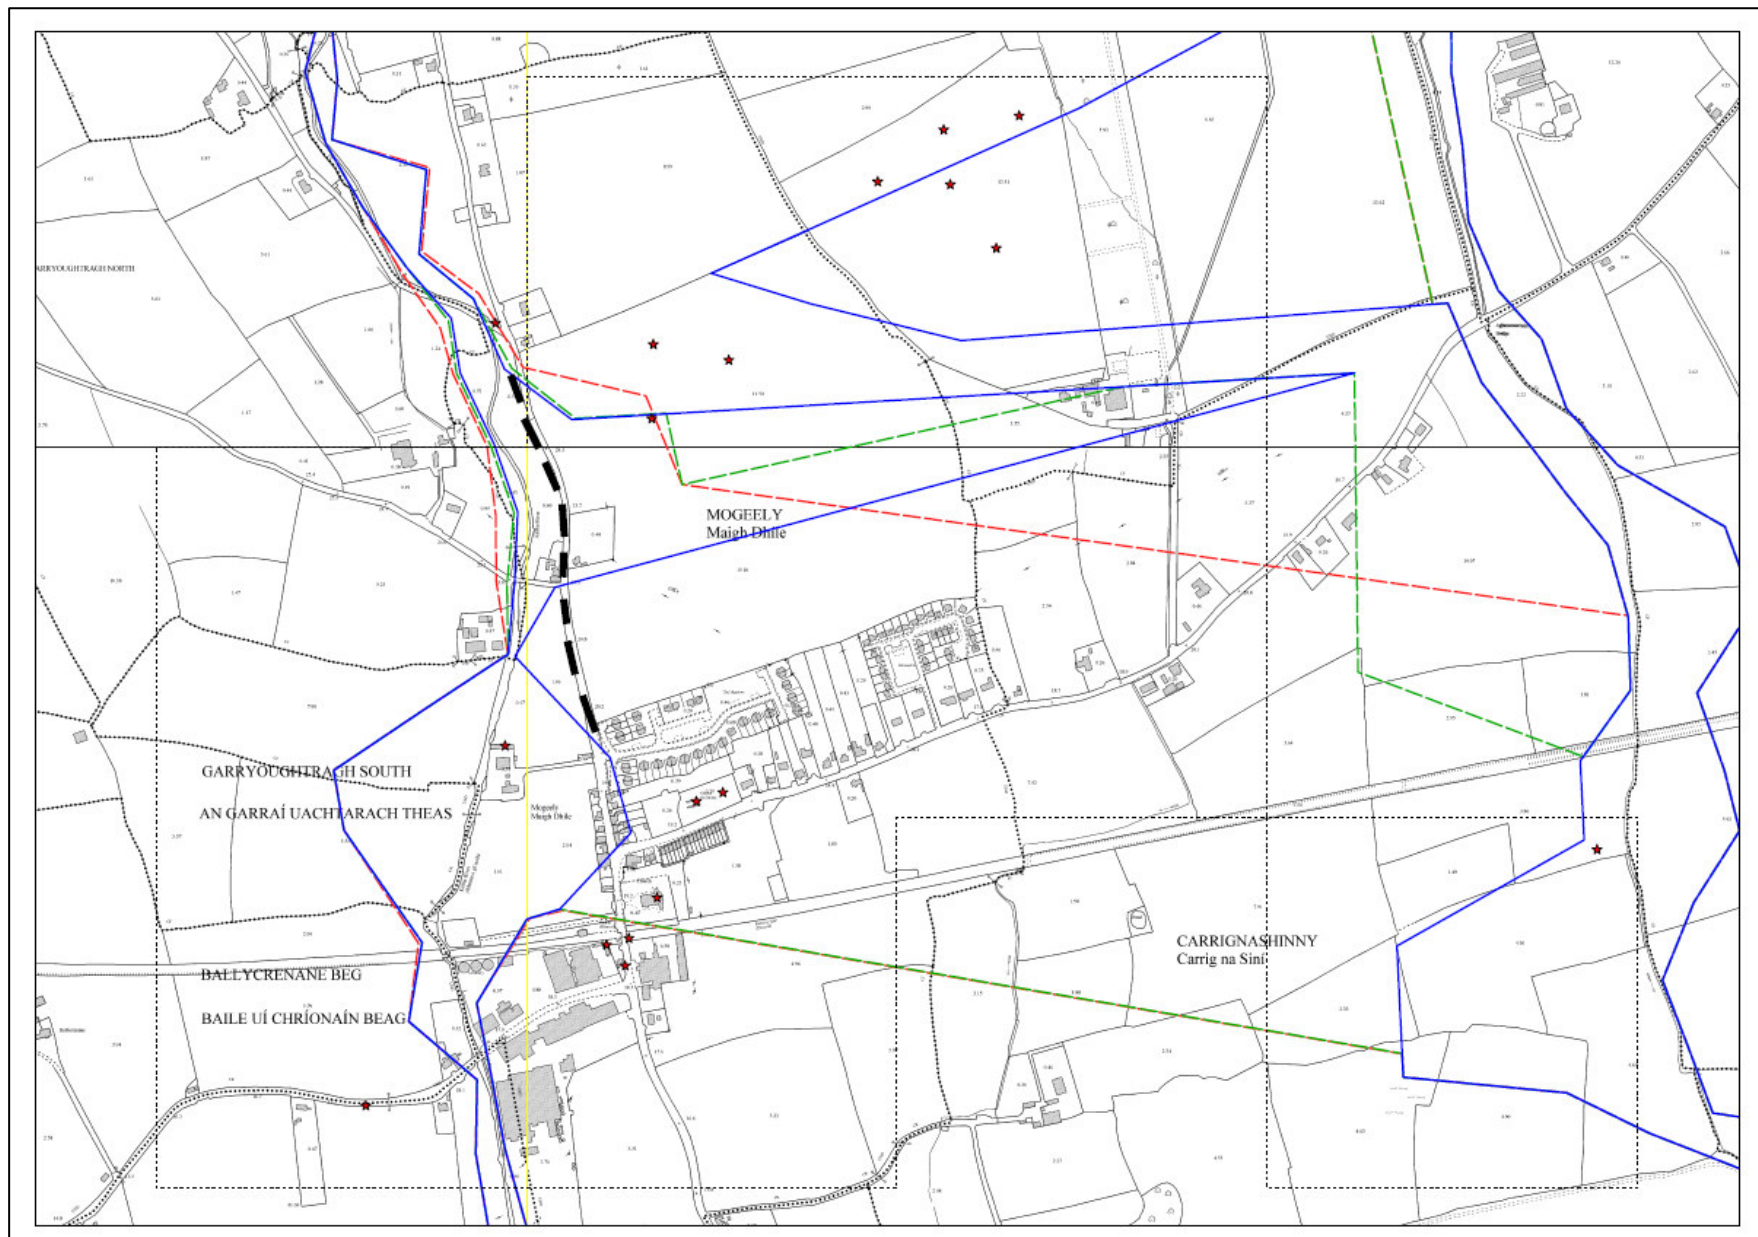
Mogeely Revised Outline

The 10%, 1% and 0.1% AEP outlines between the Kiltha River and the river/stream to the east of the village in the vicinity of the new housing estate and railway line are not representative of the local topography, therefore overestimating flood risk in this area. From the site visit it would appear that there are errors in these outlines which would remove a total of 3 residential and commercial properties within the 10% AEP outline from the FRI and a total of 118 residential and commercial properties within the 1% AEP outline from the FRI.

Based on the site visit the PFRA outlines for Mogeely have been amended as shown in the attached map.

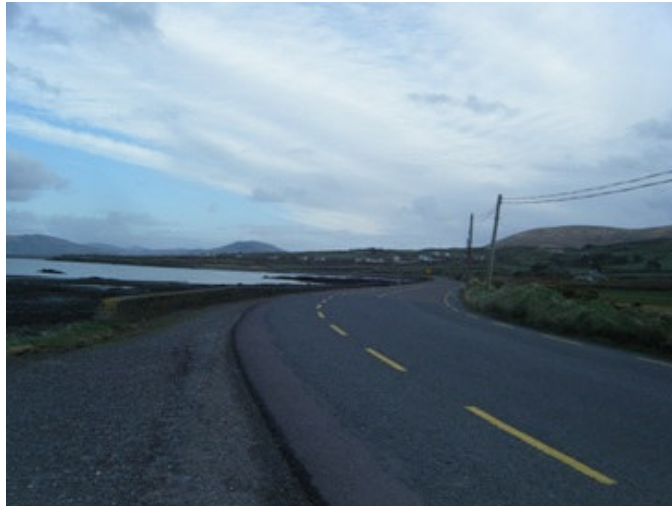
During discussion with all of the above locals of Portmagee they confirmed that frequent flooding occurs to the R565 Regional Road prior to entering to village which causes the road to become impassable. They stated that at times of high tide the level of the sea is level with the road and that the adjacent field also floods. It is felt that the road should be raised in this area and appropriate warning signage should be installed.

R565 Regional Road – Frequently flooded

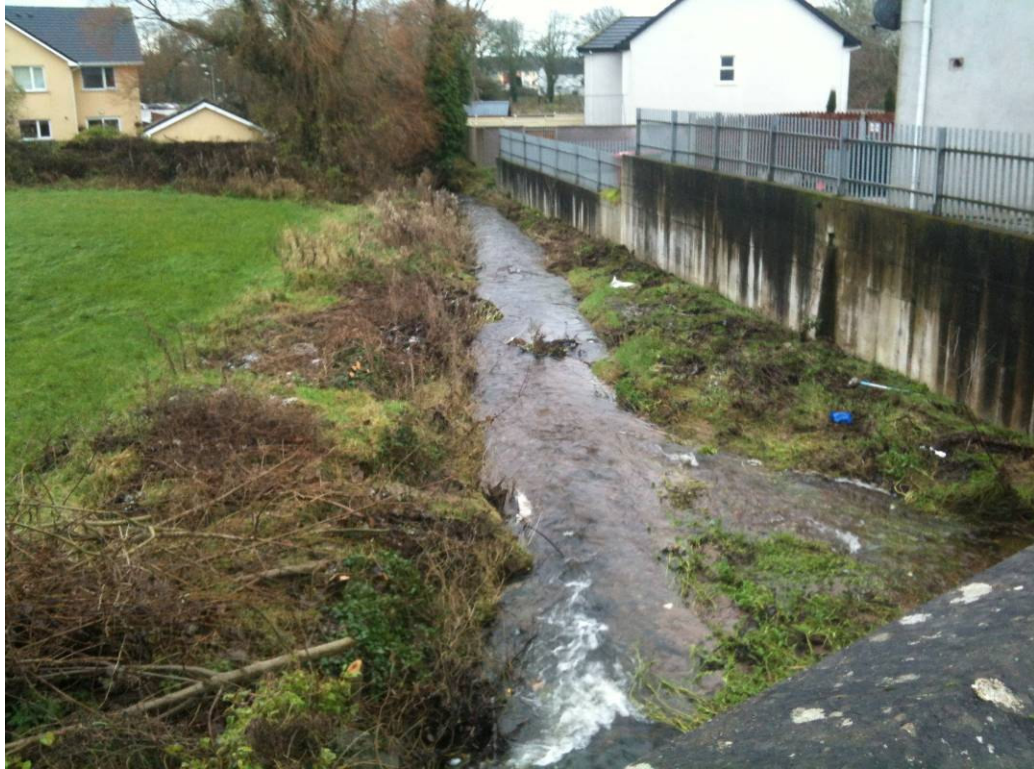
South of the Shanowen River bridge in the town retaining walls have been constructed at the stream bank.

Retaining wall south of Shanowen River bridge in Rathcormack town.

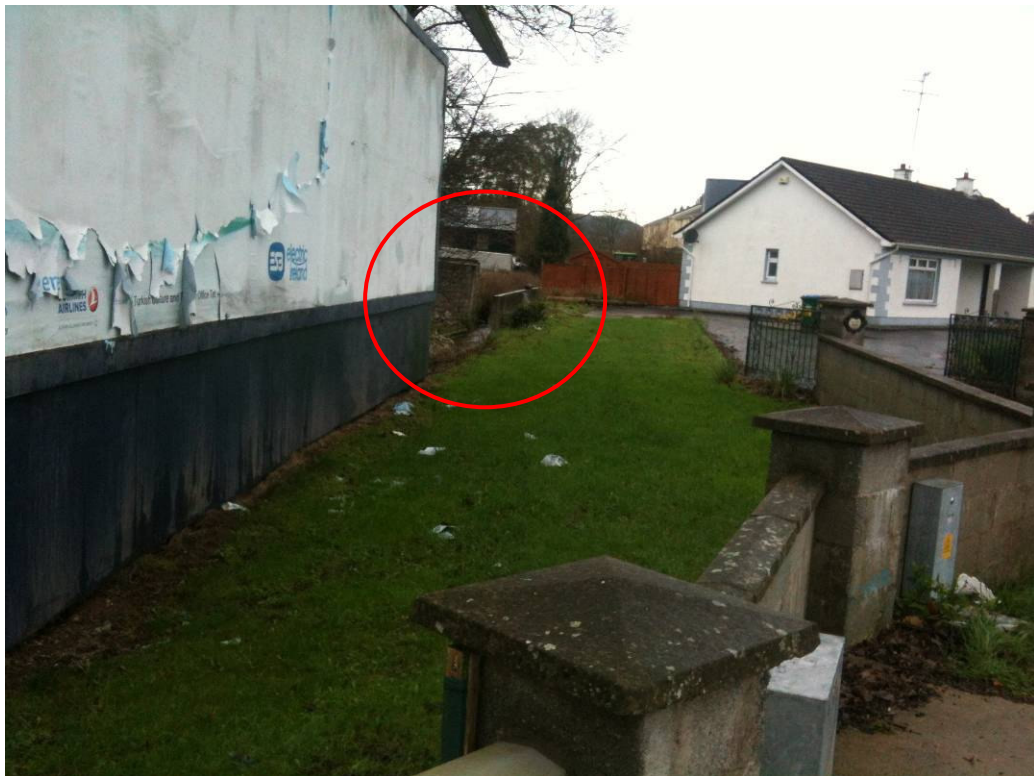
Retaining wall north of Shanowen River bridge in Rathcormack town.

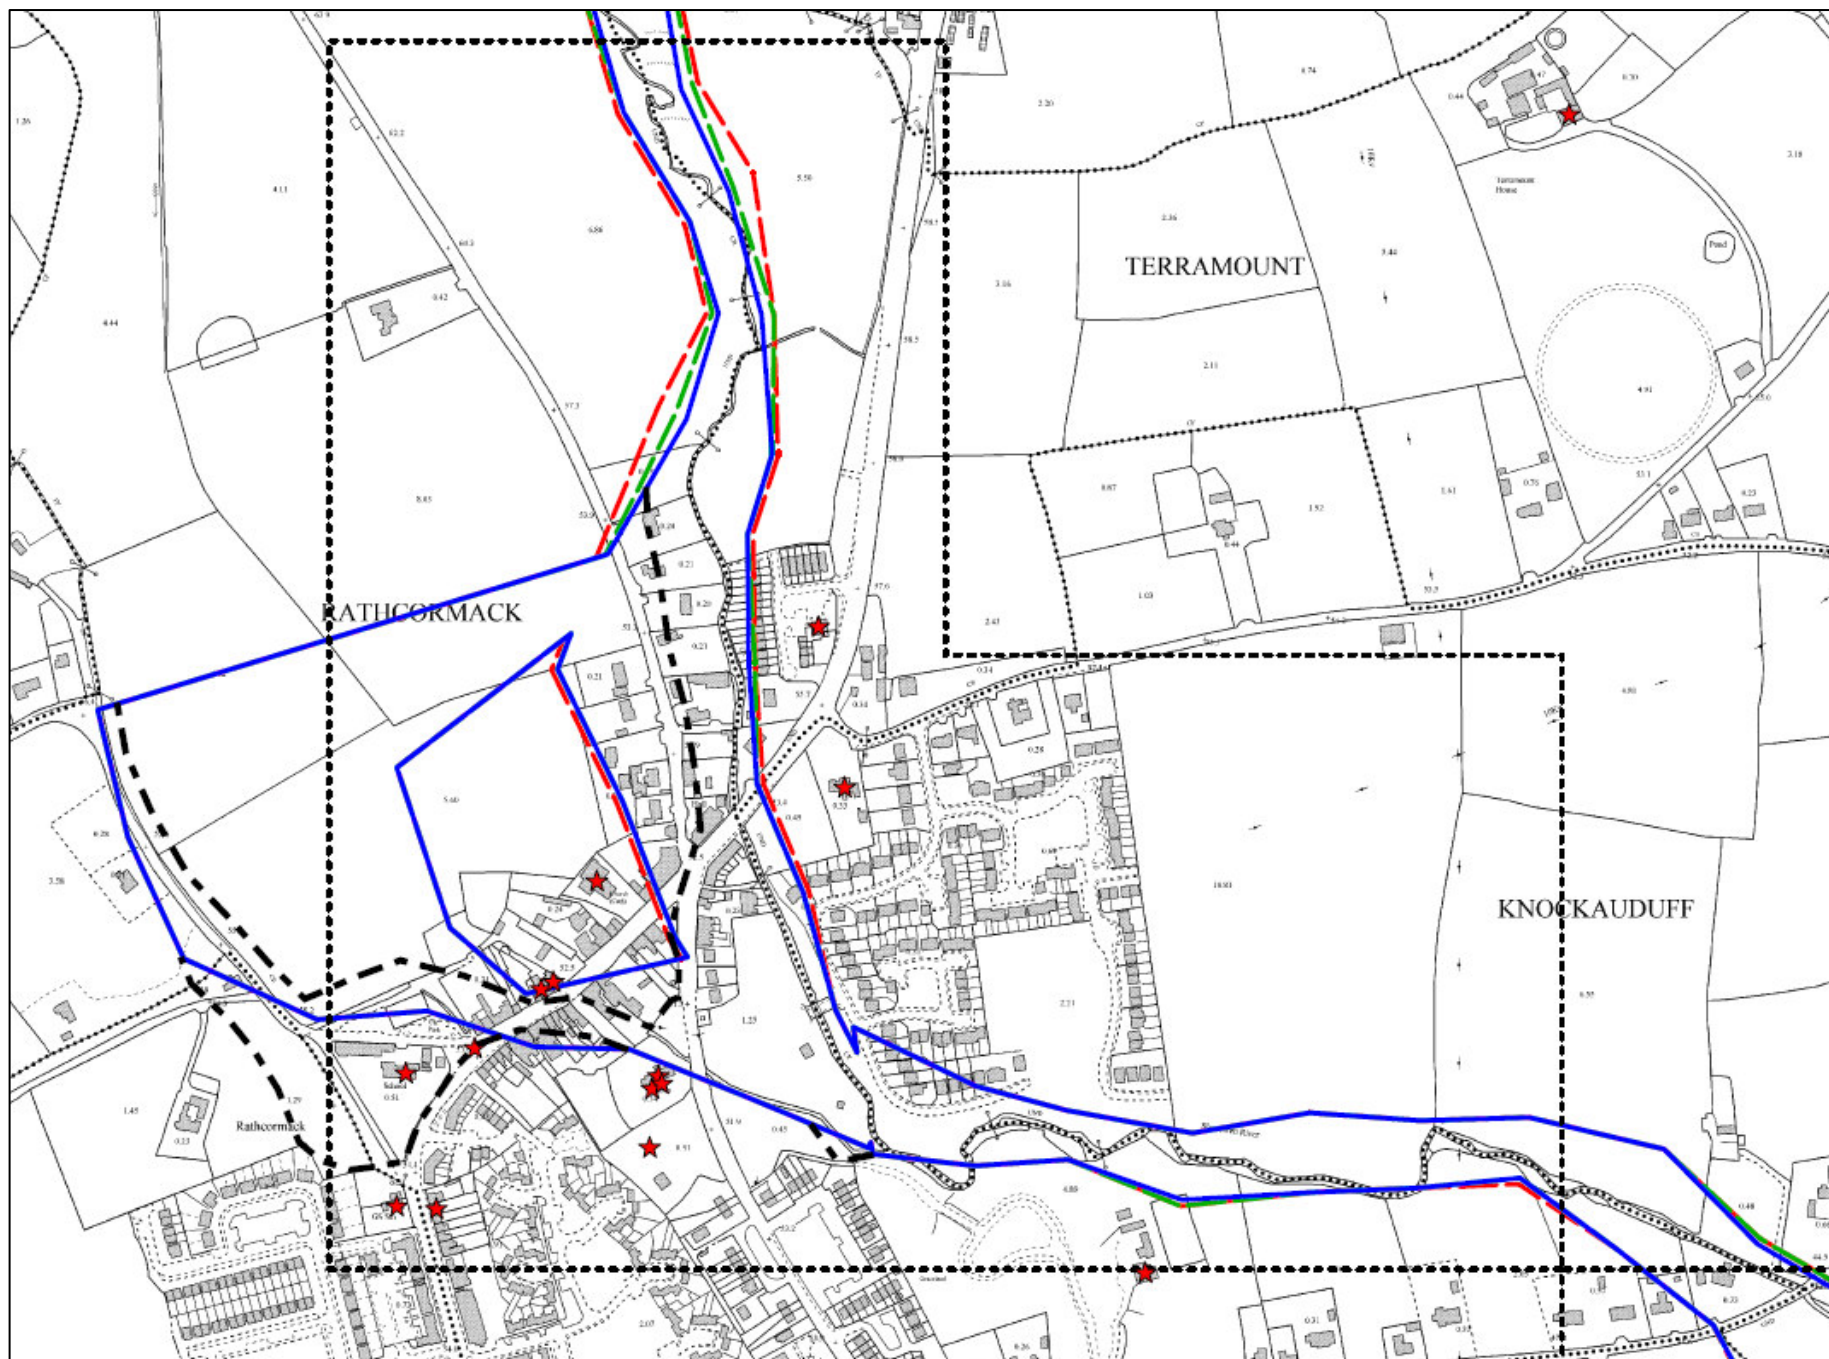
Revised Flood Boundary

During the site inspection, it was noted that the stream located north side of the Scoil Bhride school appeared to be dry with the main flow diverted south to a stream west of the school. The stream west of the school had a strong flow and appears to be culverted at the Garda Station. The currently dry stream channel north of school passes east through the town in a culvert to the Church of Ireland church, after which it leads to the Shanowen River. Currently the dry stream is choked with vegetation, but may act as an overflow channel. The flood extent outlines have been amended on the maps attached to this Site Inspection Report.

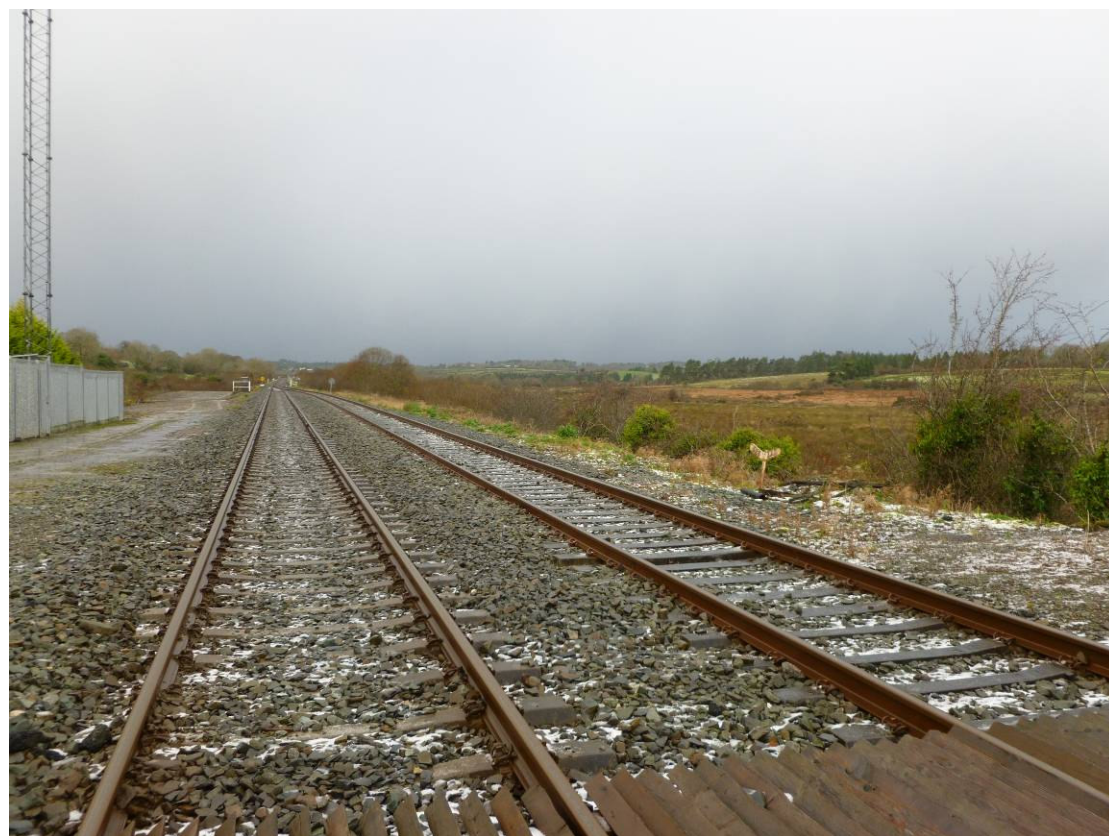
Upstream of the town the fluvial outlines are shown to cross the railway track for a short section. The site visit confirmed that this is unlikely to occur due to the topography.

Rathmore – view along railway track
