SWRBD CFRAM Study

Flood Risk Review Report

February 2012
Office of Public Works

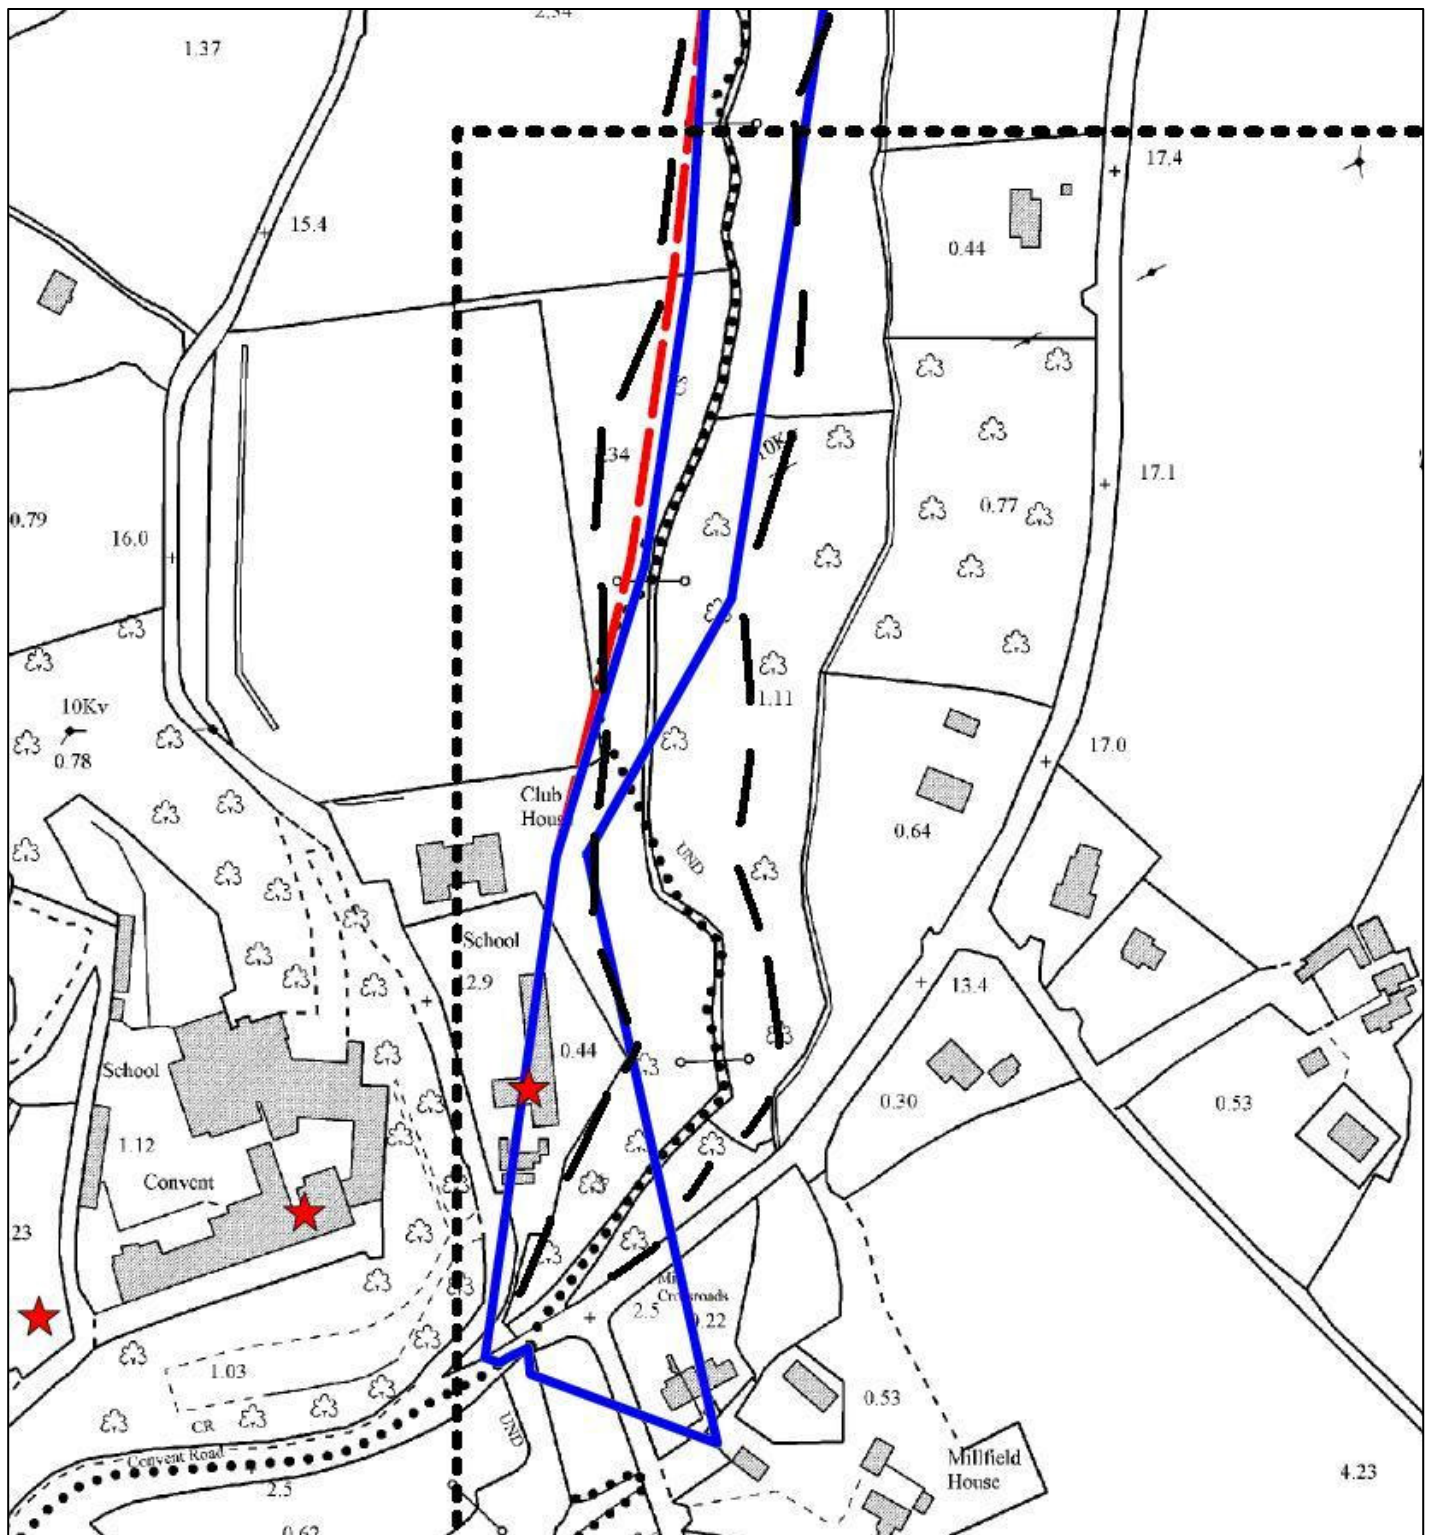
Ross Carbery South: revised outlines

The more significant alignment issues occur to the north east where the flood extent includes a Primary School. The site visit corrected this outline and determined that the Primary School is elevated well above the river bank and not at risk from flooding.

Based on the site visit the PRFA fluvial outlines in this area have been amended as shown in the map attached to this Site Inspection Report. No changes are recommended to the coastal outlines.

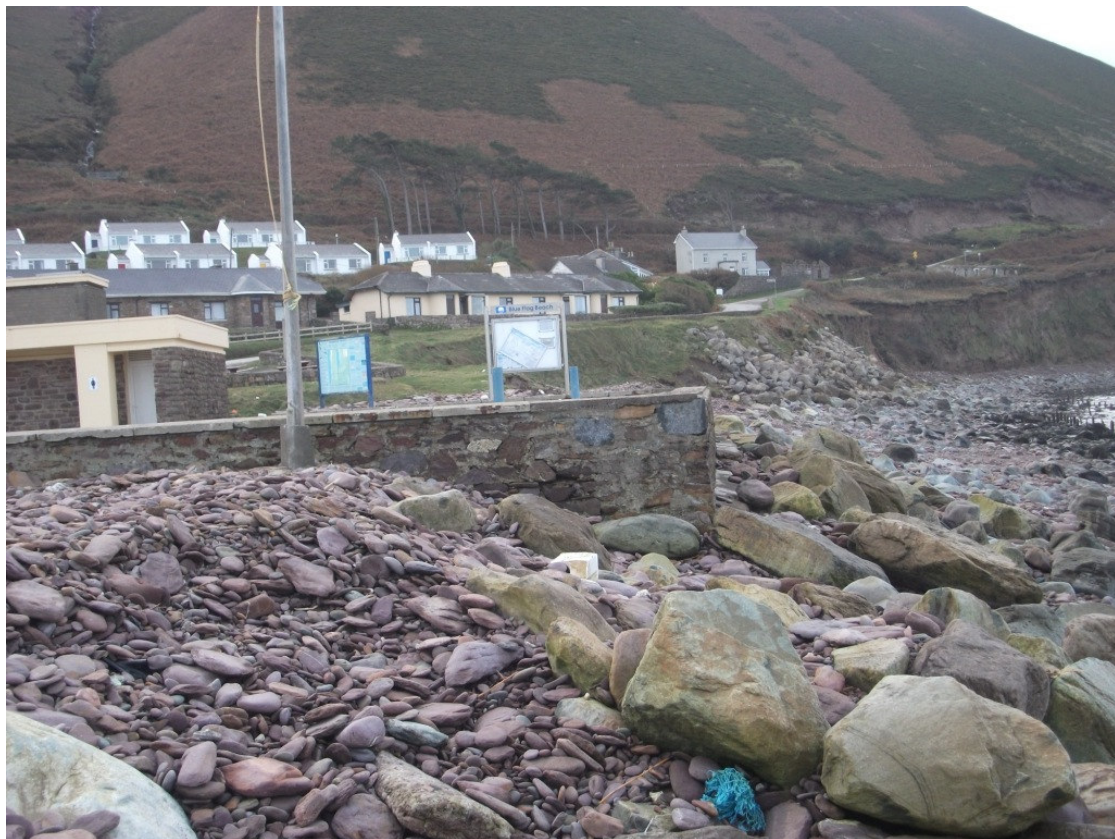
A fast food outlet, a public toilet block and a playground appear to be at the lowest elevations in the village but are still above normal high tide level as indicated in the photo below:

Fast food and toilet block (single building) adjacent to beach area.

These were also outside the predicted 10%, 1% and 0.1% flood boundaries.

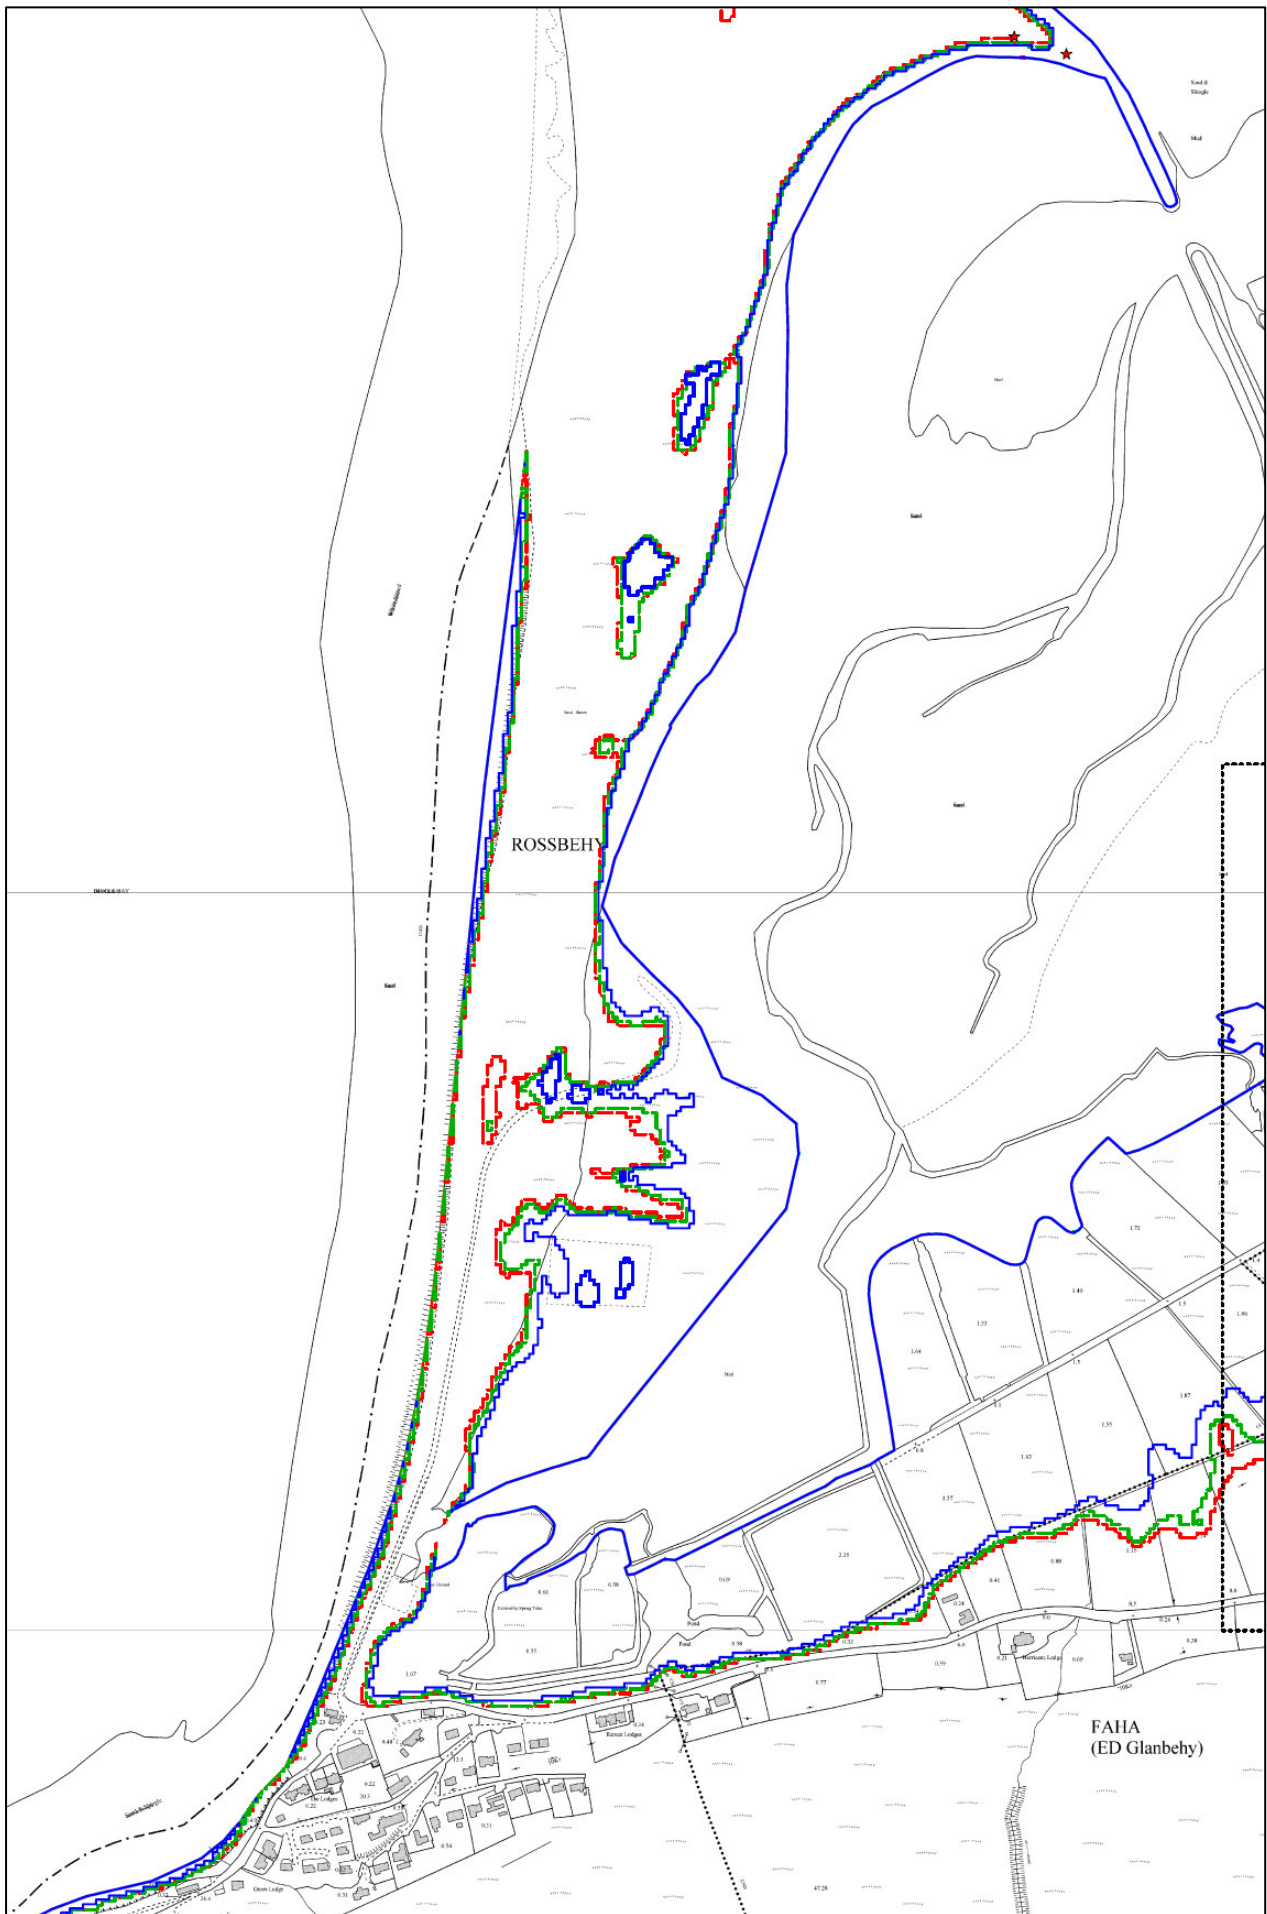
Tidal flood outline (No changes proposed)

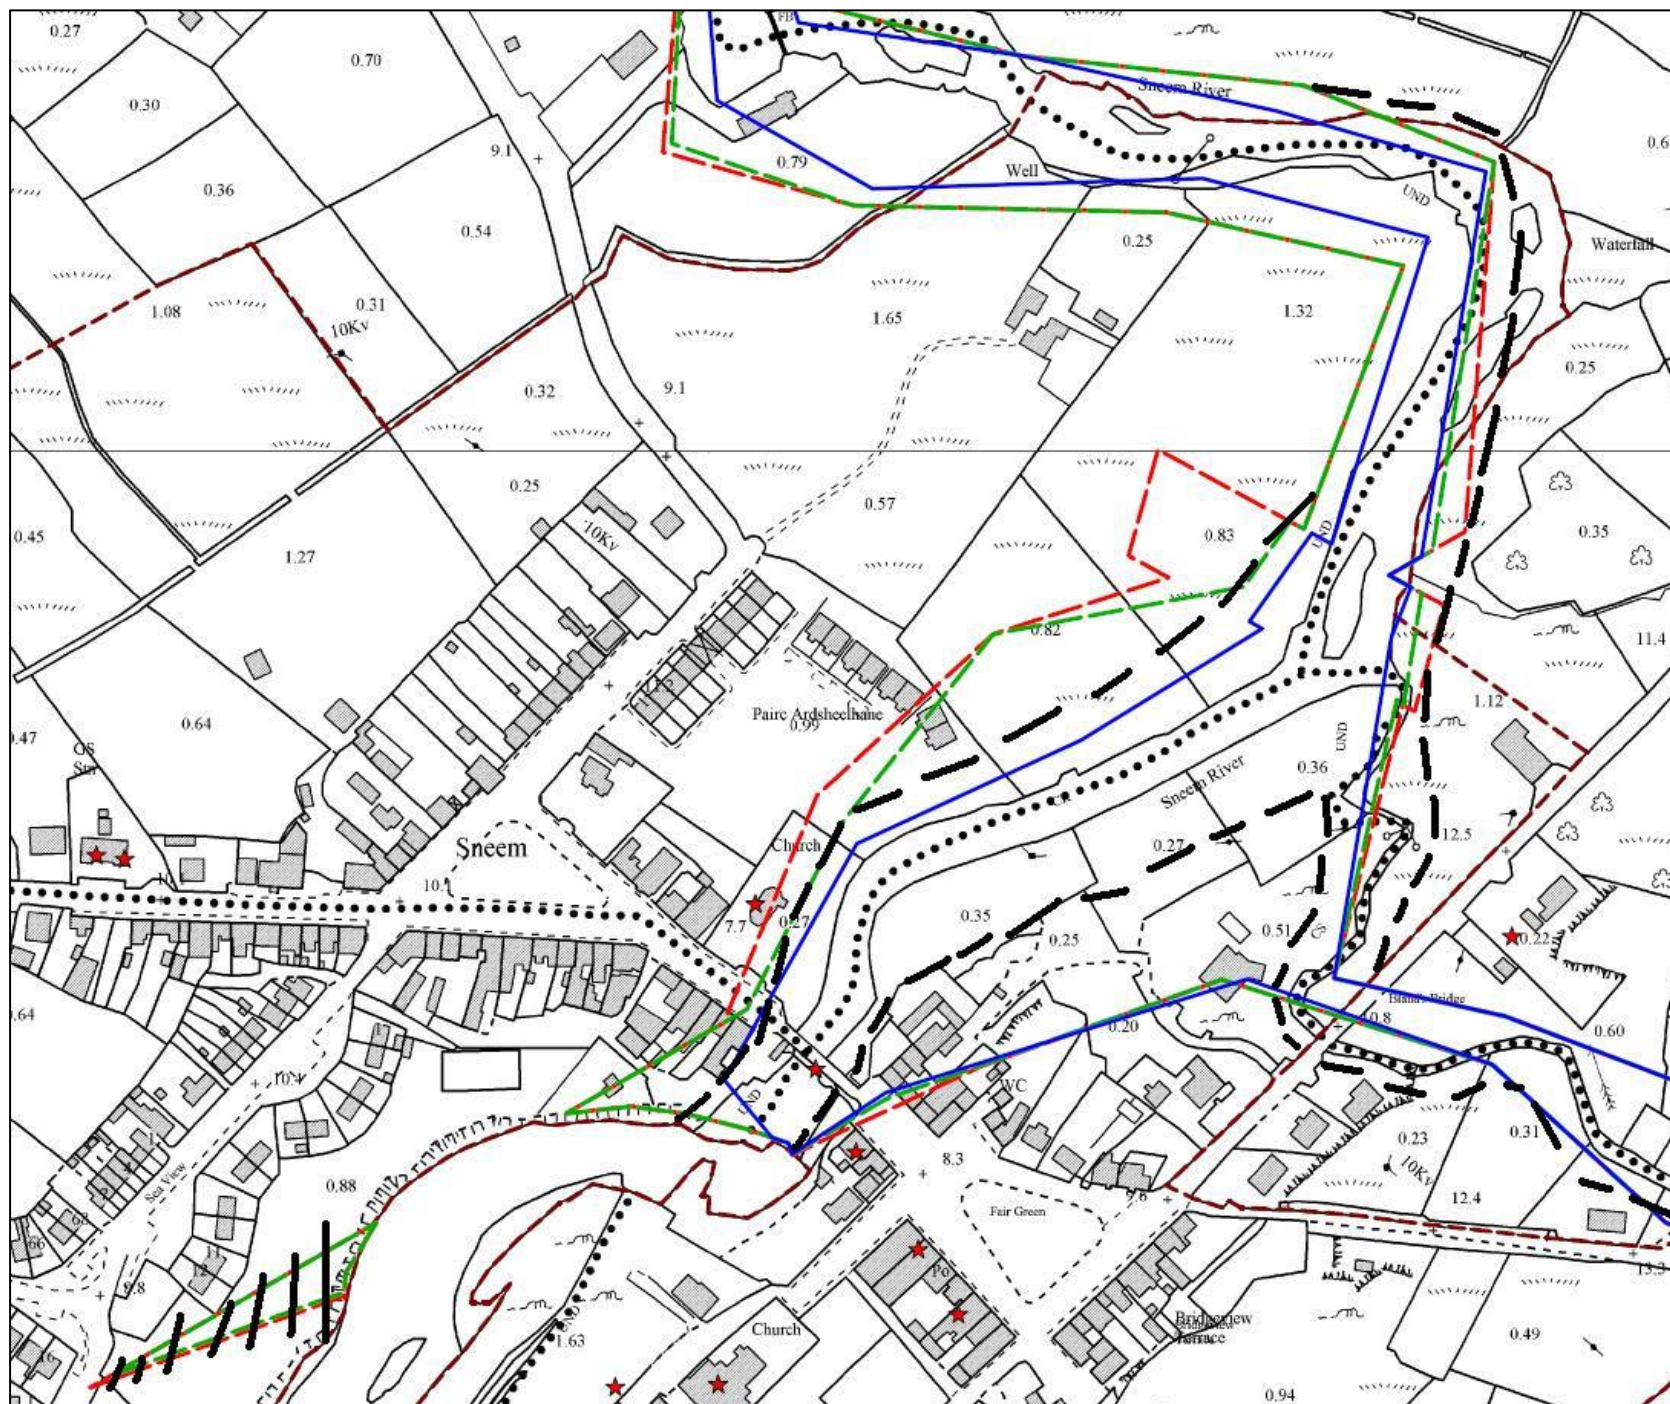
Based on the topography observed during the site visit it would appear that the fluvial outlines have over estimated the extent of flooding for the 10%, 1% and 0.1% AEP events. The difference in height between the river bank and the surrounding lands to the north of the bridge are significant, in excess of 5m. The outlines have been modified to reflect the topography.

Based on the site visit the PRFA fluvial outlines in this area have been amended as shown in the attached map included in the Appendix to this Site Inspection Report. No changes are recommended to the coastal outlines.

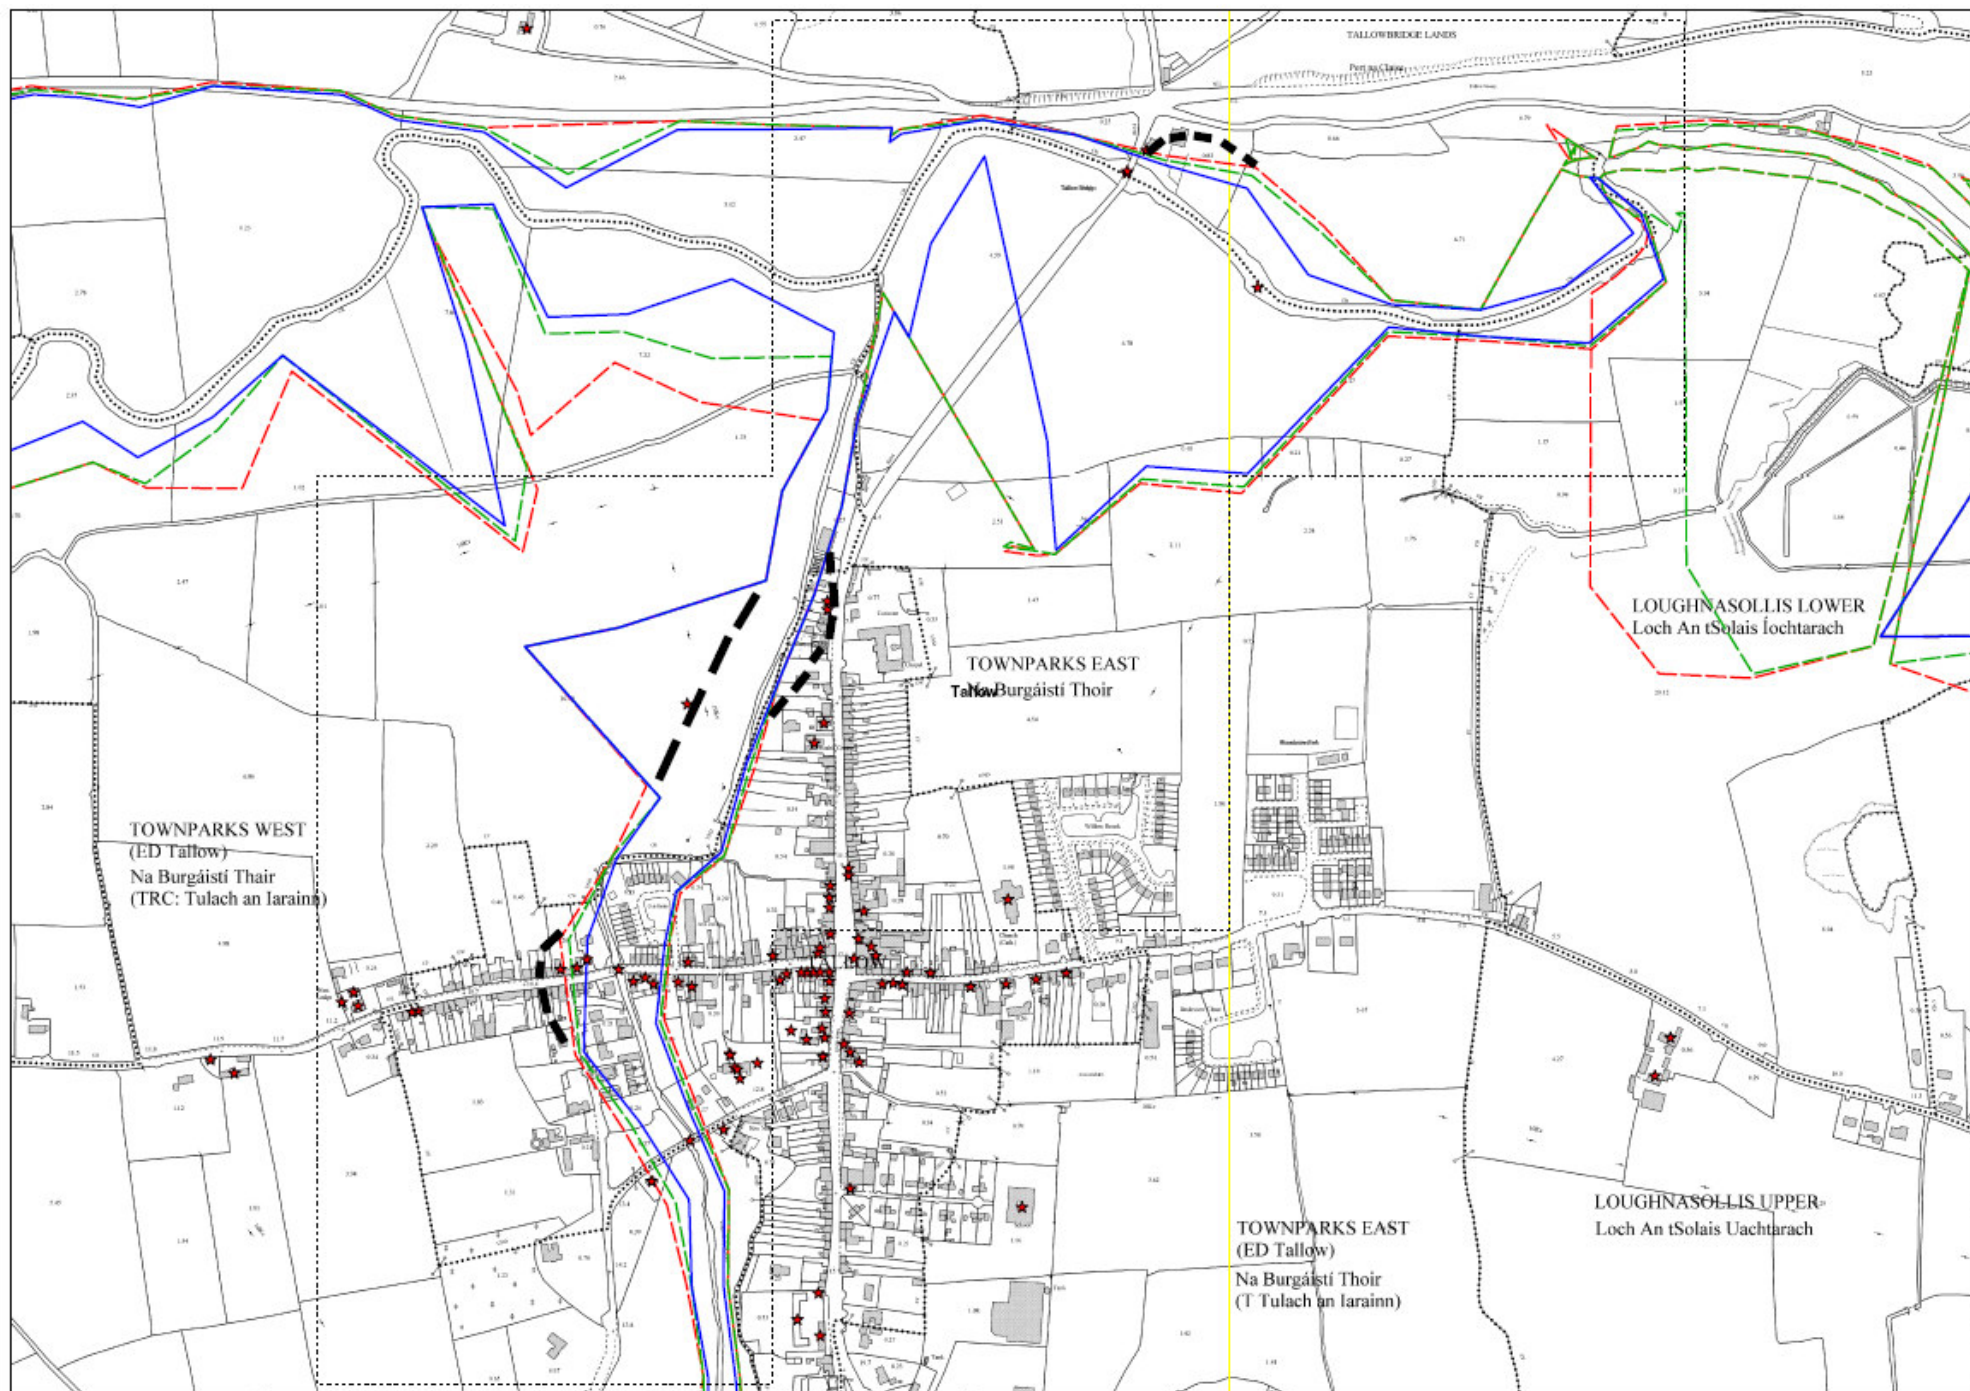
Some sections of the predicted outlines within Tallow appear to be under estimating flood risk in this area. The amendment to the outlines includes approximately 12 residential and commercial properties to the Flood Risk Index (FRI).

Based on the site visit the PFRA outlines for Tallow have been amended as shown in the map attached to this Site Inspection Report.

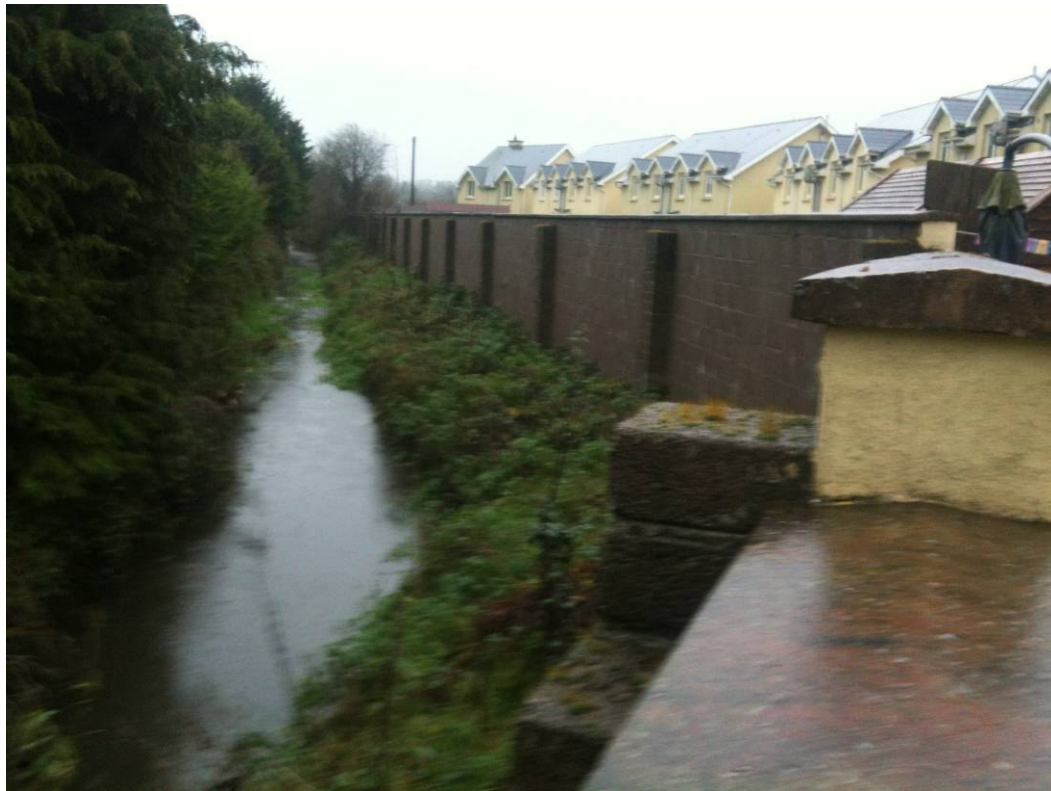
There is a masonry wall separating the new residential development near the N20 national road from the stream.

Masonry wall separating the new development from the stream

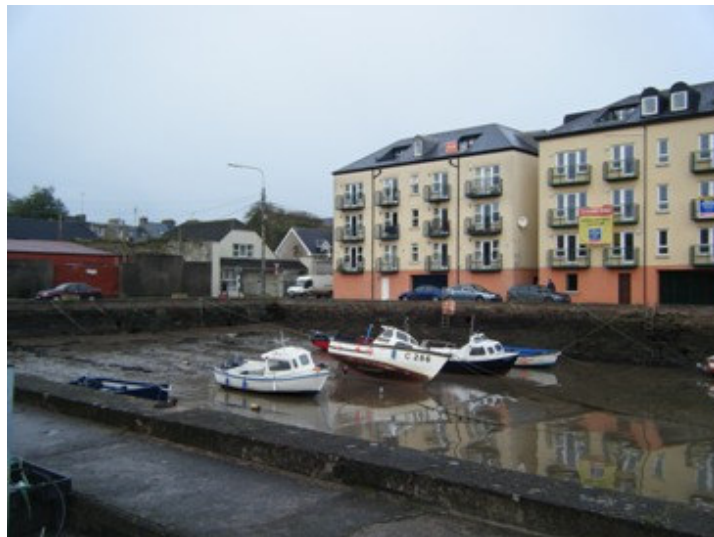
Youghal – Quay

It was further noted that there appeared to be evidence of water marks present on the outside of some buildings within the town adjacent to the piers/coast where previous flooding had occurred.
