DAMAGE ASSESSMENT OF CHURCHES IN THE CITY OF CAMERINO AFTER THE 2016 CENTRAL ITALY SEISMIC SEQUENCE

E. Giordano¹, A. Ferrante¹, F. Clementi¹ and S. Lenci¹

¹ Dept. of Civil and Building Engineering, and Architecture, Polytechnic University of Marche, Ancona, Italy
e-mail: {e.giordano,a.ferrante}@pm.univpm.it, {francesco.clementi,lenci}@univpm.it

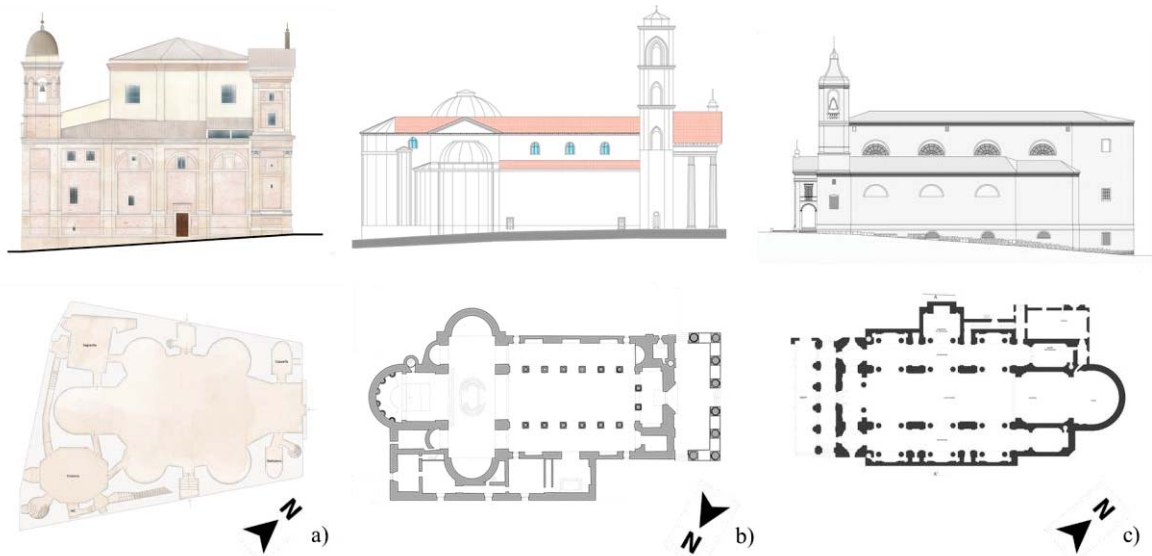
Figure 3 Geometric configuration; a) Santa Maria in Via; b) San Venanzio; c) Santa Maria Annunziata

The nave of the church has an elliptic shape with a larger diameter of about 28m and smaller of 13m, on both sides there are four chapels (Figure 3-a). On the two sides of the entry, there are two symmetric rooms that are a baptizer and a chapel. The sacristy and the oratory are on the sides of the presbytery. On the south side, there is the bell-tower high 15m. The bearing structure is made of solid bricks with an inner core of poor materials. The hall is covered by a camorcanna vault and the roof is made by wood trusses

The basilica has a Latin-cross (39mx68m) layout with the principal nave of double-length respect the lateral ones Figure 3-b. The principal nave is divided by the others whit fourteen Corinthian columns built with blocks stone and solid bricks. Under the presbytery, there is the crypt covered by cross vaults supported by Porfido columns. The crypt is accessed through two symmetrical stairs in the transept. The bell-tower is on the north-west side with a height of 45 m, three different orders are visible on it. On the principle nave there is a light barrel vault covered by a wood roof. The bearing structure is made of solid bricks

The church has a Latin-cross layout (29mx70m), the naves are divided by columns and pillars on which rest round arches Figure 3-c. Under the church, there is a large crypt cover by cross and barrel vaults. On the two sides of the facade, arrears of six meters, there are two identical bell-towers of 40 m high covered by domes. The naves are covered by camorcanna vaults and the roof is made of wood trusses. The bearing structure is made of solid bricks and stone blocks

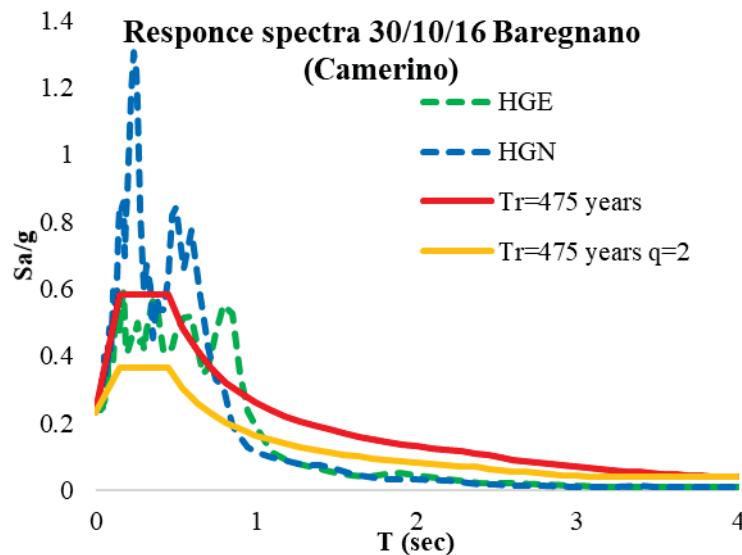
Figure 4 Comparison between the maximum acceleration expected for the SLV and accelerations recorded

The 2016 earthquakes caused damages to all these churches. Indeed, comparing the accelerations recorded to Camerino during the 30th October quake with the maximum acceleration expected to preserve the human life, according to the Italian code [16], they have been, in North direction, twice respect to expected values Figure 4.

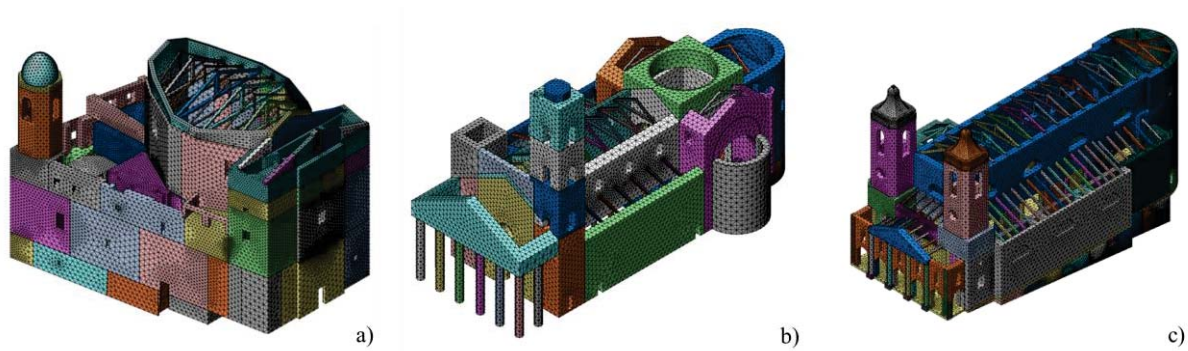
Figure 6 Numerical Models of a) Santa Maria in Via; b) San Venanzio; b) Santa Maria Annunziata

The geometries were reproduced carefully and subsequently discretized with 4-nodes tetrahedral brick elements Figure 6. In the Table 1 are reported the number of elements, nodes and degree of freedom used for each case study.

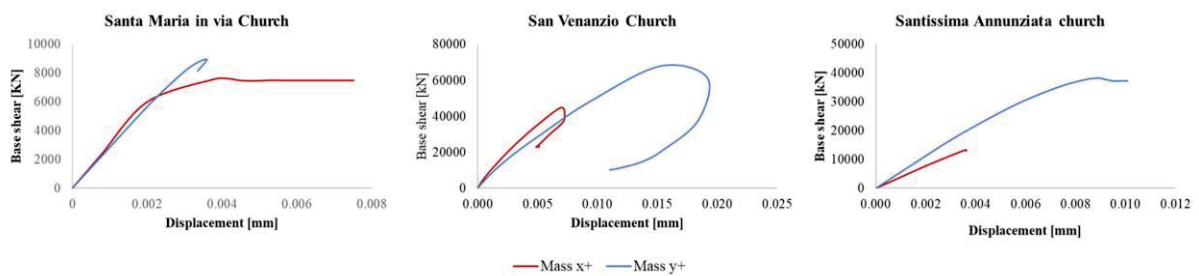
Figure 8 Examples of PushMass curves in +X-Direction and +Y-Direction of a control node for each church

From these analyses, the capacity curves of each church were obtained for different control nodes. The curves show different behaviors and resistances for both in the directions and control nodes chosen, due to the geometry complexity. In Figure 8 are reported the capacity curves of one control node for each church obtain by PushMass analysis in +X-Direction and +Y-Direction.
