# **Preliminary Flood Risk Analysis Report**

**Waterways Ireland**

**18<sup>th</sup> July 2011**

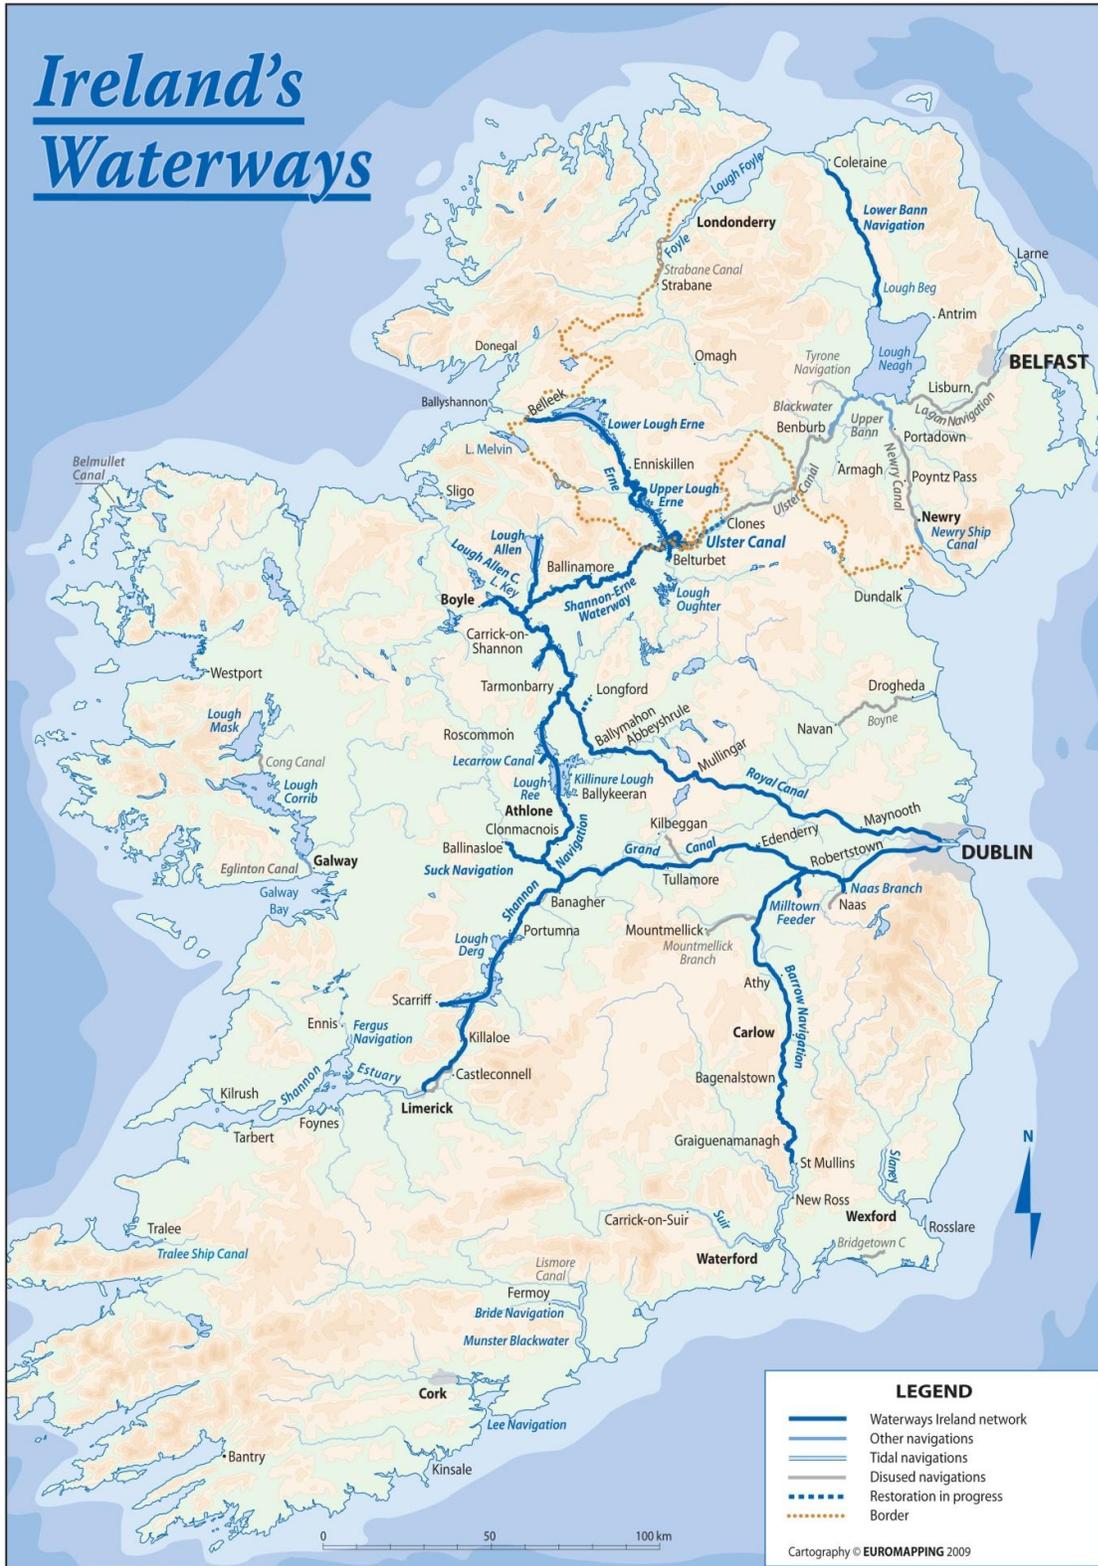
**Figure 1**

# Ireland's Waterways

Waterways Ireland has responsibility for approximately 1,000 km of navigable waterways (Figure 1) comprising;
