YOUR ONESURVEY
HOME REPORT

5 Ardenraig Chalet
High Craigmore
Rothesay, Isle of Bute
PA20 9EP

HOME REPORT

SINGLE SURVEY

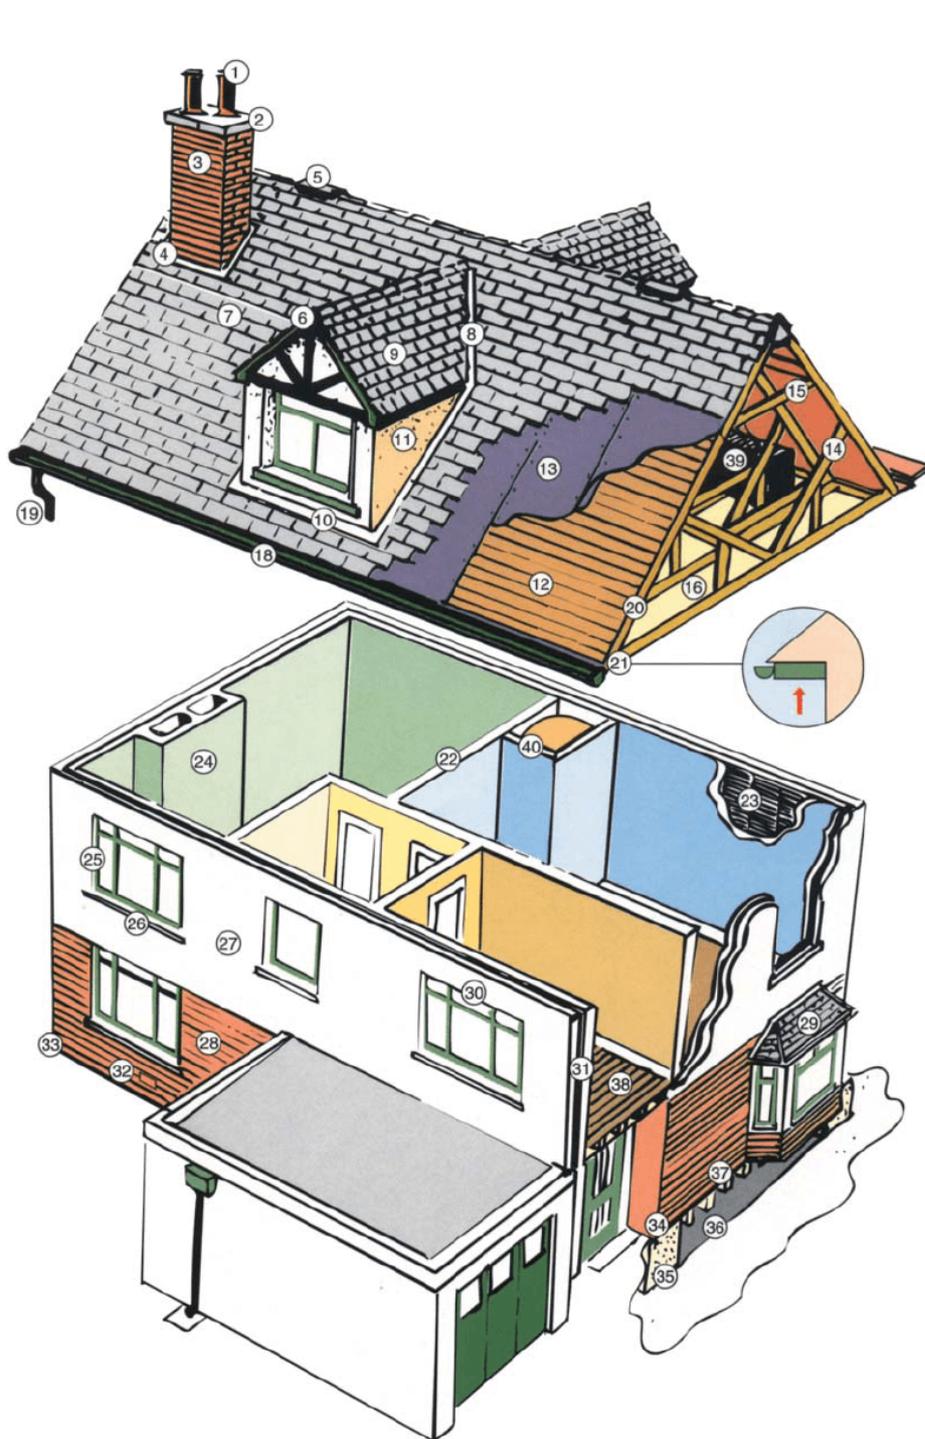
Sectional Diagram showing elements of a typical house

- ① Chimney pots
- ② Coping stone
- ③ Chimney head
- ④ Flashing
- ⑤ Ridge ventilation
- ⑥ Ridge board
- ⑦ Slates / tiles
- ⑧ Valley guttering
- ⑨ Dormer projection
- ⑩ Dormer flashing
- ⑪ Dormer cheeks
- ⑫ Sarking
- ⑬ Roof felt
- ⑭ Trusses
- ⑮ Collar
- ⑯ Insulation
- ⑰ Parapet gutter
- ⑱ Eaves guttering
- ⑲ Rainwater downpipe
- ⑳ Verge boards /skews
- ㉑ Soffit boards
- ㉒ Partiton wall
- ㉓ Lath / plaster
- ㉔ Chimney breast
- ㉕ Window pointing
- ㉖ Window sills
- ㉗ Rendering
- ㉘ Brickwork / pointing
- ㉙ Bay window projection
- ㉚ Lintels
- ㉛ Cavity walls / wall ties
- ㉜ Subfloor ventilator
- ㉝ Damp proof course
- ㉞ Base course
- ㉟ Foundations
- ㊱ Solum
- ㊲ Floor joists
- ㊳ Floorboards
- ㊴ Water tank
- ㊵ Hot water tank

Reference may be made in this report to some or all of the above component parts of the property. This diagram may assist you in locating and understanding these items.

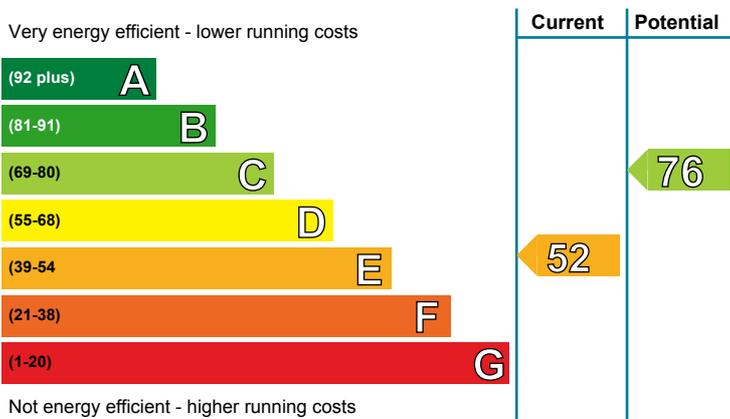
Energy Efficiency Rating

This graph shows the current efficiency of your home, taking into account both energy efficiency and fuel costs. The higher this rating, the lower your fuel bills are likely to be.

Your current rating is **band E (52)**. The average rating for EPCs in Scotland is **band D (61)**.

The potential rating shows the effect of undertaking all of the improvement measures listed within your recommendations report.

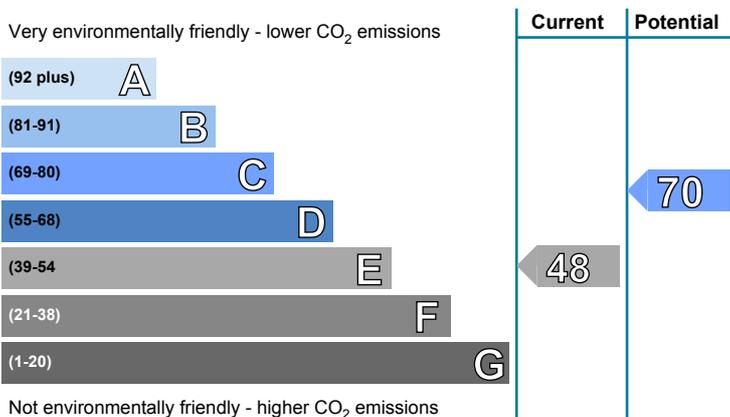
Environmental Impact (CO₂) Rating

This graph shows the effect of your home on the environment in terms of carbon dioxide (CO₂) emissions. The higher the rating, the less impact it has on the environment.
