Home Report on

6 Rose Bank 29 Argyle Street

SINGLE SURVEY

survey report on:

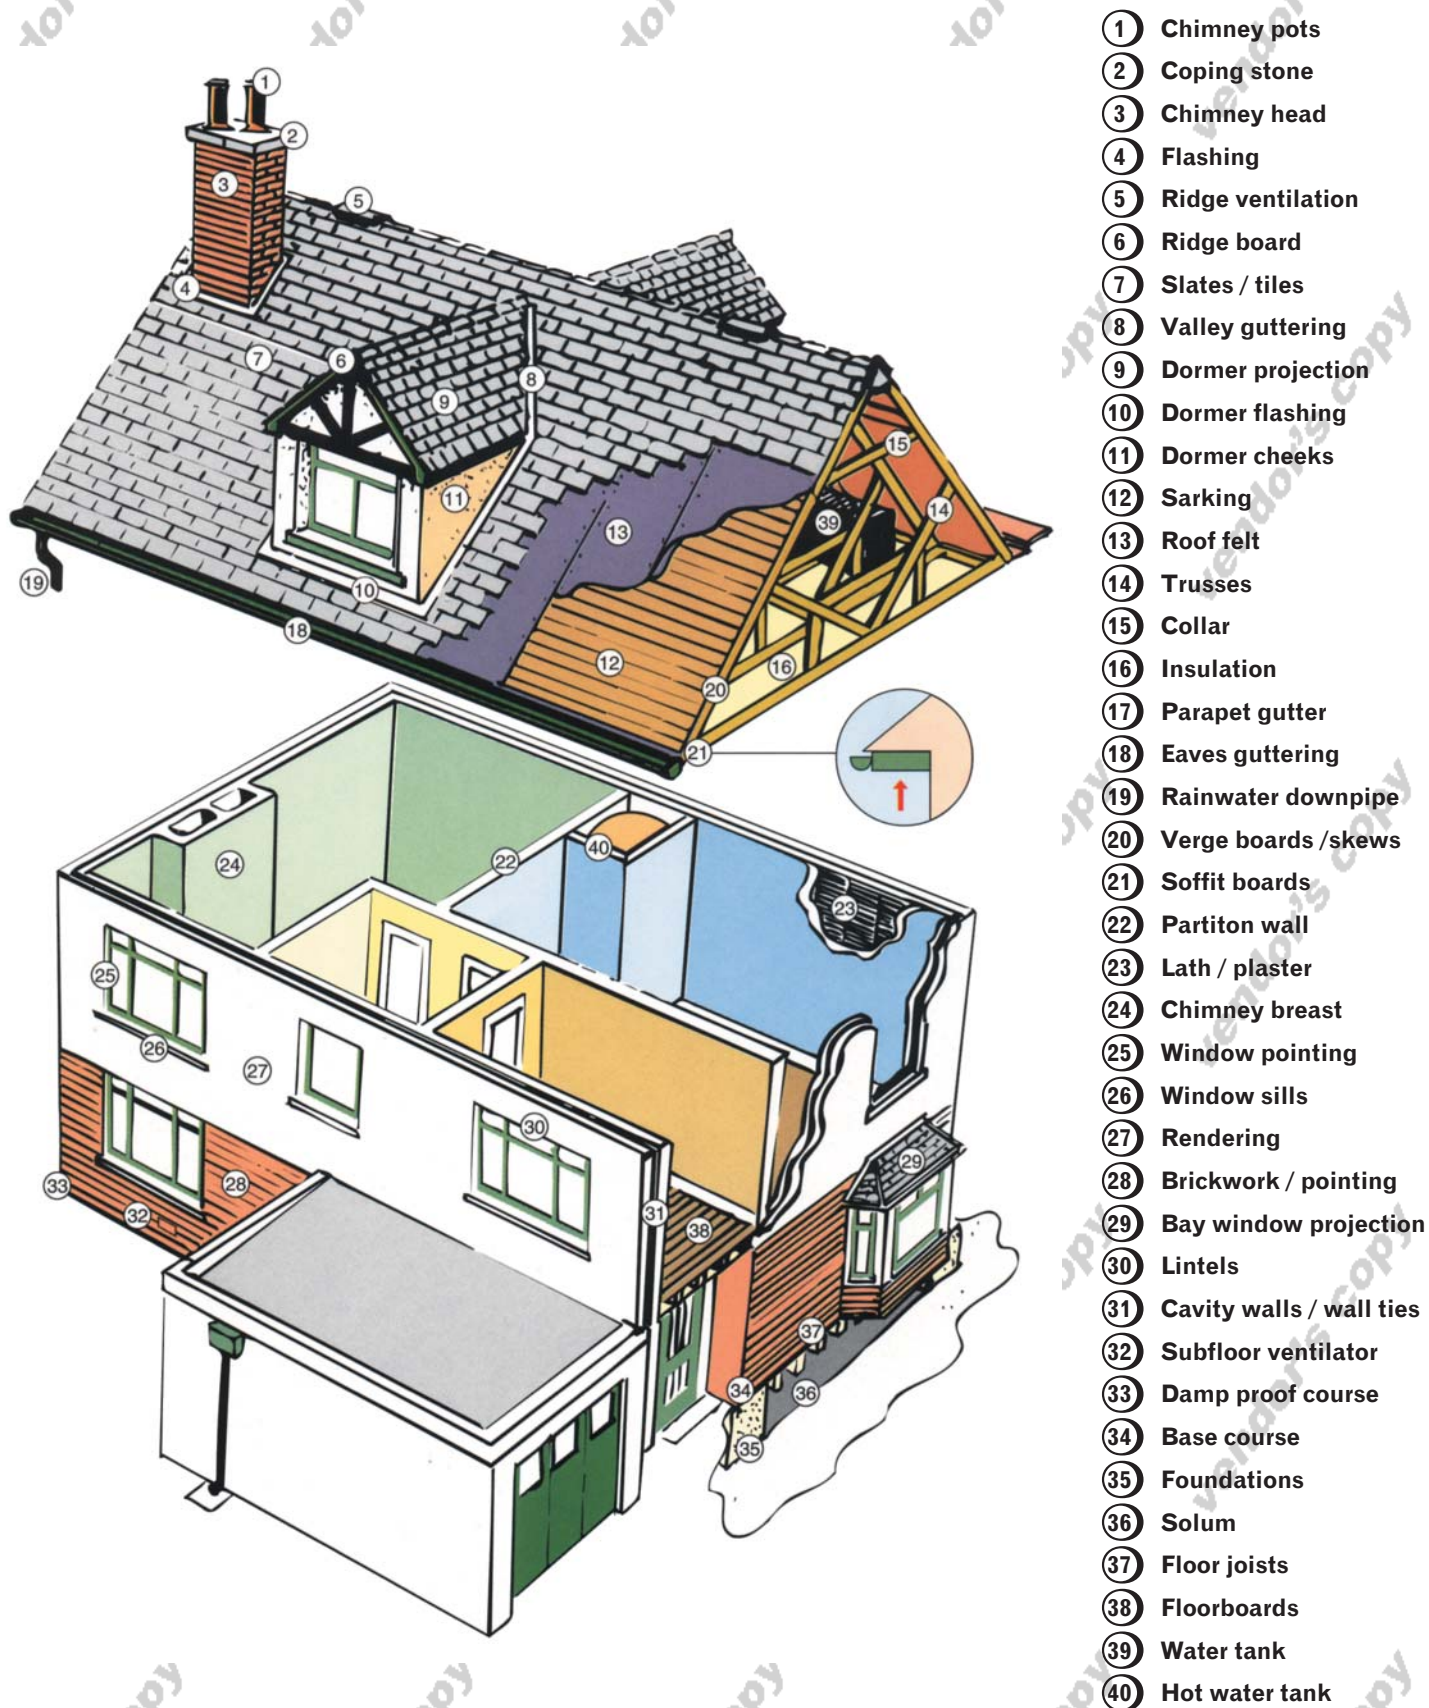
Sectional Diagram showing elements of a typical house

Reference may be made in this report to some or all of the above component parts of the property. This diagram may assist you in locating and understanding these items.

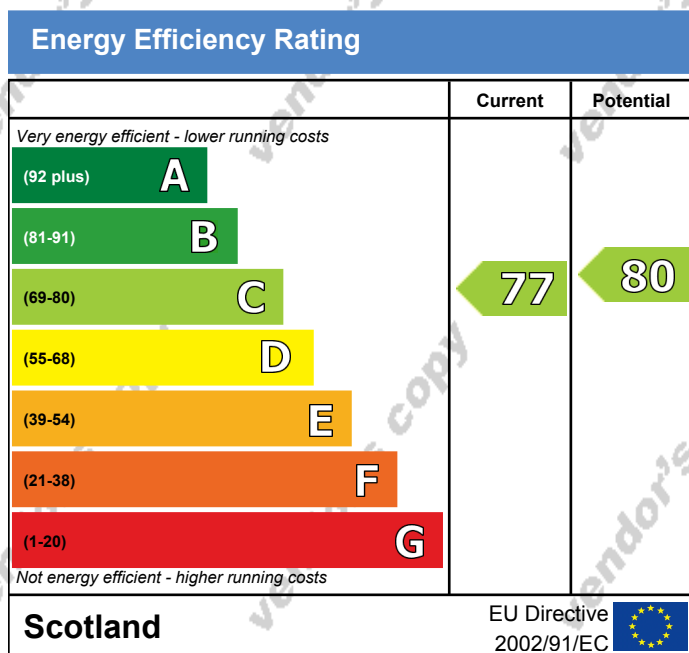
This dwelling has been assessed using the RdSAP 2005 methodology. Its performance is rated in terms of the energy use per square metre of floor area, energy efficiency based on fuel costs and environmental impact based on carbon dioxide (CO₂) emissions. CO₂ is a greenhouse gas that contributes to climate change.

The energy efficiency rating is a measure of the overall efficiency of a home. The higher the rating the more energy efficient the home is and the lower the fuel bills are likely to be.

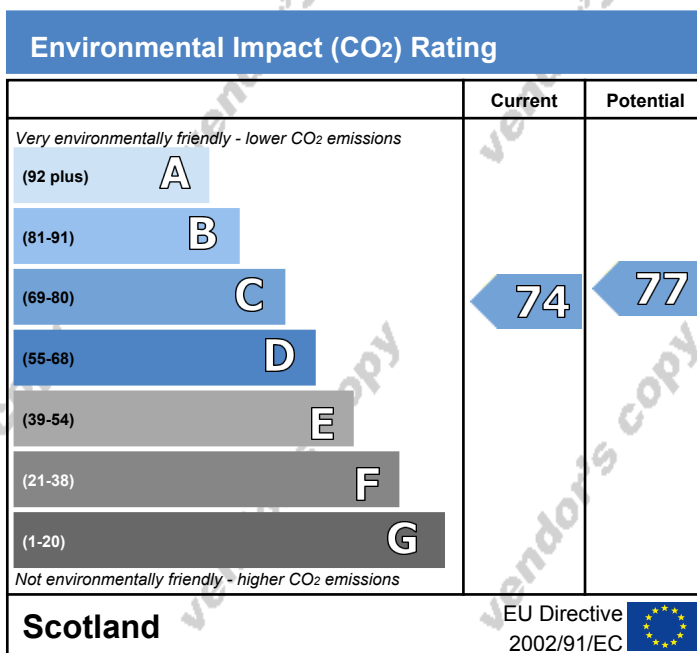
Approximate current CO₂ emissions: 33 kg/m² per year

The environmental impact rating is a measure of a home's impact on the environment in terms of carbon dioxide (CO₂) emissions. The higher the rating the less impact it has on the environment.
