ESB Energy International
Production Engineering
Generation Operations

Executive Summary

ESB operates hydro-electric power plants on five rivers in Ireland, i.e. Rivers Liffey, Lee, Shannon, Erne and Clady, and a pumped storage scheme at Turlough Hill. Dams and embankments form part of the infrastructure associated with these schemes. A preliminary flood risk assessment for ESB's dams and embankments has been undertaken to address the requirements of EU Directive 2007/60/EC on the Assessment and Management of Flood Risks and the European Communities (Assessment and Management of Flood Risks) Regulations (S.I. No. 122 of 2010). This preliminary flood risk assessment was undertaken to assess the role of the dams and embankments during past floods and also during potential future floods with the following flooding scenarios being investigated:

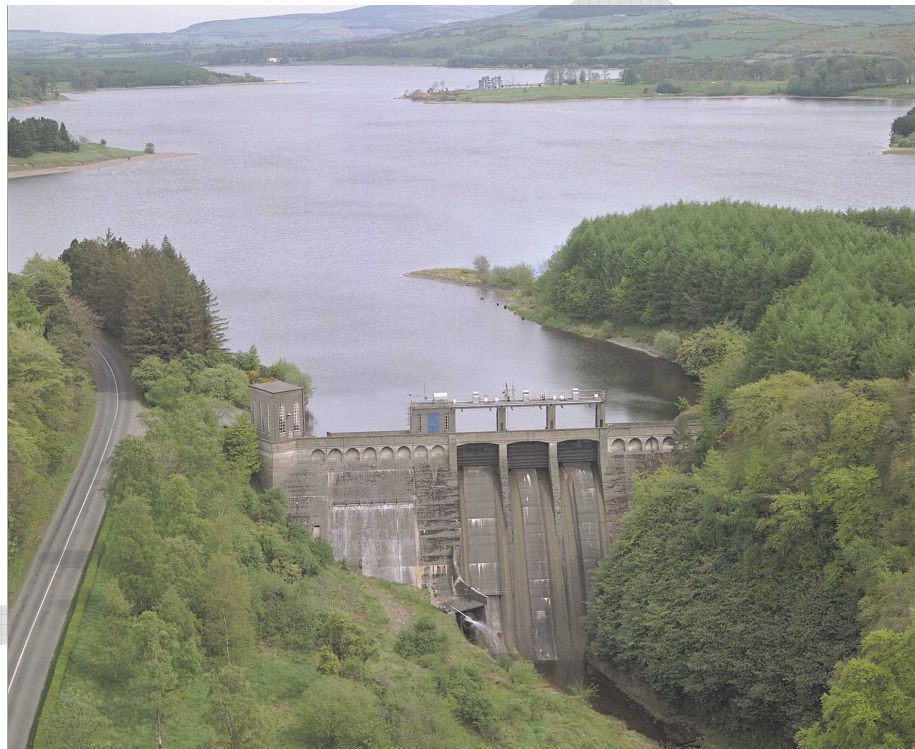
Figure 1.1 Pollaphuca Dam and Reservoir

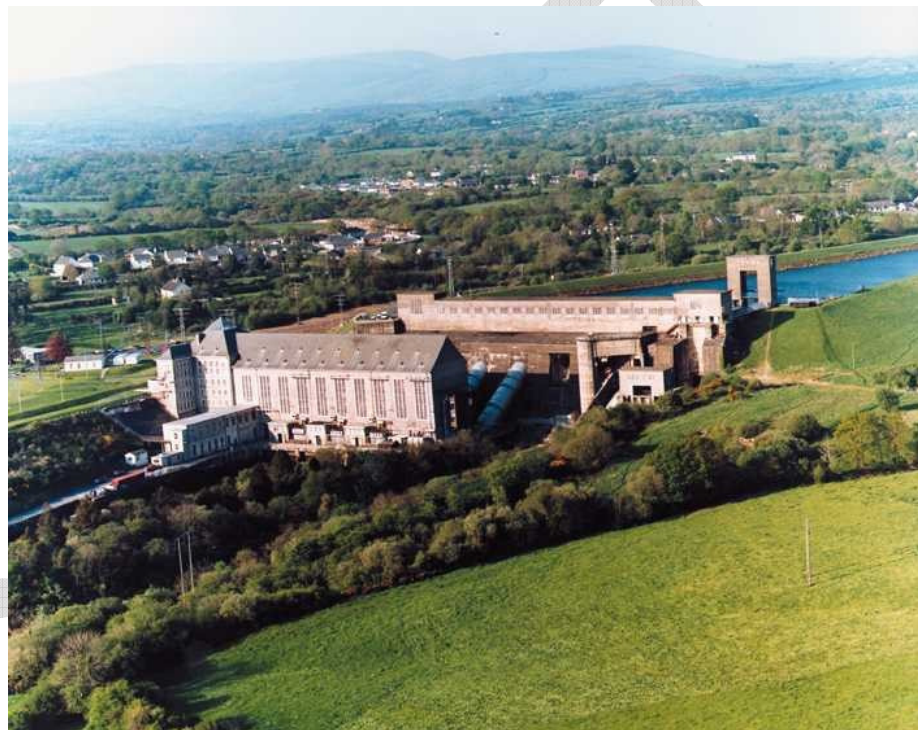
Figure 1.2 Ardnacrusha Dam

Portumna No. VI (a) Embankment – earthfill embankment
Portumna No. VI (b) Embankment – earthfill embankment
Kilmastulla Embankment – earthfill embankment
Fort Henry Embankment – earthfill embankment
Ardclooney Embankment – earthfill embankment
Parteen Weir and Canal Intake Structure – concrete gravity dam
Ardnacrusha Headrace Left Bank – earthfill embankment
Ardnacrusha Right Bank – earthfill embankment
Ardnacrusha Dam – concrete gravity dam

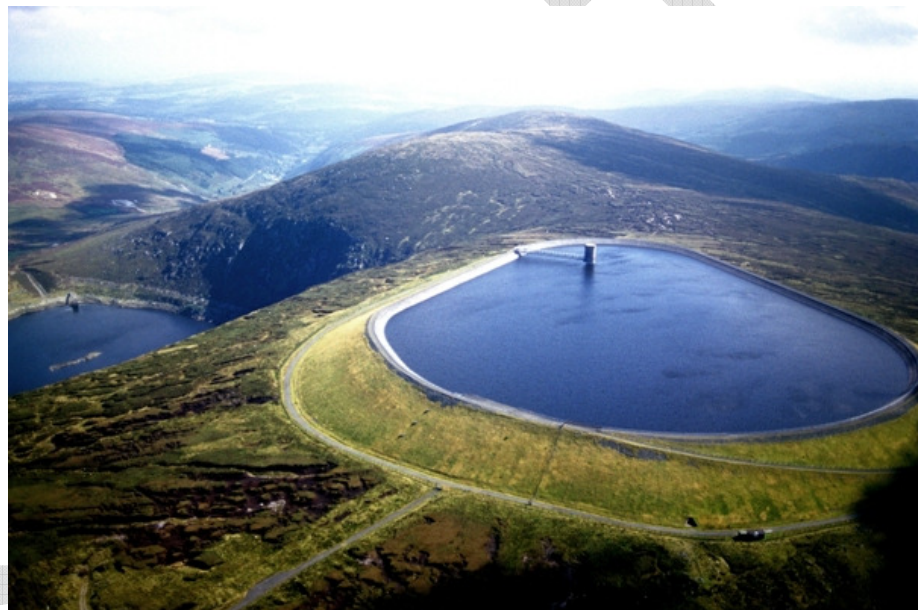
Figure 1.3 *Turlough Hill Upper Reservoir*

Upper Reservoir Embankment – rockfill embankment

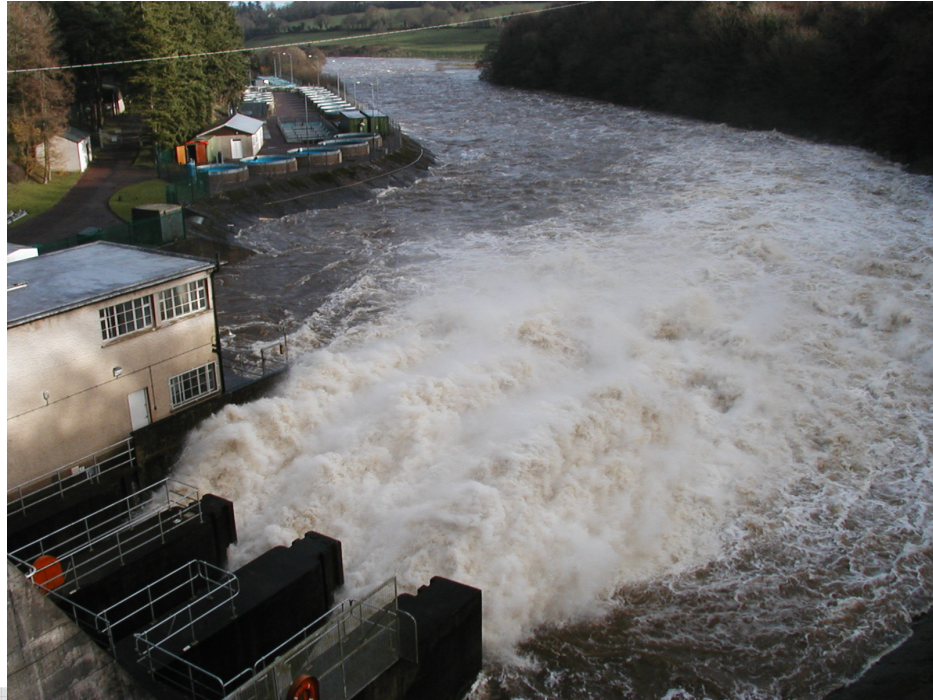
Figure 2.1 Flood Discharge at Carrigadrohid Dam (December 2006)

The peak hourly inflow to Carrigadrohid was $480\text{m}^3/\text{s}$ and the peak discharge at Carrigadrohid during the flood period was $342\text{m}^3/\text{s}$. The peak hourly inflow to Inniscarra was $415\text{m}^3/\text{s}$ and the peak discharge at Inniscarra during the flood period was $323\text{m}^3/\text{s}$. The maximum catchment inflow reached $475\text{m}^3/\text{s}$ on 3rd December 2006.

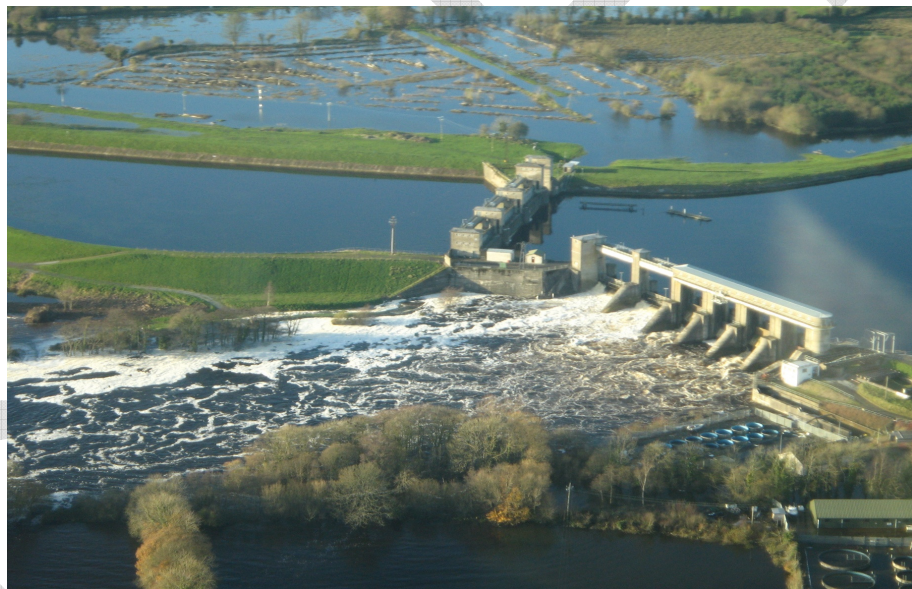
Figure 2.2 Parteen Weir (November 2009)

On the Lower Shannon Catchment, downstream of Athlone, the peak flood levels which occurred at Banagher, Victoria, Portumna and Killaloe were more than 0.3m higher than the highest ever recorded previously. The total discharge from Lough Derg was 12% greater than the previous highest. This total discharge comprised flow to the old channel at Parteen, which was 27% greater than the previous highest, and flow to the power station. The maximum total catchment daily inflow to Parteen Weir was approximately $1,243\text{m}^3/\text{s}$ on 19th November 2009. The maximum estimated Winter 2009 daily inflow to Lough Derg was $929\text{m}^3/\text{s}$ also on 19th November 2009. The maximum average daily discharge at Parteen
