Single Survey Report

Studio House Front Road St Margaret's Hope

Date of inspection: 13/09/2021

Prepared by: N J Coward, MRICS
The Office
Burgar House
Evie
KW17 2NJ

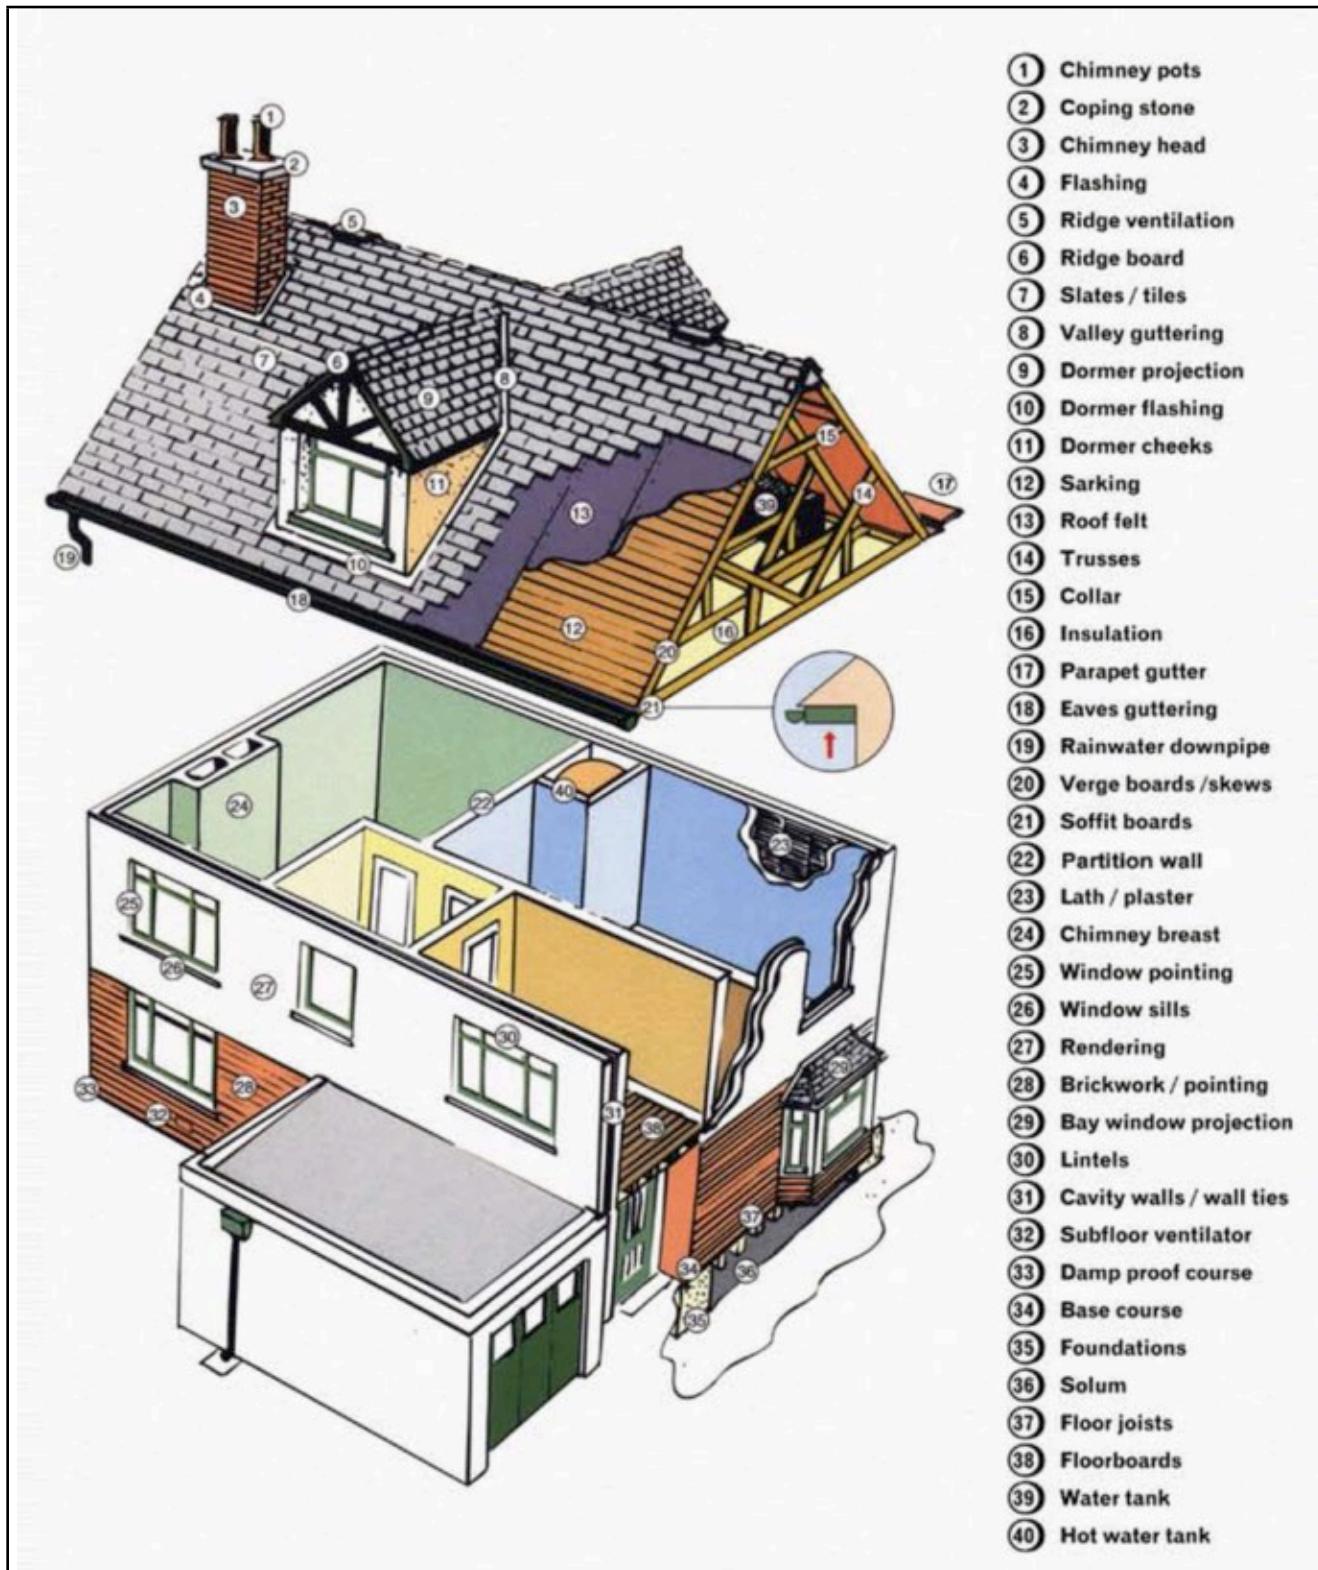
Sectional diagram showing elements of a typical house

Reference may be made in this report to some or all of the above component parts of the property. This diagram may assist you in locating and understanding these terms.
