## Survey Report On

**Madras Villa,  
Bignold Park Road,  
Kirkwall,  
Orkney,  
KW15 1PT.**

**Date of inspection:** 28<sup>th</sup> September 2021.

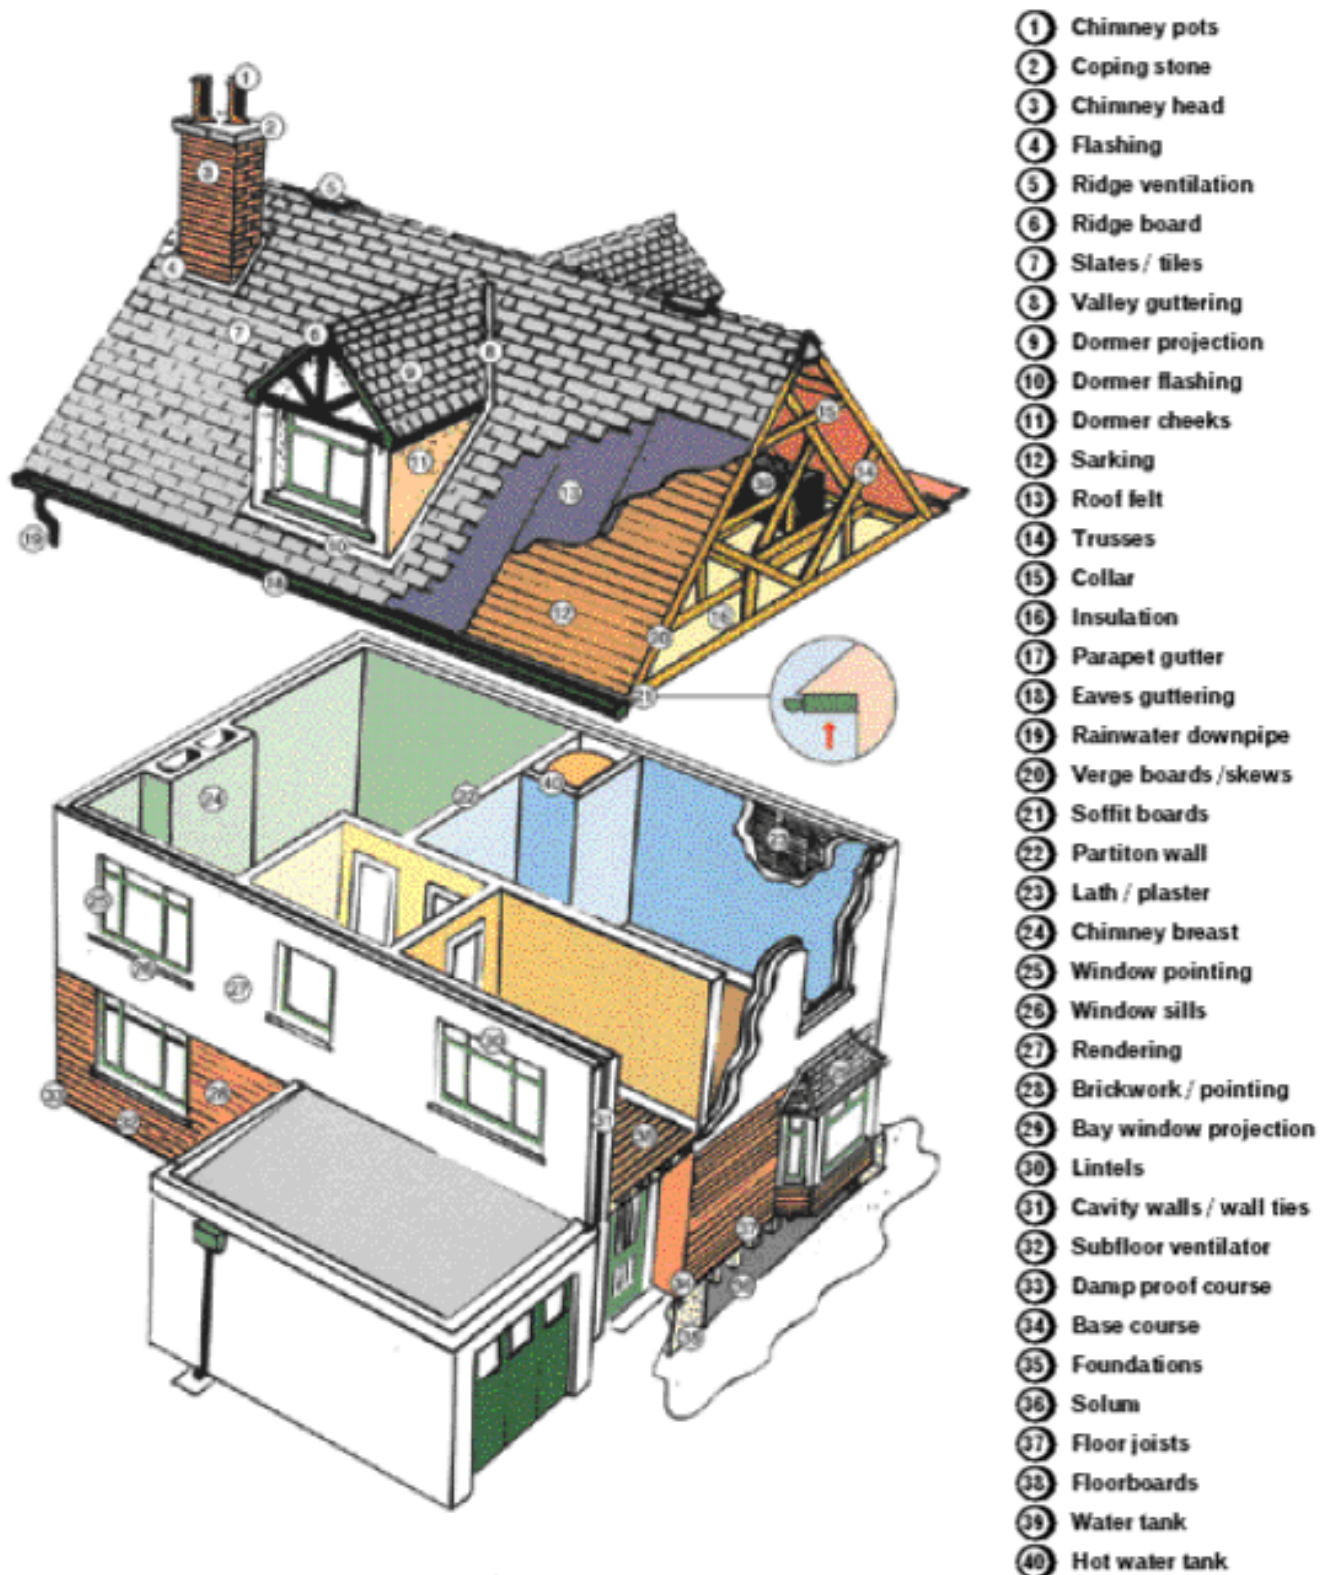
## Sectional diagram showing elements of a typical house

Reference may be made in this report to some or all of the above component parts of the property. This diagram may assist you in locating and understanding these terms.
