Single Survey

**66 Rose Street
Thurso
KW14 7HW**

survey report on :

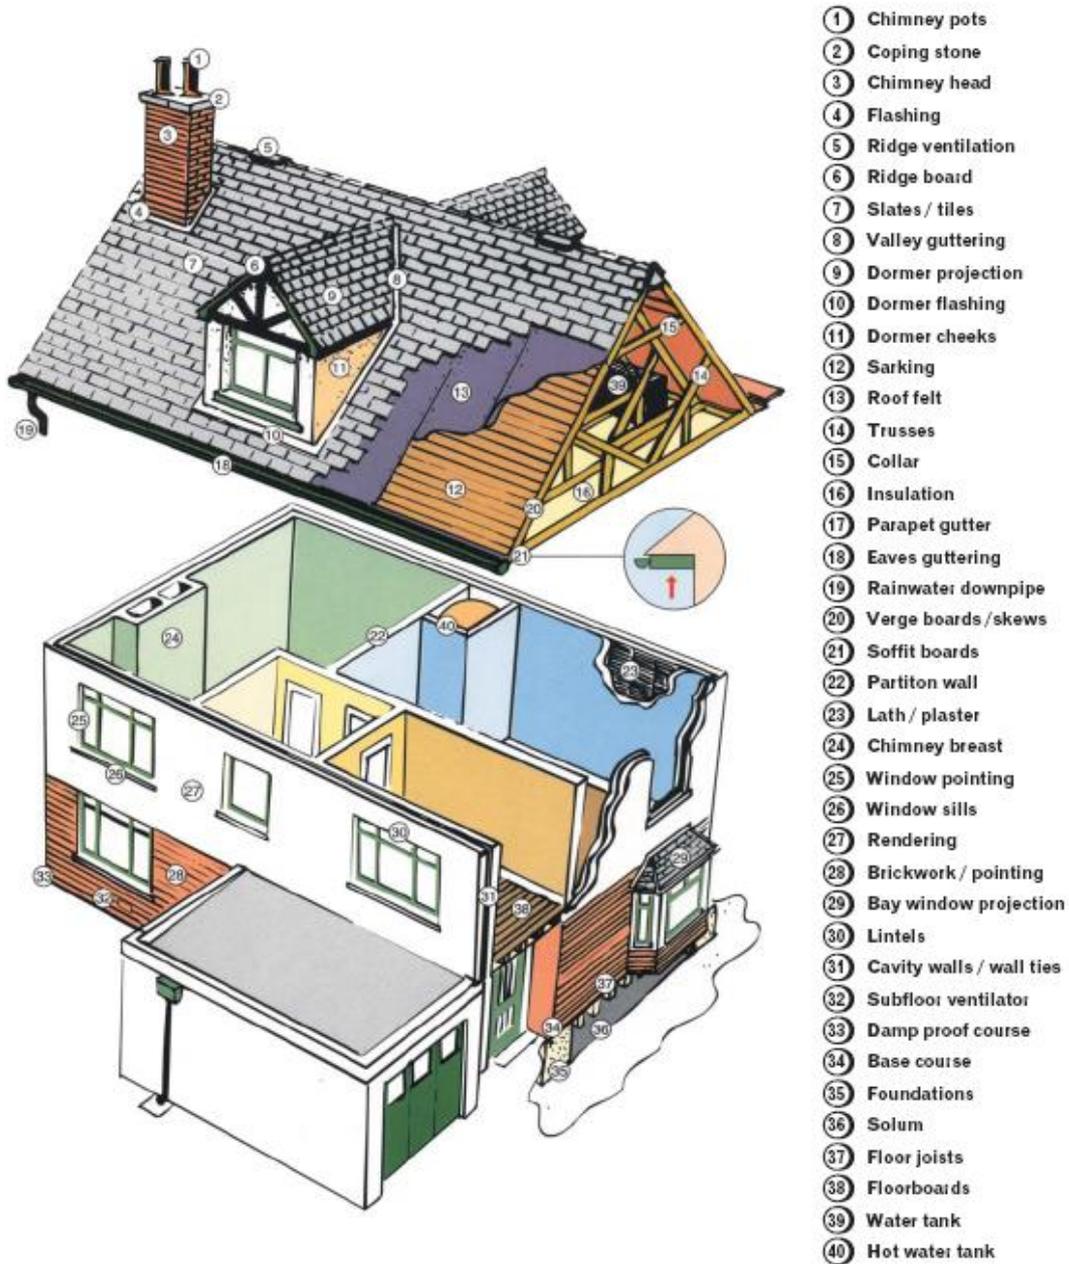
Sectional Diagram showing elements of a typical house

Reference may be made in this report to some or all of the above component parts of the property. This diagram may assist you in locating and understanding these items.
