HOME REPORT

FLAT 1/2,
4 HIGHBURGH ROAD,
GLASGOW,
G12 9YD

Single Survey

Property address	FLAT 1/2, 4 HIGBURGH ROAD, GLASGOW, G12 9YD
Customer	Mr M. Abu-Toq
Customer address	
Prepared by	Home Survey Scotland Ltd
Date of inspection	13th May 2022

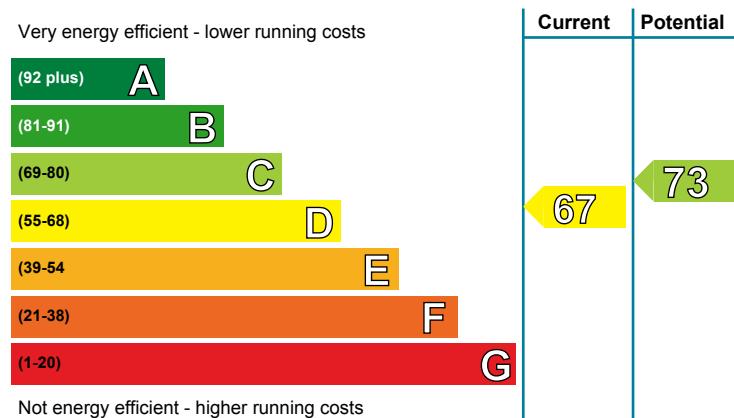
Energy Efficiency Rating

This graph shows the current efficiency of your home, taking into account both energy efficiency and fuel costs. The higher this rating, the lower your fuel bills are likely to be.

Your current rating is **band D (67)**. The average rating for EPCs in Scotland is **band D (61)**.

The potential rating shows the effect of undertaking all of the improvement measures listed within your recommendations report.

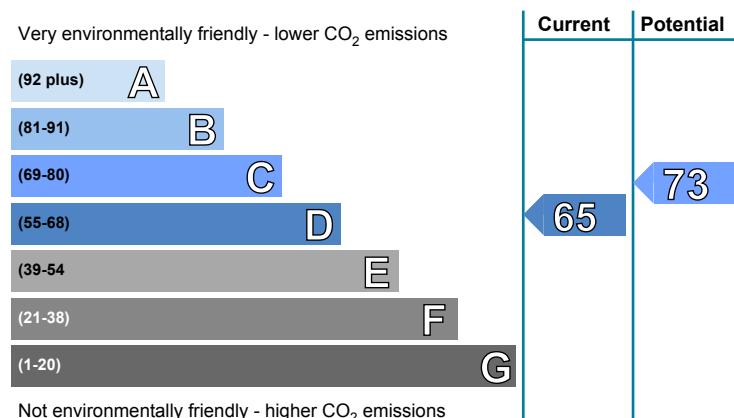
Environmental Impact (CO₂) Rating

This graph shows the effect of your home on the environment in terms of carbon dioxide (CO₂) emissions. The higher the rating, the less impact it has on the environment.
