FLAT 2/2  
71 LAUDERDALE GARDENS  
GLASGOW  
G12 9QU

# Home Report

FLAT 2/2 , 71 LAUDERDALE GARDENS, GLASGOW, G12 9QU

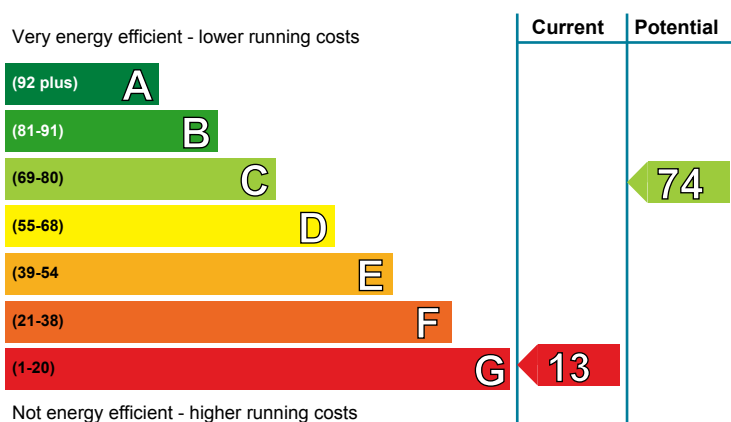
## Energy Efficiency Rating

This graph shows the current efficiency of your home, taking into account both energy efficiency and fuel costs. The higher this rating, the lower your fuel bills are likely to be.

Your current rating is **band G (13)**. The average rating for EPCs in Scotland is **band D (61)**.

The potential rating shows the effect of undertaking all of the improvement measures listed within your recommendations report.

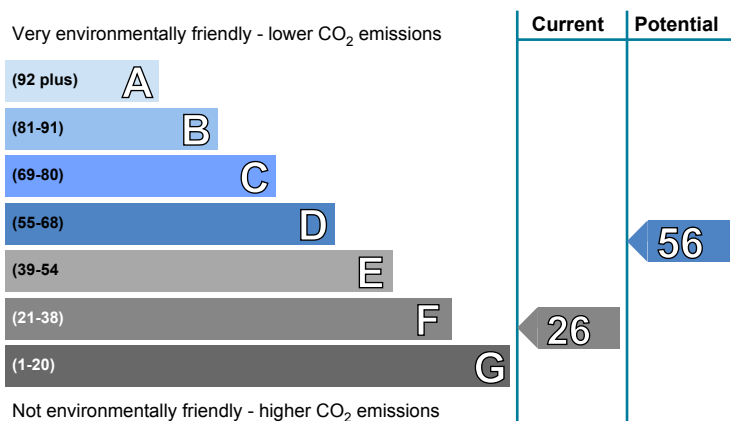
## Environmental Impact (CO<sub>2</sub>) Rating

This graph shows the effect of your home on the environment in terms of carbon dioxide (CO<sub>2</sub>) emissions. The higher the rating, the less impact it has on the environment.

Your current rating is **band F (26)**. The average rating for EPCs in Scotland is **band D (59)**.

The potential rating shows the effect of undertaking all of the improvement measures listed within your recommendations report.
