# Damage assessment in CFRP laminates exposed to impact fatigue loading

**George Tsigkourakos<sup>1\*</sup>, Vadim V Silberschmidt and I A Ashcroft**

Wolfson School of Mechanical and Manufacturing Engineering, Loughborough University, Leicester-shire, LE11 3TU, UK

**Abstract.** Demand for advanced engineering composites in the aerospace industry is increasing continuously. Lately, carbon fibre reinforced polymers (CFRPs) became one of the most important structural materials in the industry due to a combination of characteristics such as: excellent stiffness, high strength-to-weight ratio, and ease of manufacture according to application. In service, aerospace composite components and structures are exposed to various transient loads, some of which can propagate in them as cyclic impacts. A typical example is an effect of the wind gusts during flight.

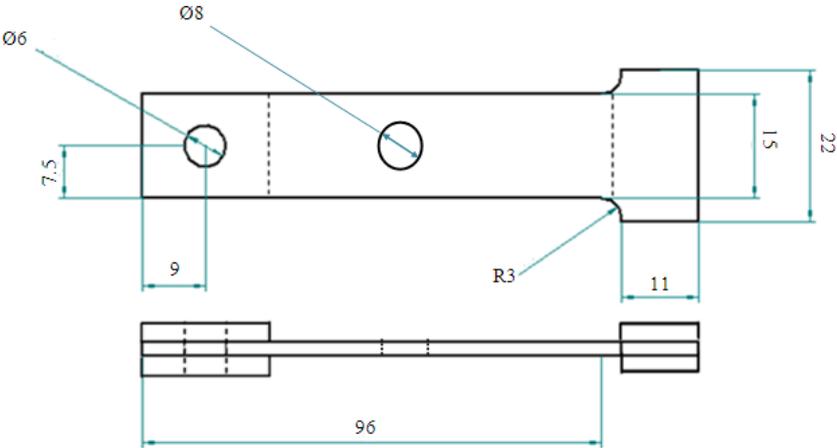
Figure 1. Dimensions of the specimens in mm.

The specimen configuration, as shown in figure 1, was adopted in conformity with BS EN ISO8256:2004, with modification to fit the tensile impact machine figure 3. End tabs were used to aid grip and provide sample alignment. These were made of aluminium alloy and bonded to the specimens with FM-73 adhesive. Holes were drilled in the specimens using a diamond coated 6 mm drill specially designed to attenuate delamination. The hole at the left end of the sample in figure 2 was used to attach the sample to the specimen support via a bolt. The hole in the centre of the sample was introduced as a representation of a bolt hole and to provide region to initiate damage.

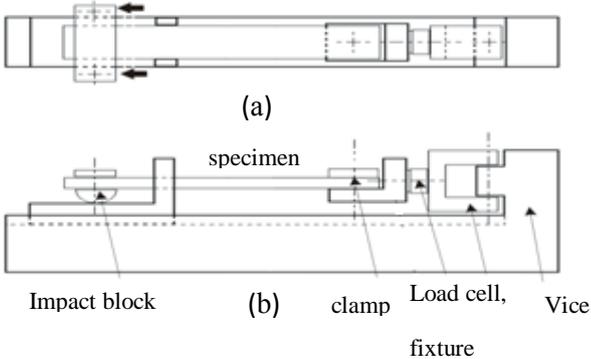
Figure 2. Schematic of specimen fixture for impact fatigue. (a) Top view, arrows denote impact loading direction. (b) Side view.

The tensile impact test used for our experiments utilises a CEAST RESIL impactor. The basis of this method is that a specimen is supported at one end in a vice and its opposite end is struck repeatedly by a controlled pendulum hammer, resulting in a dynamic uniaxial tensile load as shown in figure 2. The specimen is clamped at one end to a specimen support using bolts. A load cells also rigidly fixed to this support. At the free end of the specimen an special impact block is fixed. This block consists of a two plates held together by bolts. A firm connection between the specimen and impact block is obtained by compression of the plates. The impact block is struck by a pendulum hammer at the location indicated in Figure 2(a).

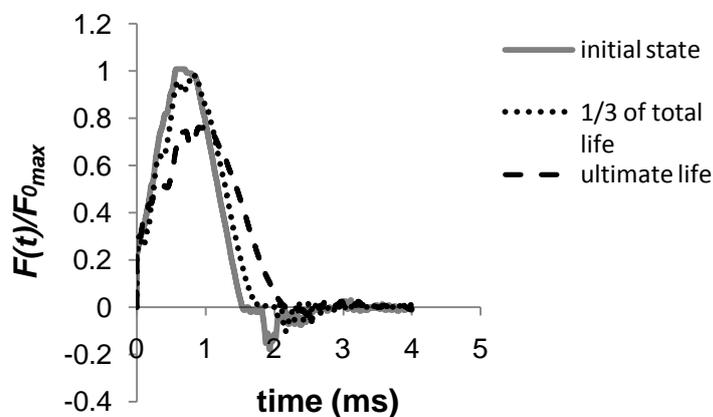
**Figure 3.** Evolution of forces in specimen in various cycles of impact fatigue.

Impact tests were conducted with a constant applied energy, this means that the applied force is not a controllable variable as it is affected by the deterioration of the specimen as a result of fatigue. Typical graphs showing the evolution of the force response to impacts at various stages in a sample's life are presented in figure 3.  $F(t)$  is the force response as a function of time,  $t$ , and  $F_{0max}$  is the maximum force obtained in the initial impact. Damage is identified as a deterioration of  $F_{max}$  under continuing impact cycles and a drastic change is seen in the final breaking impact (ultimate life).

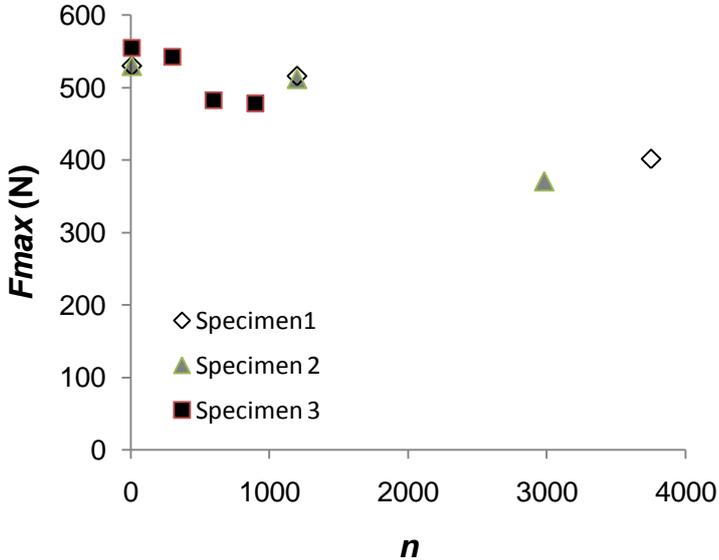
**Figure 4.** Deterioration of  $F_{max}$  as a function of number of cycles.

The reduction in  $F_{max}$  with increasing number of impacts can be seen in figure 4. This is accompanied with a reduction in stiffness, as shown in figure 5. These two figures indicate that the studied response is changing as a function of damage accumulated in the sample as a result of the repeated impacts.

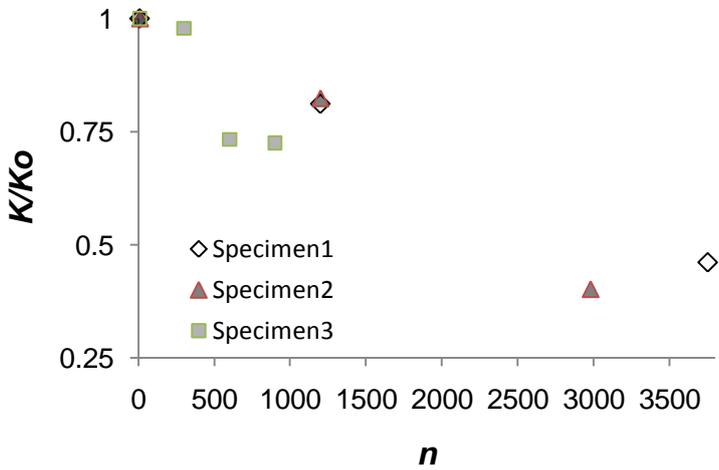
**Figure 5.** Deterioration of  $K$  with respect to number of cycles

From the above figure it is apparent that the decrease in stiffness after 40% of life is drastic. The preliminary objective of the paper is to correlate the changes in stiffness and force with the observed damage in the sample. This will be described in the following section.

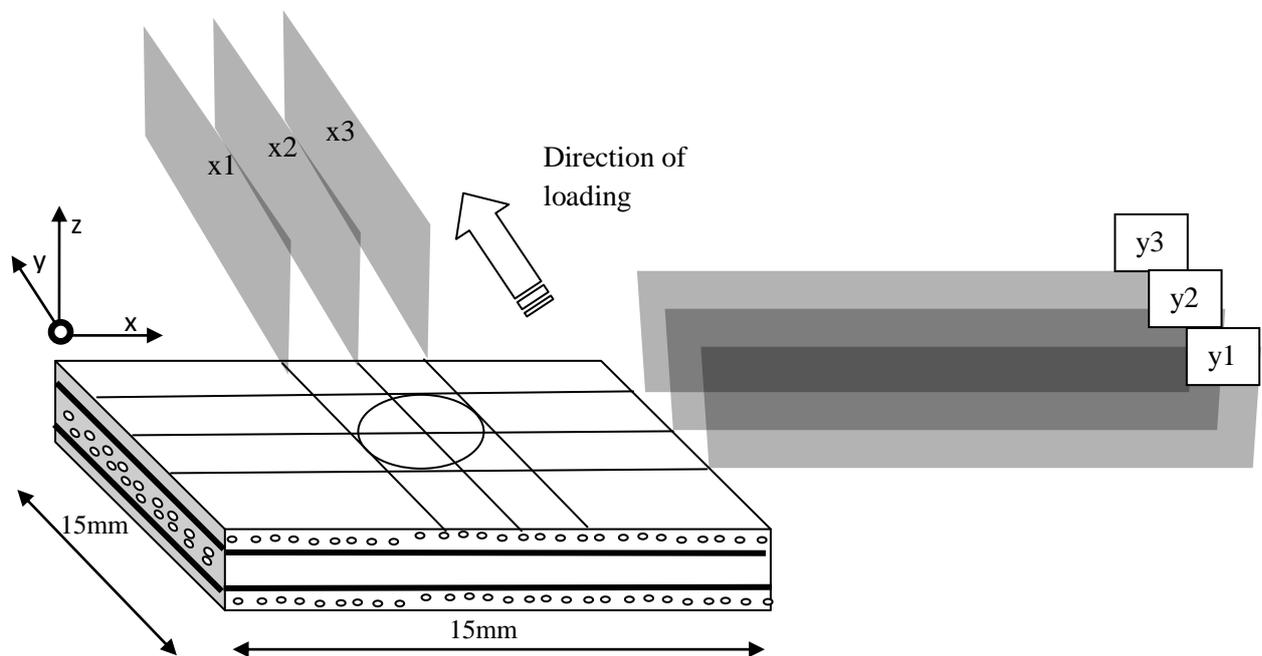
**Figure 6.** Schemating indicating the postprocessing procedure and direction of loading. Slices selected at the edges and centre of the hole along the x and y axes .

Macroscopic evaluation at early stages of the fatigue life of the samples revealed only  $0^\circ$  cracks in the outer plies of the samples. For that reason microscopic evaluation utilising Xrays was performed. Figure 6 shows the inspection area as well as the sectioning procedure of the post processing of the results. The individual slices that were examined along the x and y axes revealed that the maximum damage was located at the edges of the hole where the stress concentrations were high. A symmetric pattern of damage was observed on either side of the hole in both the x and y directions. For this reason slices y1 and x3 were selected for comparison of damage patterns after 300 900 and 1200 impacts.

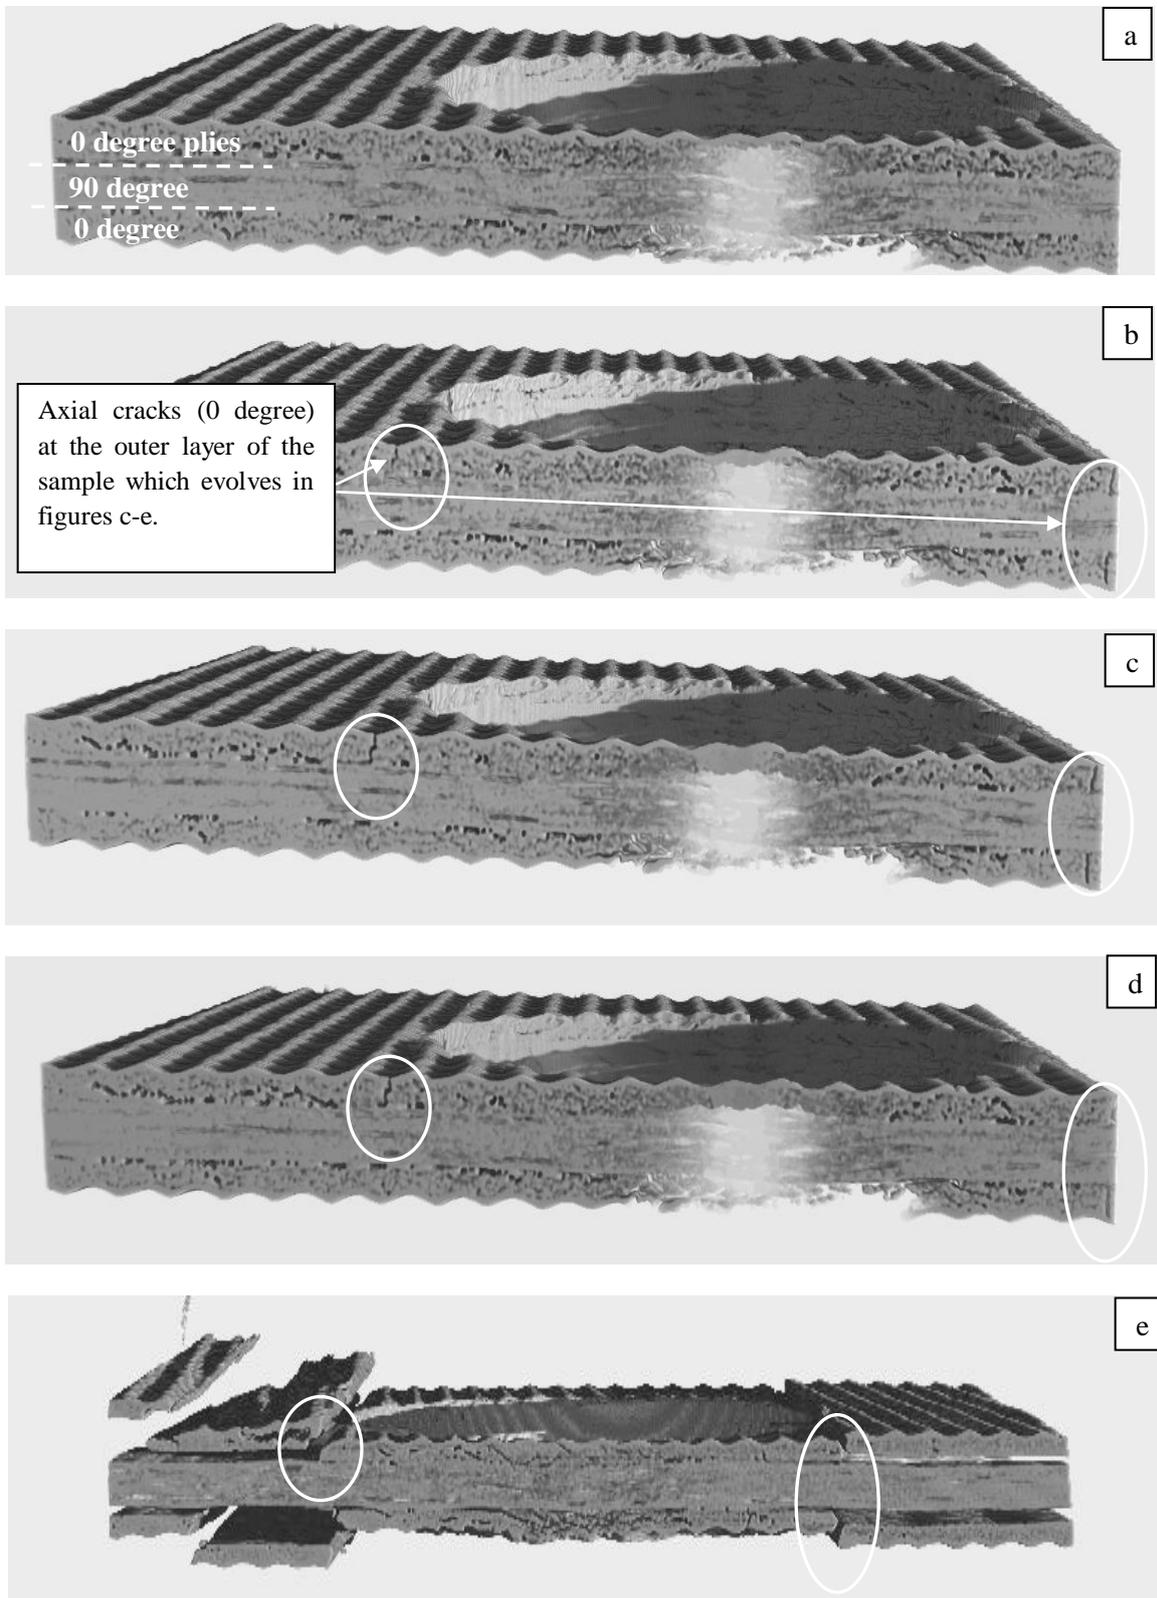
Figure 7. Individual y1 slices at a) post-manufacturing state, b) 300 impacts , c) 900 impacts ,d)1200 impacts and e) 3750 impacts(ultimate life)

Figure 7 presents the slices along the y axis while figure 8 along the x axis. In figure 7 it is apparent that the axial cracks initiated by microdefects at the virgin state figure 7(a) are evolving by increasing in width and length as they reach the 90 degree plies figure 7(b)-(d). At the final stage of damage Figure7 (e) these axial cracks are joined by delamination and complete decohesion of the  $0^\circ$  degree plies takes place. In Figure 8 the slices along the x axis are demonstrated. Delamination signs are vivid at the area adjacent to the hole and seem to grow away from the hole along the length of the specimen. Transverse cracks in the 90 degree plies grow towards the  $0/90$  and  $90/0$  interfaces joining the delaminations at areas next to the drilled area. Finally 3D views of the last stage of damage show the complete failure scenario in figure 9.

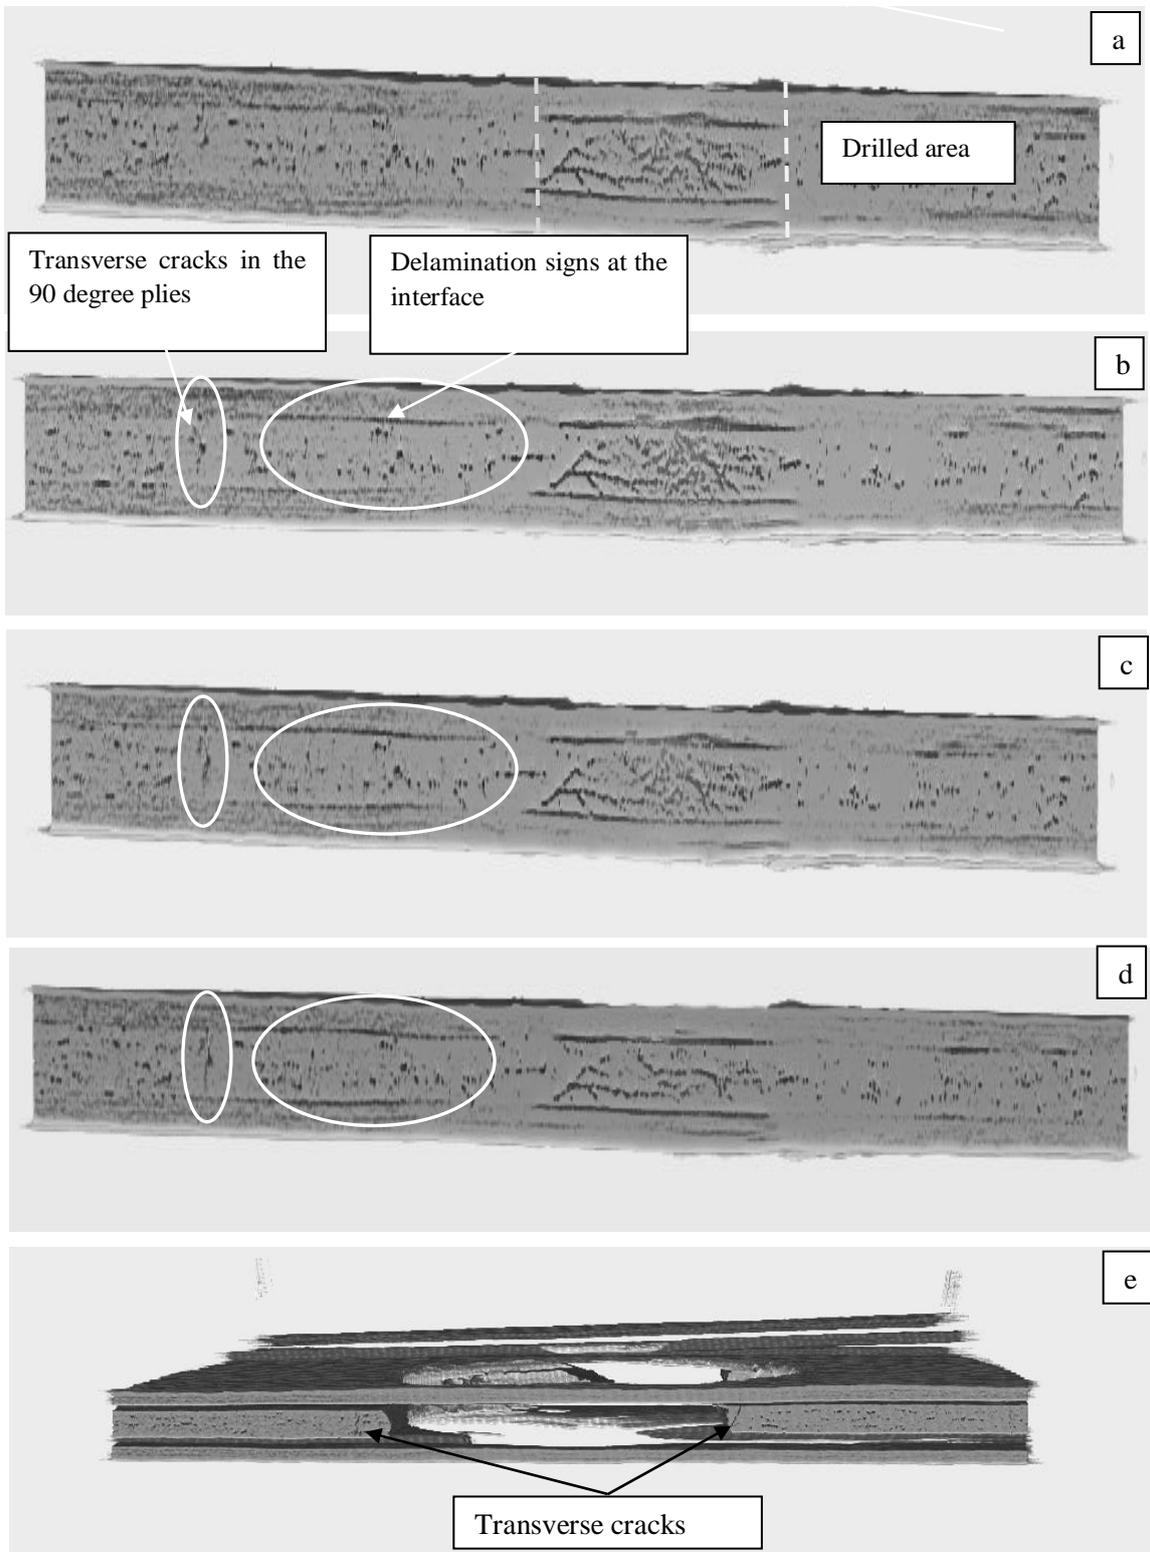
Figure 8. Individual x3 slices at a) post-manufacturing state, b) 300 impacts , c)900 impacts ,d)1200 impacts and e)3750 impacts(ultimate life)

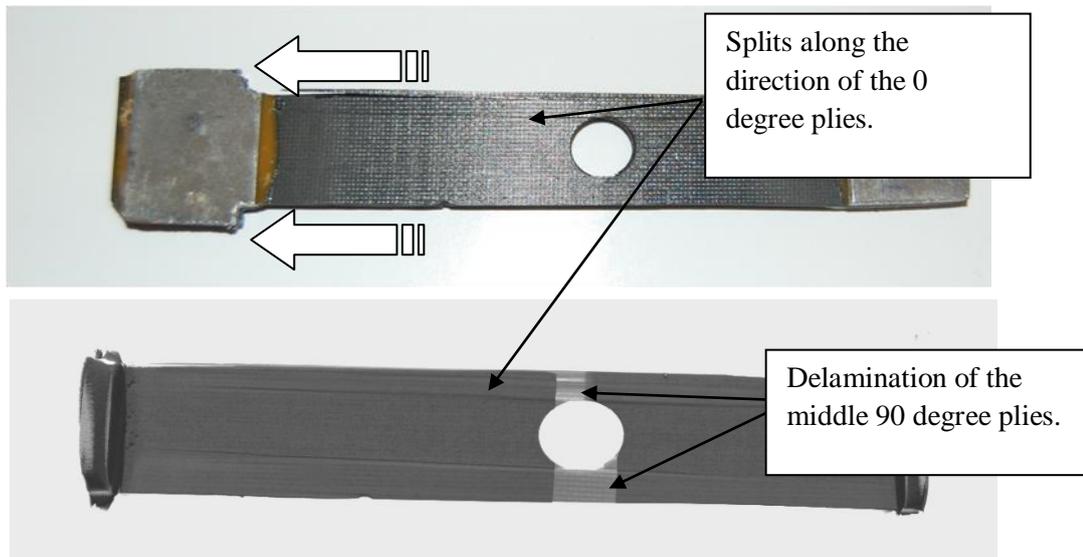
**Figure 9.** (a) Macroscopic evaluation with arrows denoting the direction of loading, (b) Semitransparent Xray front view of the whole specimen at the final stage of damage.
