Lower Shannon Hydromorphology: **Fluvial Audit**

Final

June 2024

JBA Ireland for the Office of Public Works

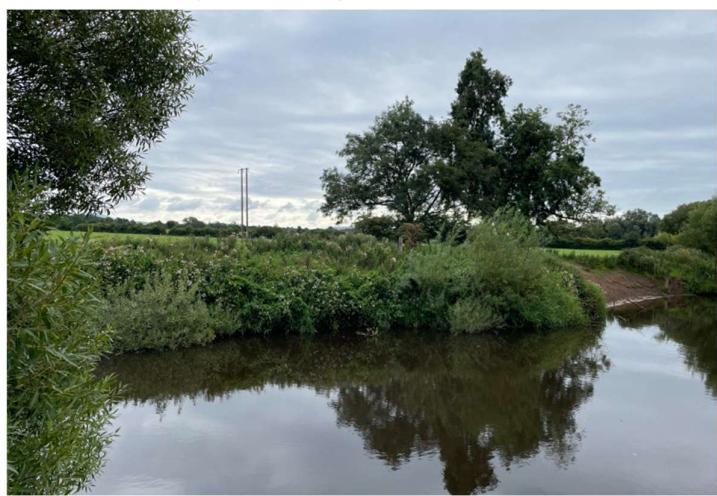
Whilst not extensive, riverbank poaching was observed and assumed to be from local livestock (Figure 4-4). This poaching will contribute a reasonable amount of fine sediment during either a localised land runoff event overbank from local fields, or during a geomorphologically competent event.

Figure 4-2 Large stand of Himalayan Balsam visible to the left of the picture and bankside poaching visible to the right (Right bank)

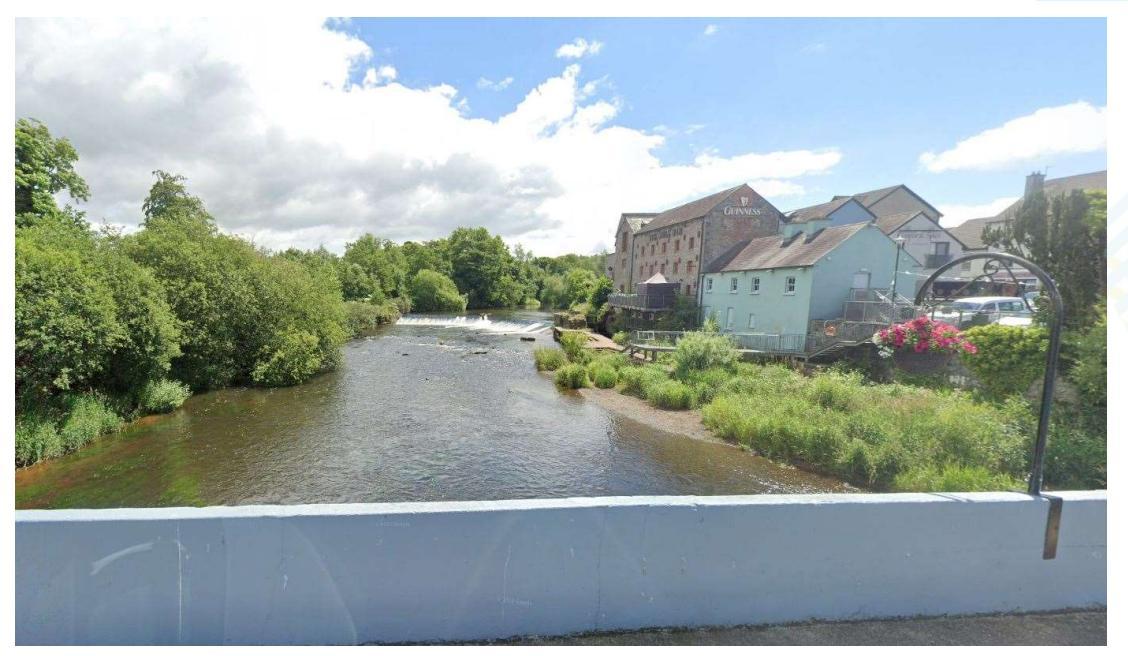
Figure 4-6 Gravel bar on left bank of Mulkear River downstream of Annacotty Weir (Source: Google Maps streetview 04/06/2024).

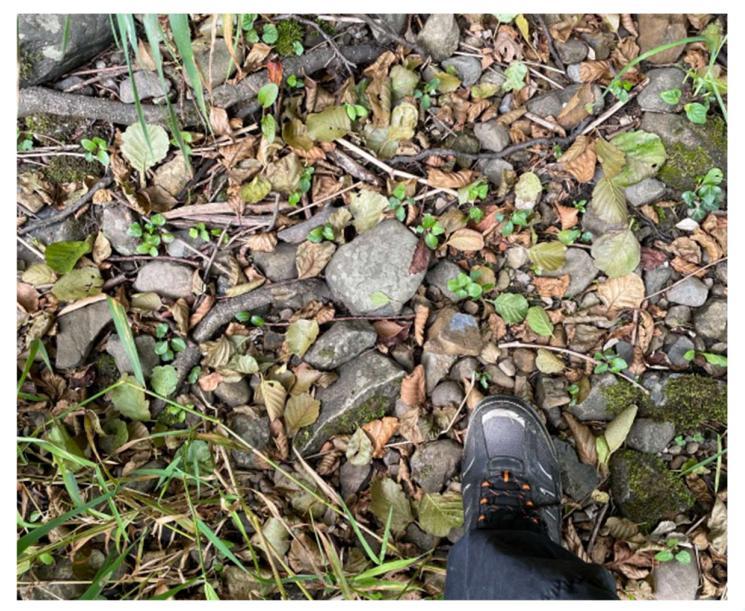
river exists; gravel and cobble sized material (Figure 4-8) is exposed within the matrix on the left bank. The cobble sized material is less mobile with evidence of mosses and lichens on the clasts, but clean gravels were observed suggesting these can be eroded and transported during events exceeding the low-flow bank height.

Figure 4-8 Gravel-pebble and cobble sized material visible on the left bank.

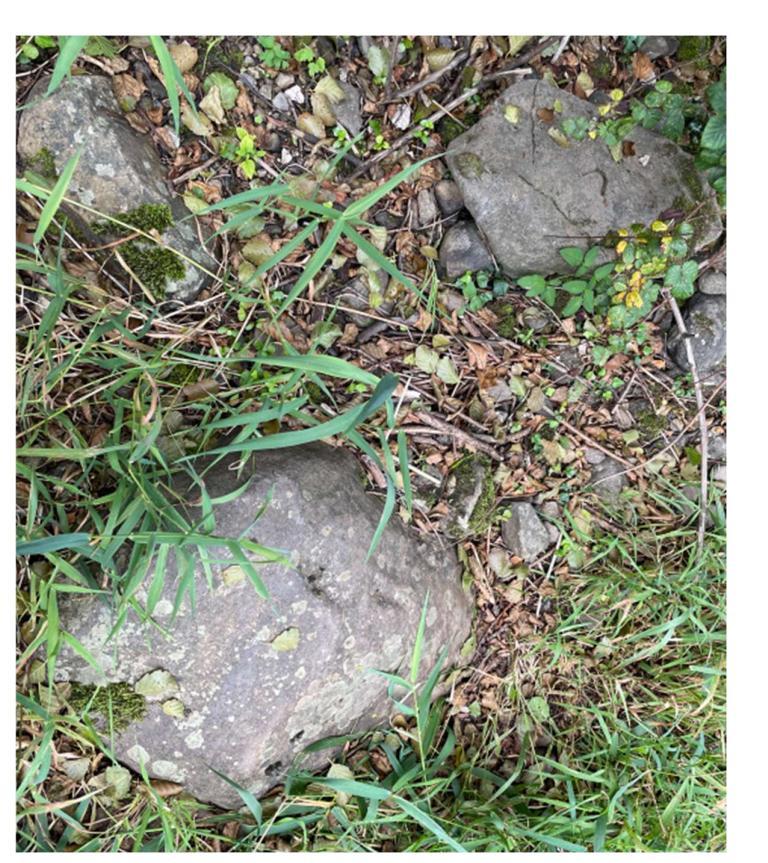
Figure 4-11 Large boulder material - lower particle b-axis (left to right) was approximately 600mm (although entire particle is not visible).

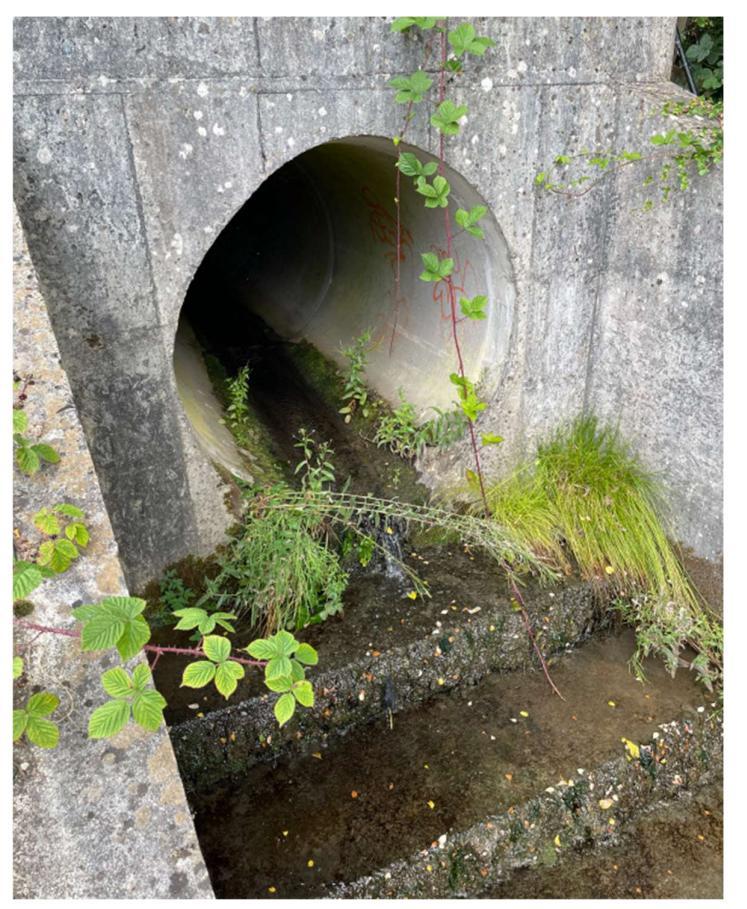
A large outfall is located in this reach (Figure 4-12), slightly downstream from the motorway and is assumed to be draining adjacent agricultural land. During high runoff events, depending on the pathways, this outfall has the potential to contribute fine sediment; local access roads and compound parking areas were dusty, and it is assumed the motorway drainage also connects into this outfall. At the time of survey the outfall was contributing to baseflow, however the flow was clear and did not appear to contain any fine sediment.

Figure 4-12 Outfall draining into Mulkear 2 downstream from the motorway.

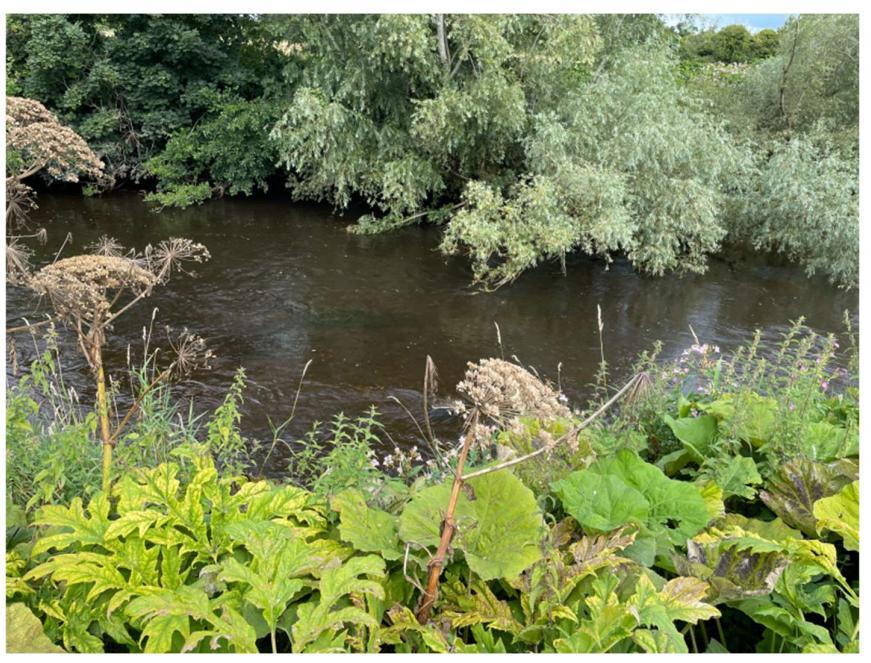
Figure 4-13 Channel bed can be seen (water looks brown but this is bed sediment), invasives are abundant but right bank is shaded by trees.

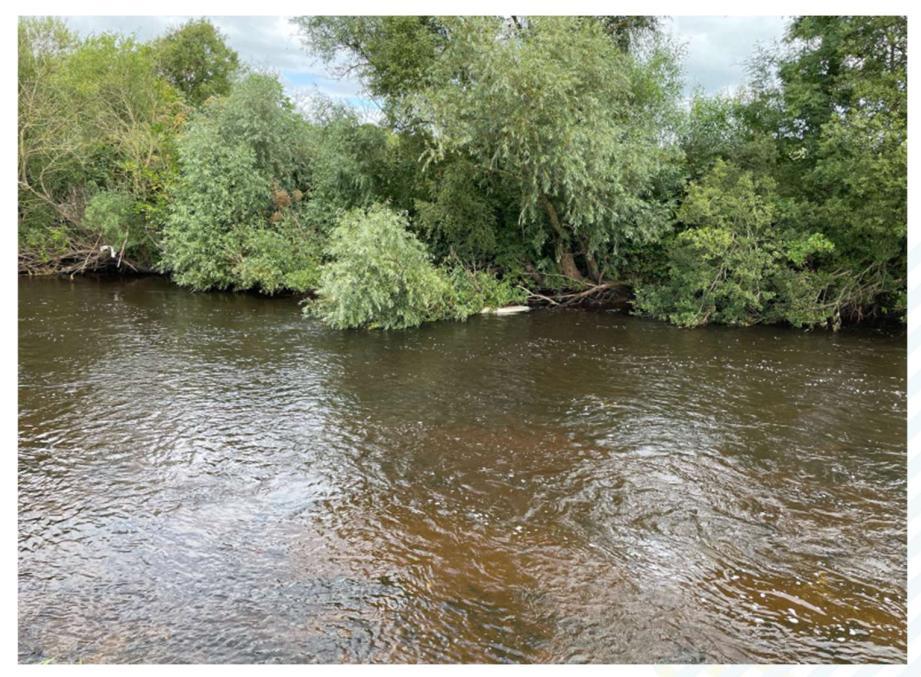
Flow typology remained typically glide, with some localised more energetic and rippled flow (Figure 4-14). Channel substrate appears to contain some finer sediment, which corresponds with sand coloured sediment observed elsewhere in the catchment.

Figure 4-14 Some rippled flow, with eddying evident and shading provided by trees on the right bank of Mulkear 3.

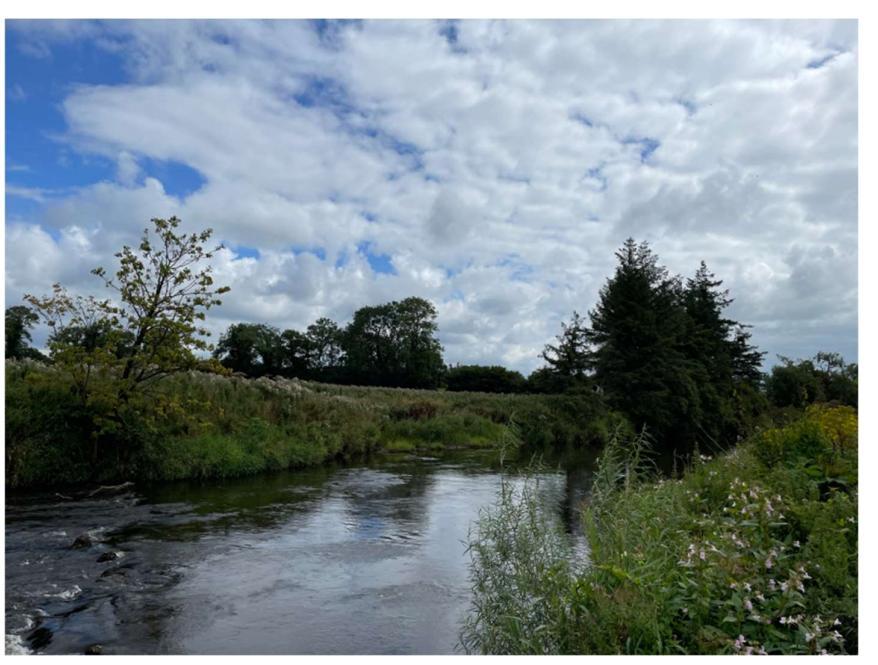
The channel geometry was again very incised, circa 2.5m below top of bank and comprising a channel width varying between 10-15m, widening to around 20m for a short distance (Figure 4-15) which has evidence of fine sediment deposition on the right bank forming a bar feature that has additionally begun to establish short grasses.

Figure 4-15 Channel widens out to approximately 20m - right bank has evidence of fine sediment accumulating and material has started to establish short grasses.

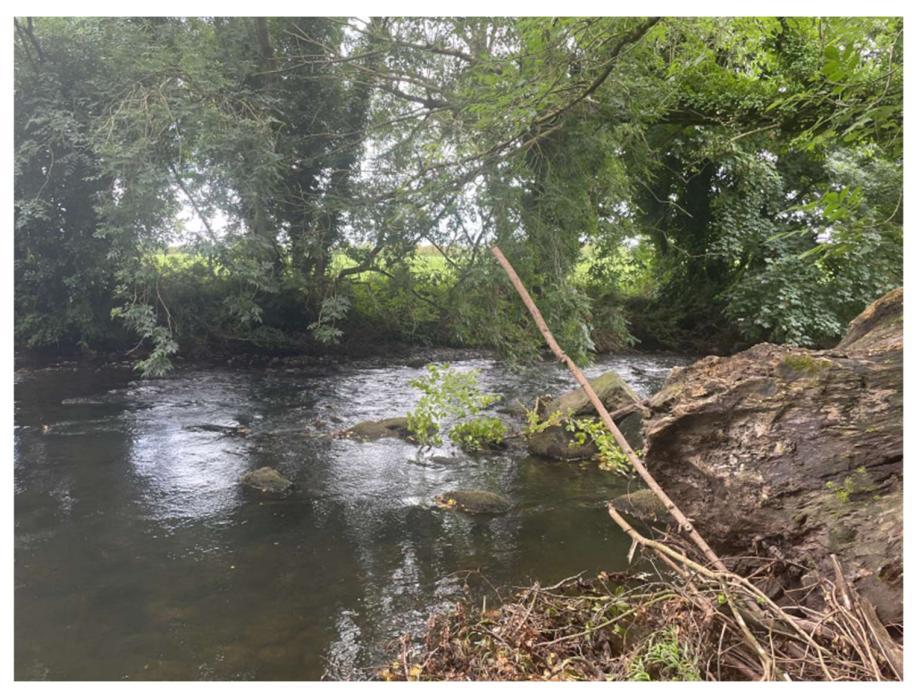
Figure 4-16 Clear water, but silt veneer exists on bed. Organic material accumulating (bottom right) within sluggish flow.

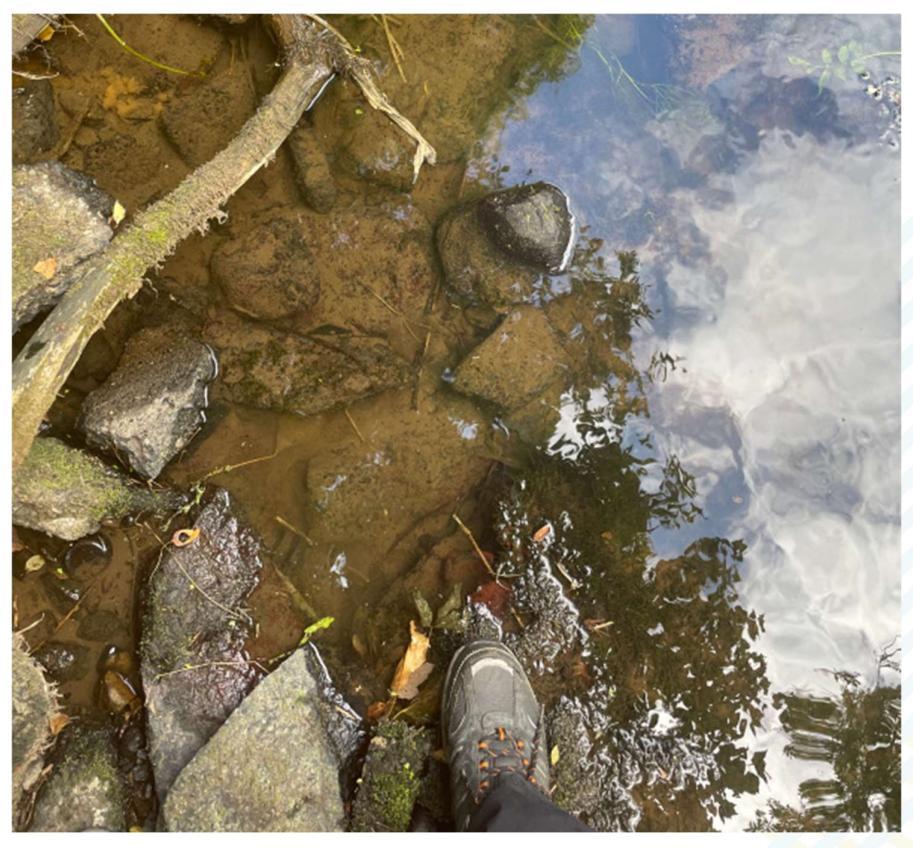
Figure 4-17 Cobble sized bed material covered with thin veneer of silt. This reach appears to temporarily store silt sized material.

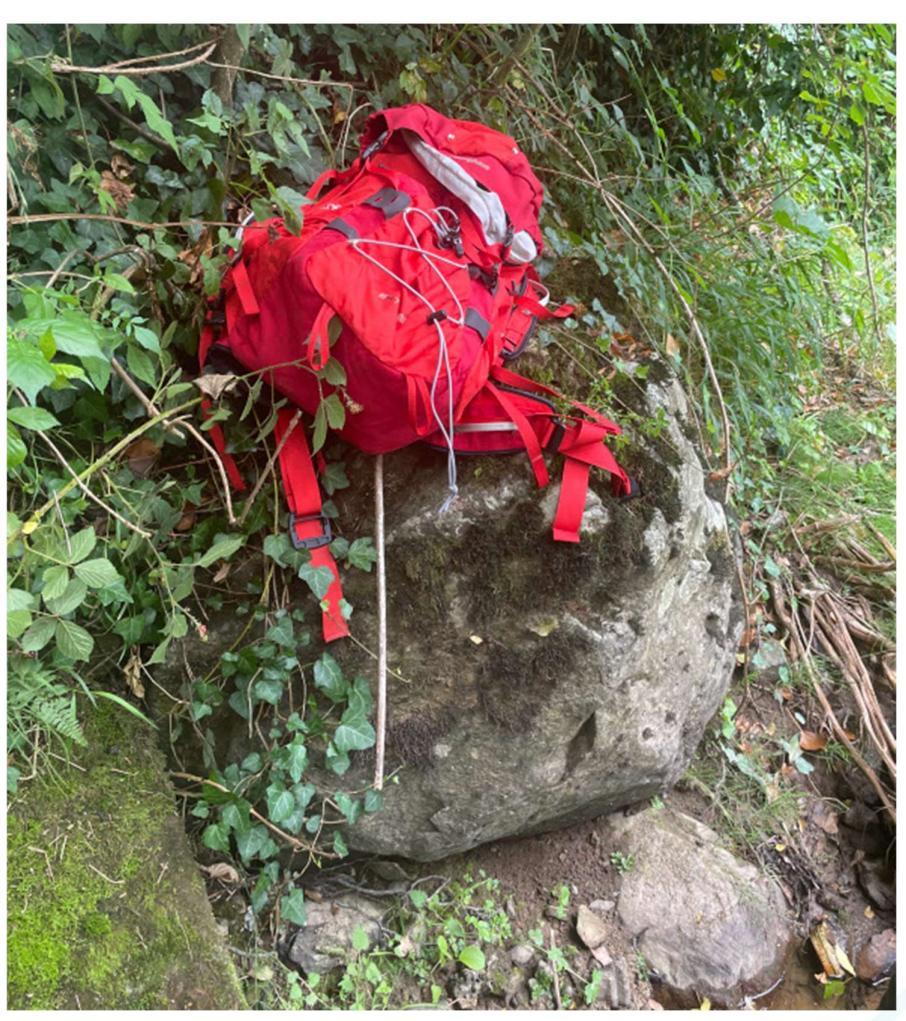
Figure 4-18 Very large boulder stacked on top of finer material, larger than 1m wide. Rucksack for scale is approximately 60cm tall.

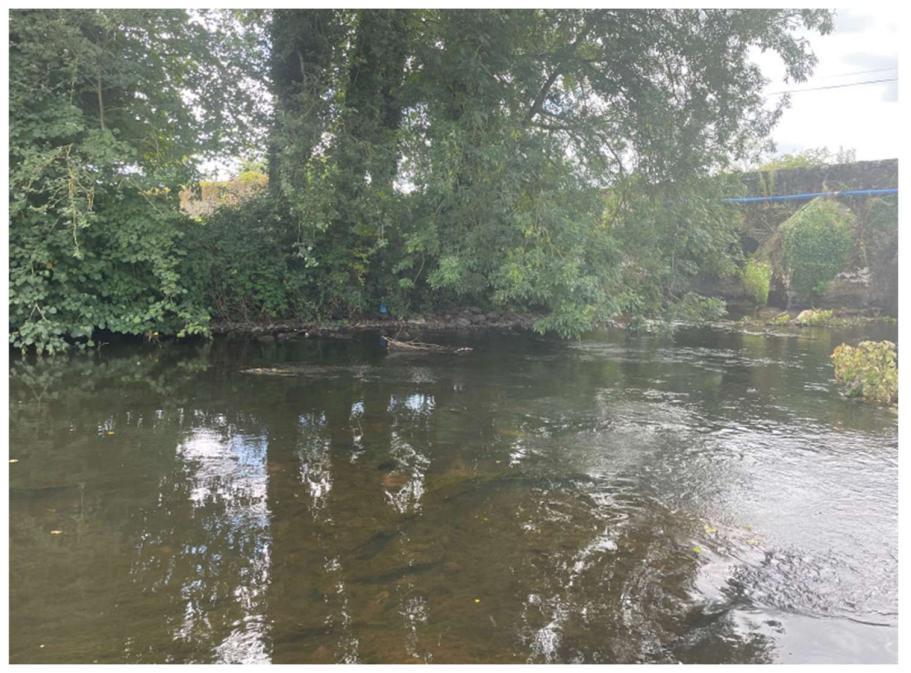
Whilst a veneer of finer silt type material was observed towards the margin on the river right bank, the flow was clear suggesting fines are either transported through the thalweg and have already passed this location or are stored as a veneer within the margins.

Figure 4-19 Bedrock channel bed at Mulkear Bridge (spot check) including veneer of finer material toward the right bank channel margin (bottom of picture).

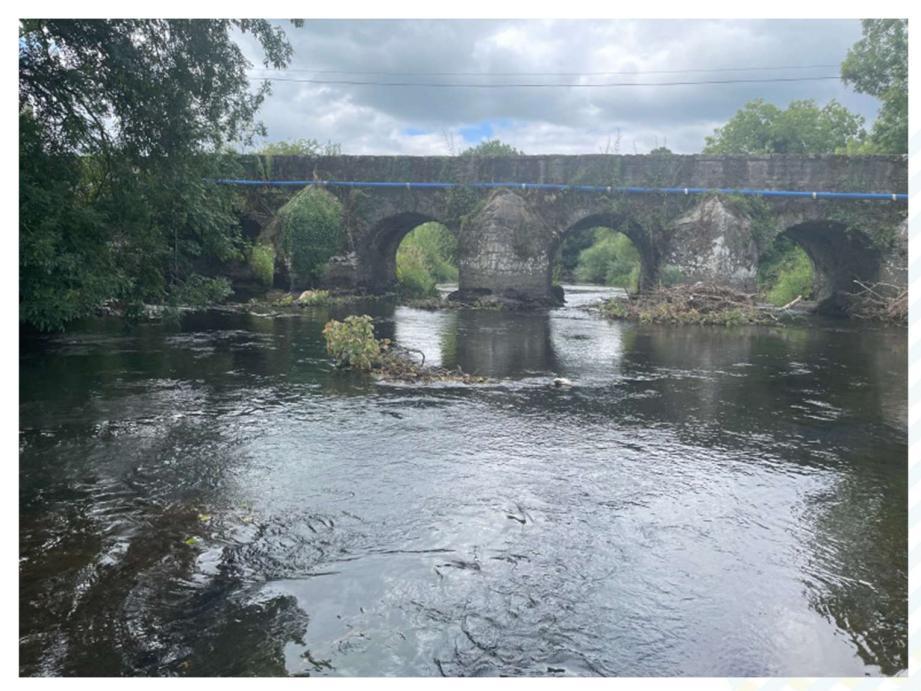
Flow patterns were swirling, upwelling and rippled, with organic and woody material trapped behind the bridge providing shelter for aquatic fauna. Some more energetic run flow typology was observed.

Figure 4-20 Varied flow types and organic debris present in the Mulkear.

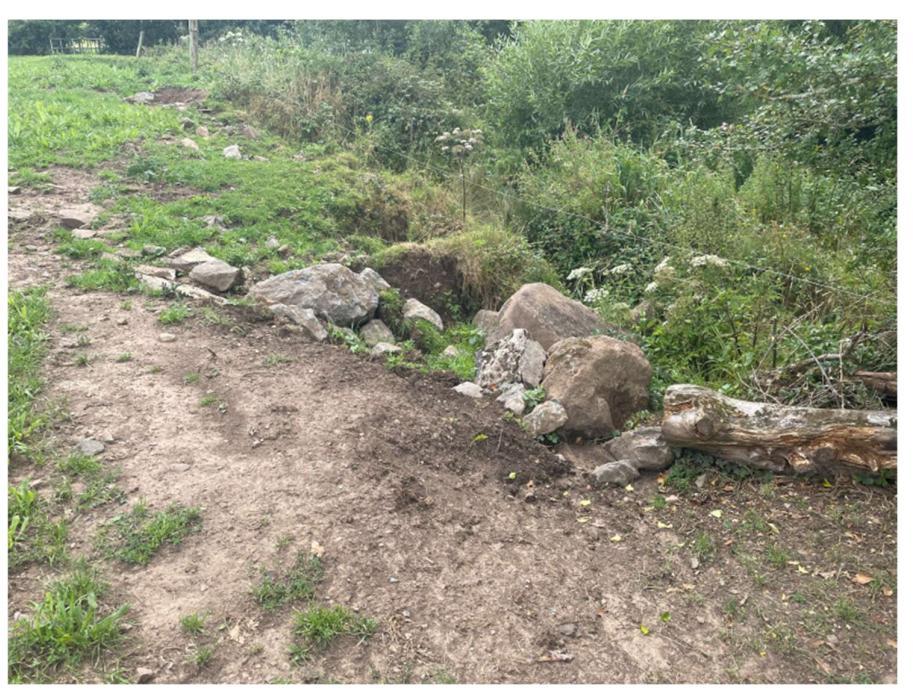
The right bank upstream from the bridge was visibly failing, slumping into the river channel, likely due to continued undercutting and winnowing of the finer material during geomorphologically competent events.

Figure 4-21 Right bank failing and slumping into the river. Additionally exposed fine sediment which could contribute to sediment load during local runoff event.

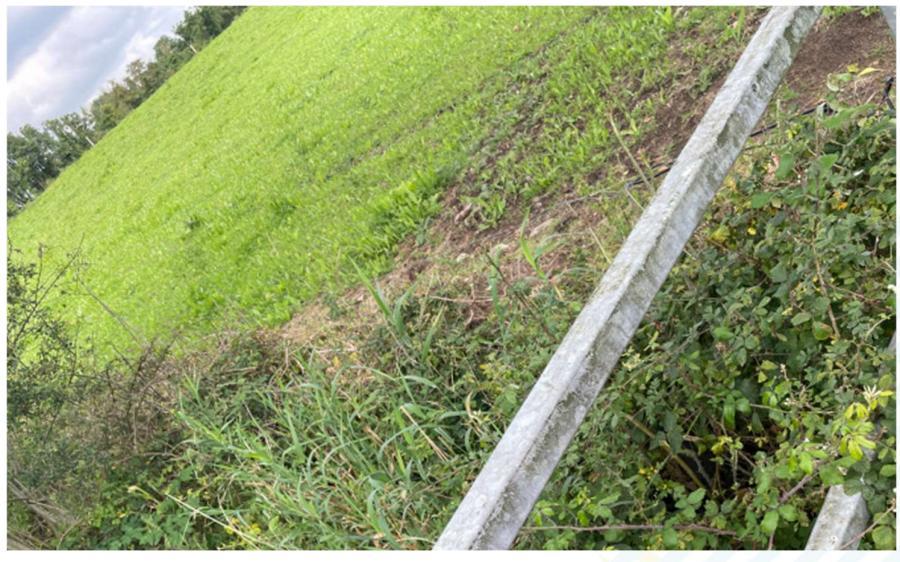
Figure 4-22 Monoculture land use – when crops are harvested fine sediment may be exposed.

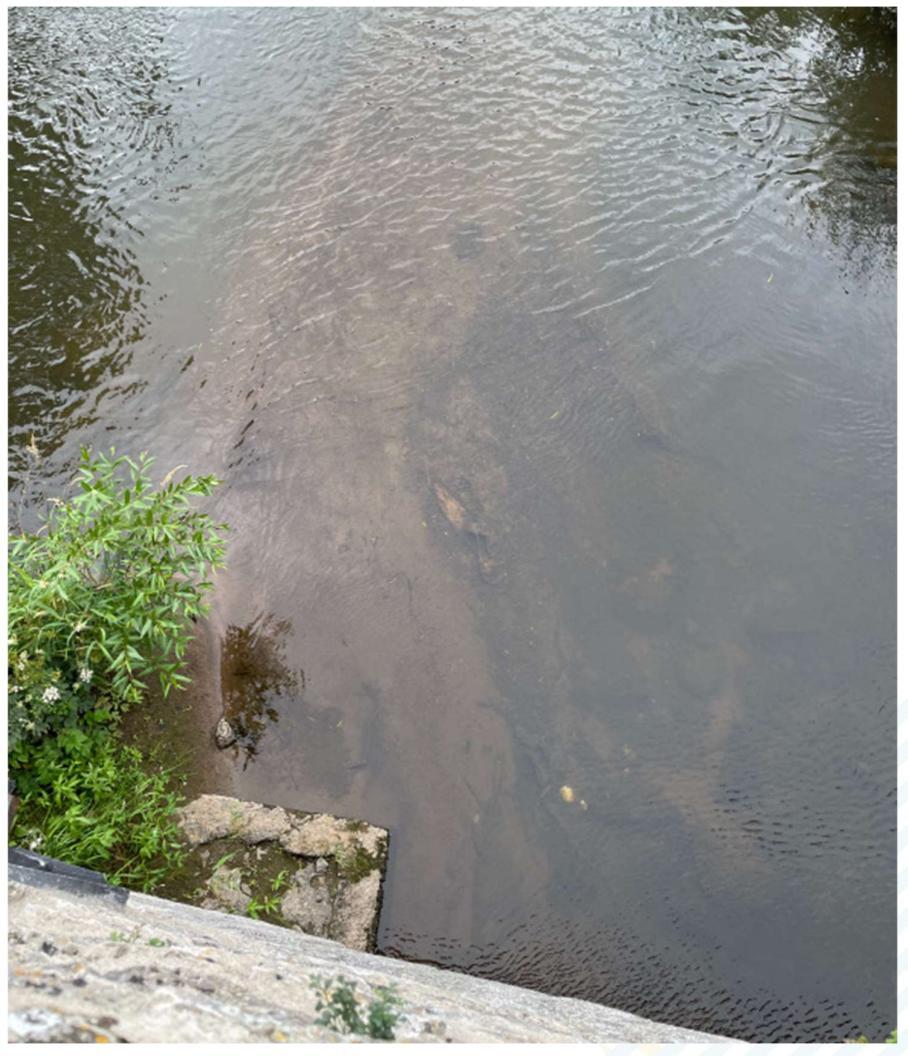
A bridge within the reach (ITM: 574014 648075) interrupts flow and causes fine sediment and sand deposition downstream (Figure 4-23). The flow clears at the bridge but a veneer of fine sediment remains on some of the bed.

Figure 4-23 Fine sediment bar feature immediately downstream of the bridge. Additionally fine sediment veneer on the channel bed.

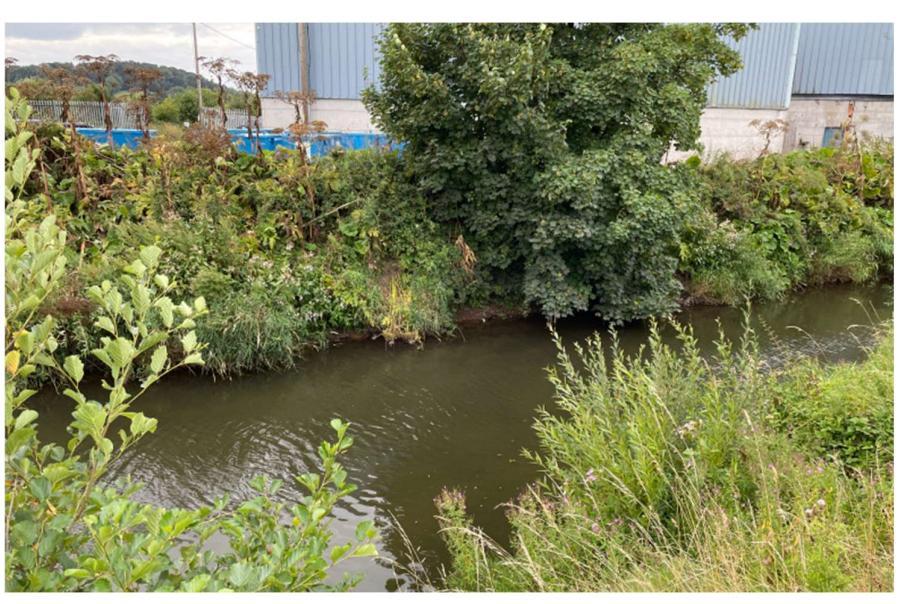
Figure 4-24 Stands of Giant Hogweed and Himalayan Balsam on the left bank and Japanese Knotweed present on right bank.

Figure 4-24 shows fine sediment exposed for a short distance on the left bank (between the tree shade area and the Giant Hogweed to the left) indicating that during die-back this could become a much greater extent of potential fine sediment input.

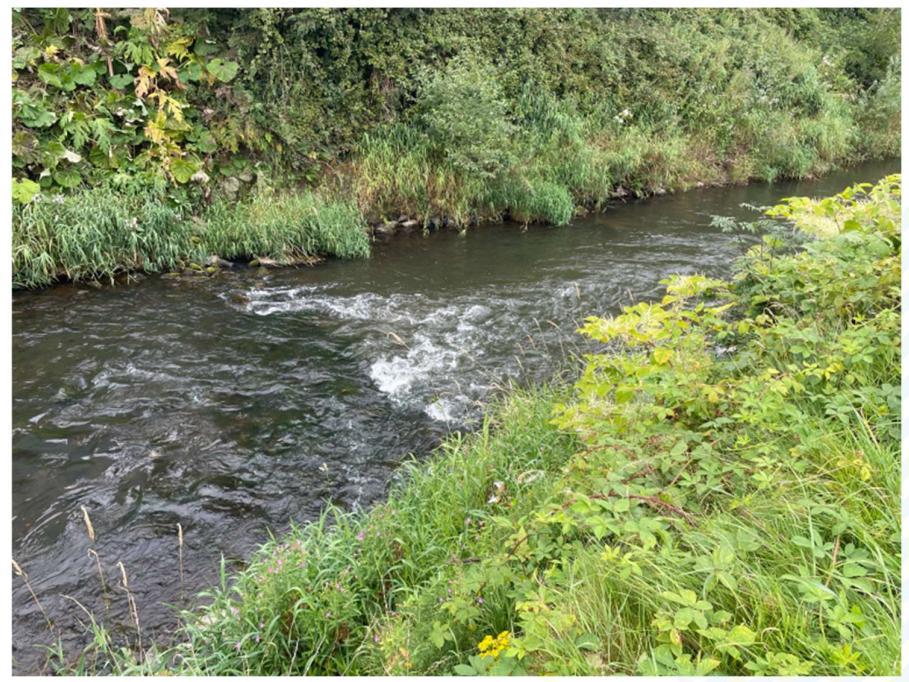
Figure 4-25 Small rock-riffle type feature. Assumed to be remnants of an old weir.

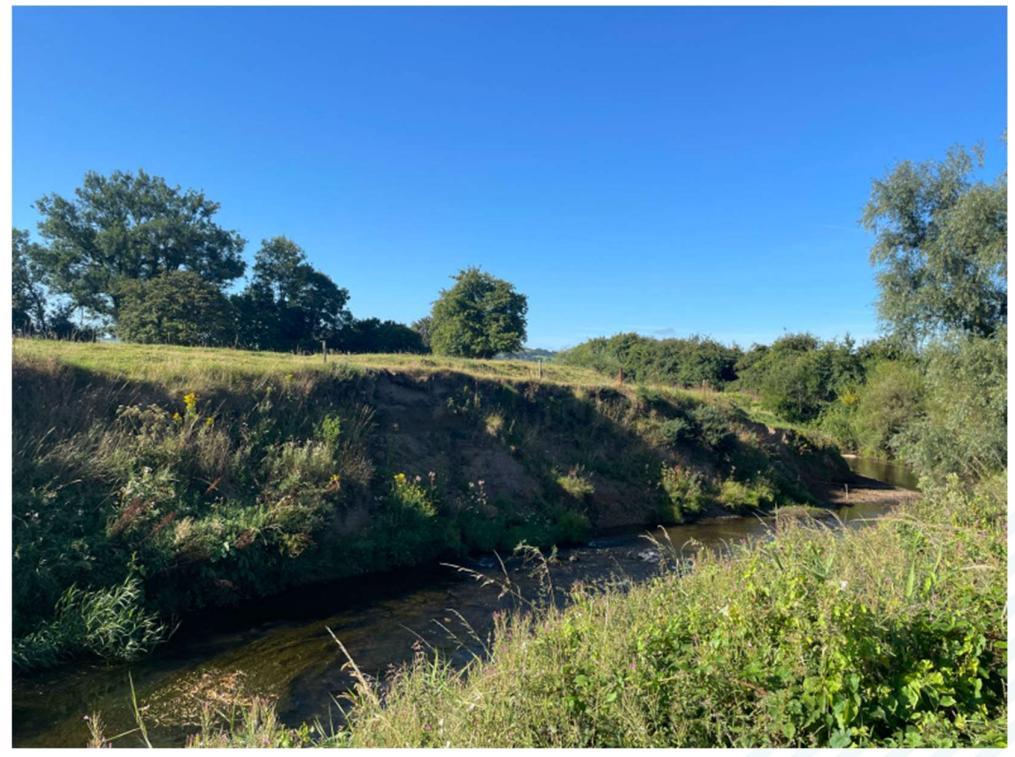
Figure 4-26 Overwide and deep channel. Fine sediment exposed on left bank with gravel bar feature on the inside of meander bend.

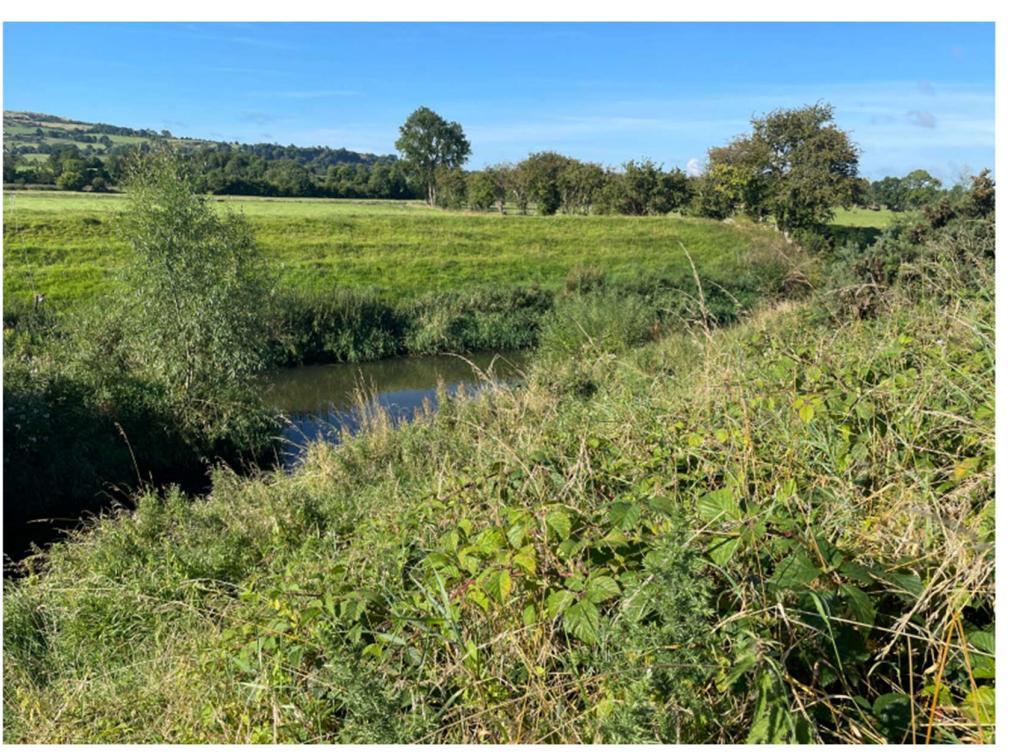
The flow was generally clear on the day of survey, except for the location downstream from the River Deed confluence (Figure 4-27 and Figure 4-28). Even though flow was low within both channels a visible fine sediment plume was being contributed into the Mulkear River from the River Deed, identifying the River Deed as a key source of fine sediment even during the normal flow duration curve.

Figure 4-27 Looking downstream of confluence with River Deed (Deed not visible, entering from left).

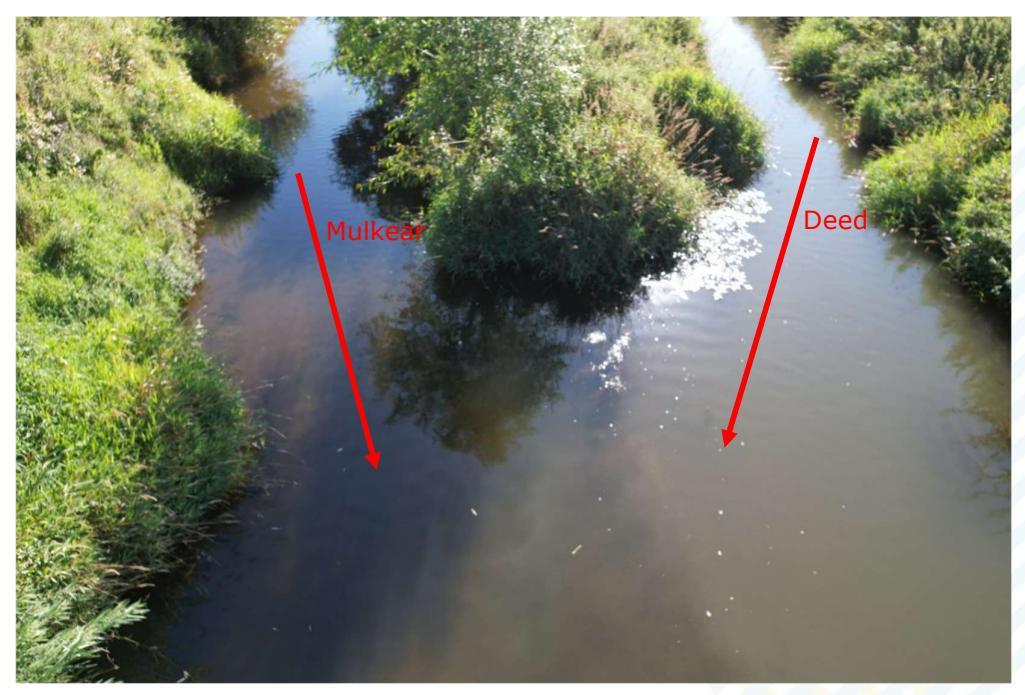
Figure 4-28 Drone imagery: Mulkear River (left) and River Deed (right) confluence, Mulkear flow approaching confluence is relatively clear whilst deed is very turbid. Fine sediment plume can be seen mixing at confluence.

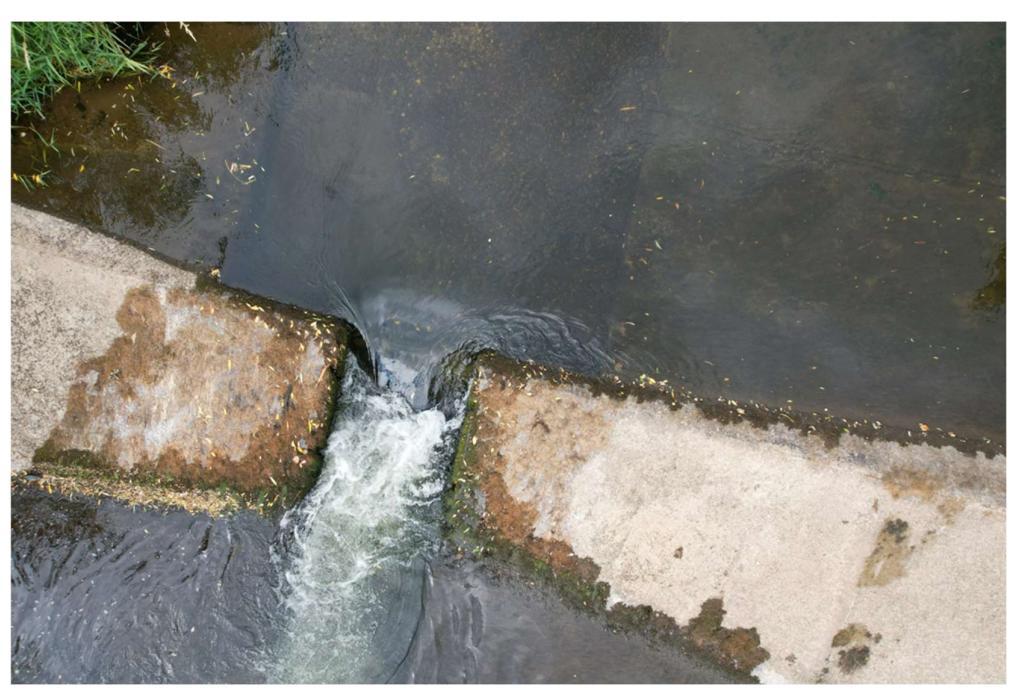
Figure 4-29 Gauging weir crest - coarse sediment slightly below water level upstream.

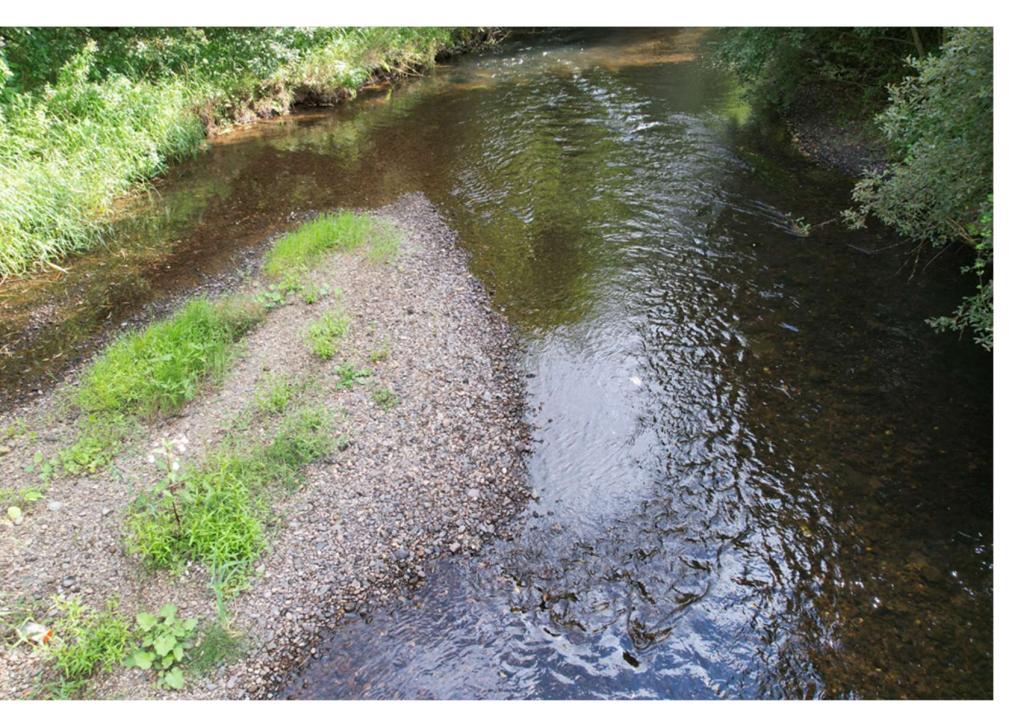
Within the reach upstream and downstream of the gauge location coarse sediment bars were widespread (Figure 4-31), and some pool features were observed on the outside of meandering features. A mixture of trees, shrubs and grasses populated both banks, with scattered areas of exposed fine sediment. Himalayan Balsam was present but less extensive than as observed within the main Mulkear River.

Figure 4-31 Partially vegetated coarse sediment mid-channel bar feature with partial riffle forming.

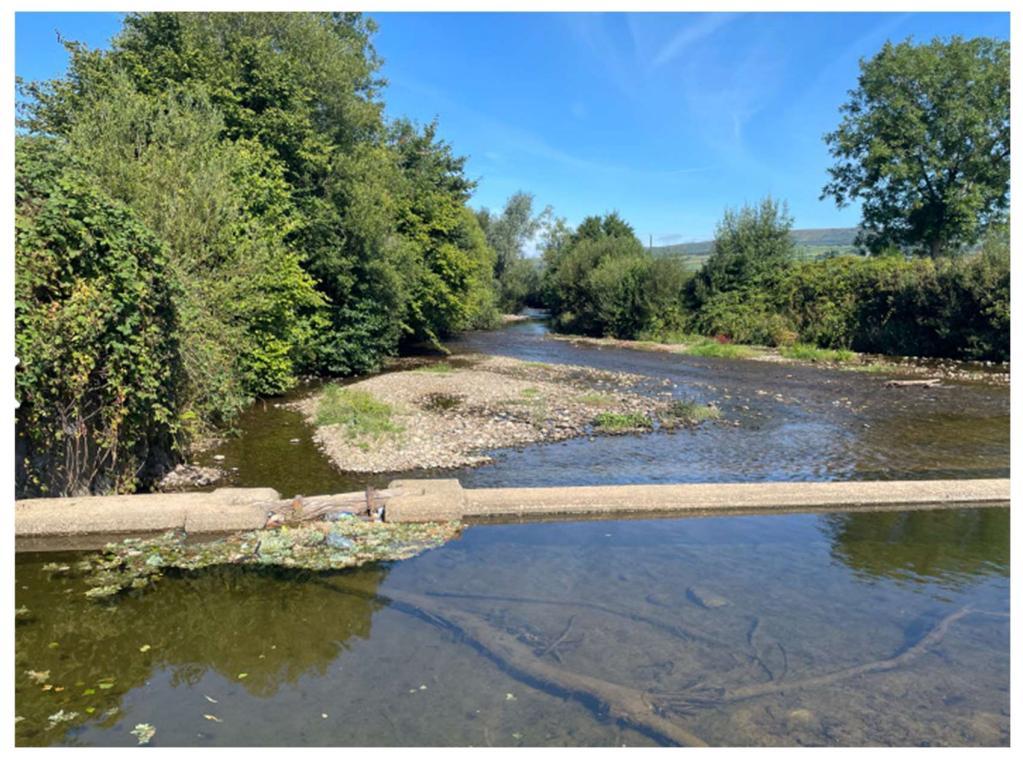
Figure 4-32 Mid-channel bar formed downstream from weir crest. Rippled flow types visible, marginal bar on right bank.

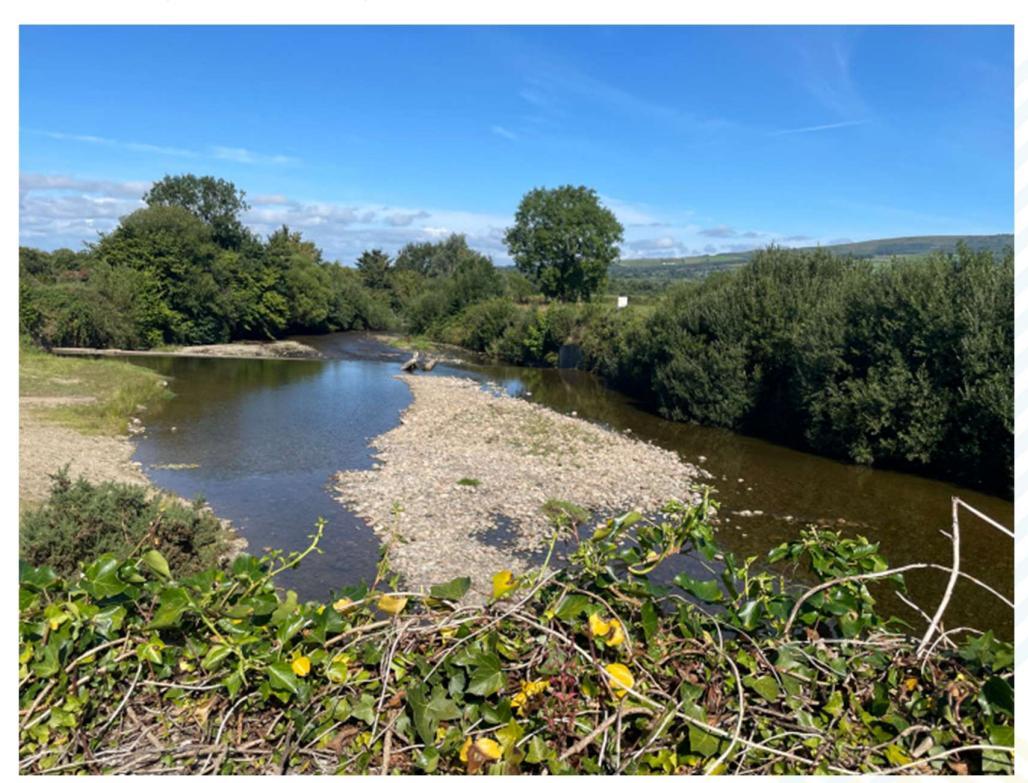
Figure 4-33 Mid-channel bar feature upstream from weir crest. Typically gravelpebble to cobble sized material.

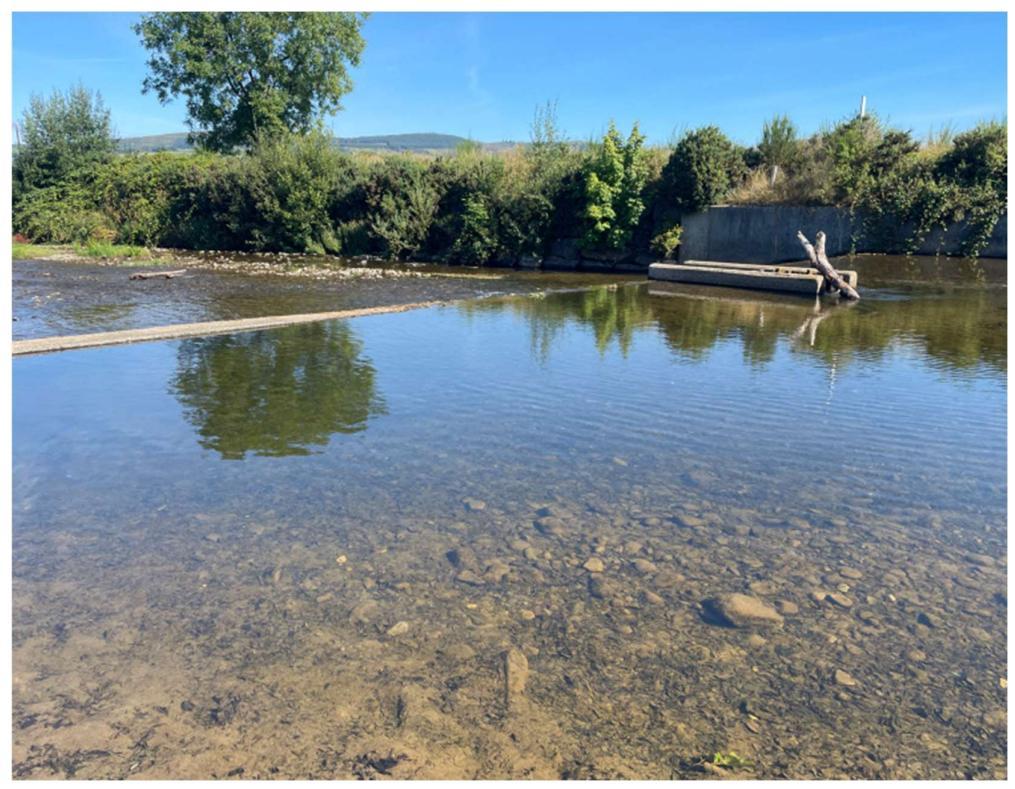
Figure 4-34 Silty material upstream from weir crest and more dynamic flow downstream.

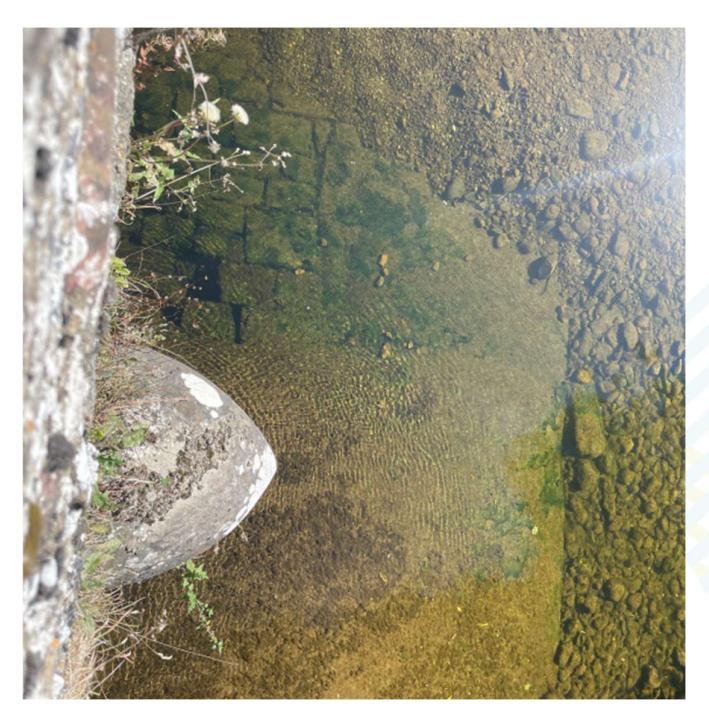
A large bridge structure is situated upstream of the weir with scouring of coarse sediments around the piers observed, although not of significant depth as to undermine the structure (Figure 4-35).

Figure 4-35 Coarse bed material scoured from bridge upstream from weir structure (structure not undermined).

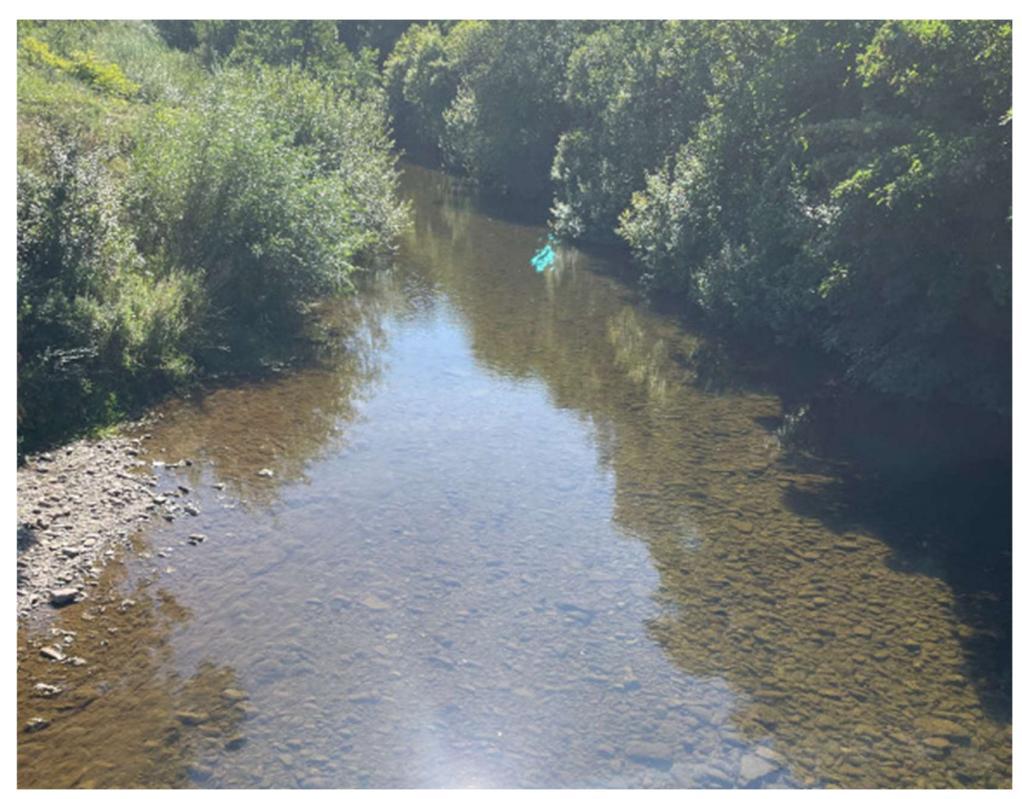
Figure 4-36 Silty veneer on material in upstream section of reach. Very shallow sluggish flow typology.

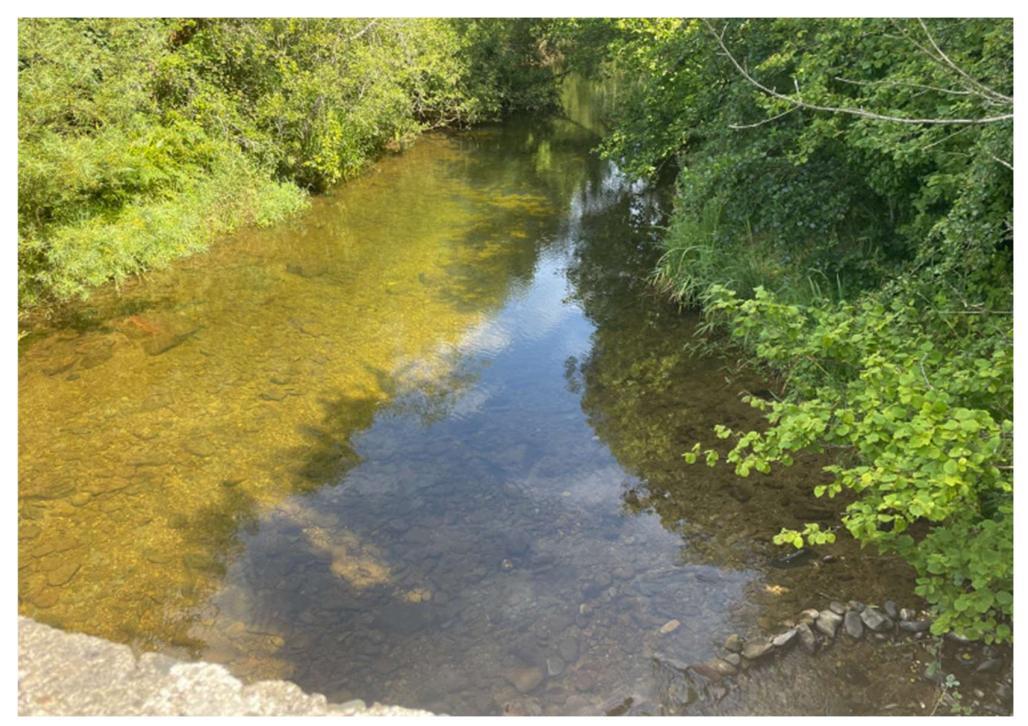
Figure 4-37 Impounded and sluggish flow upstream from bridge. Small rock dam visible in lower right of image extended across channel.

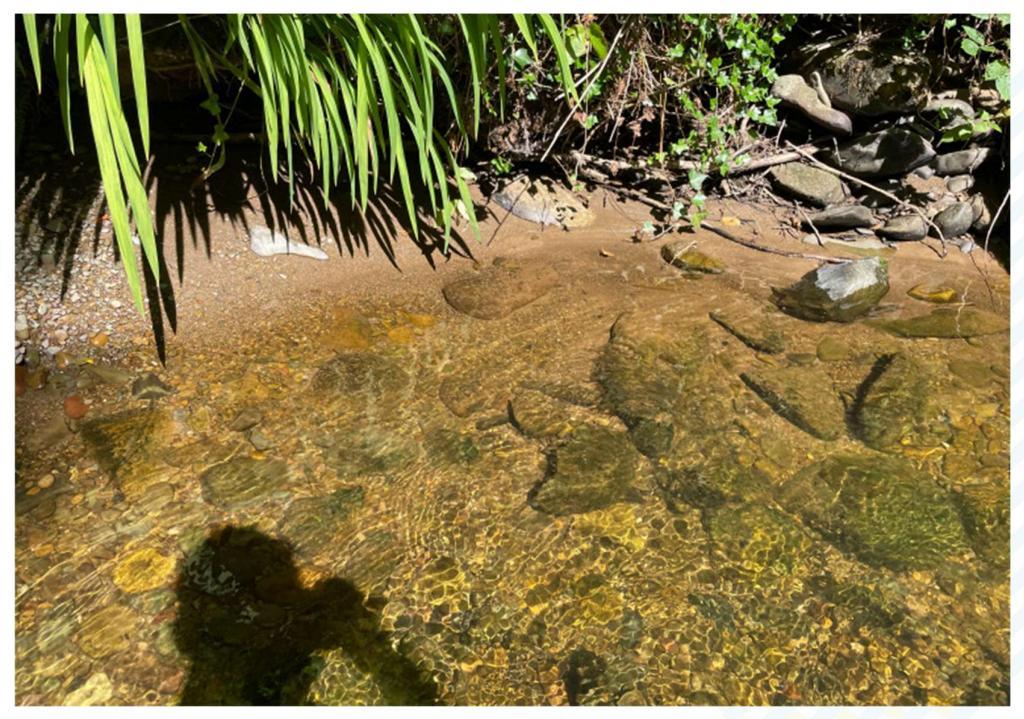
Figure 4-40 Sandy material within channel margins, slightly undercut bank.

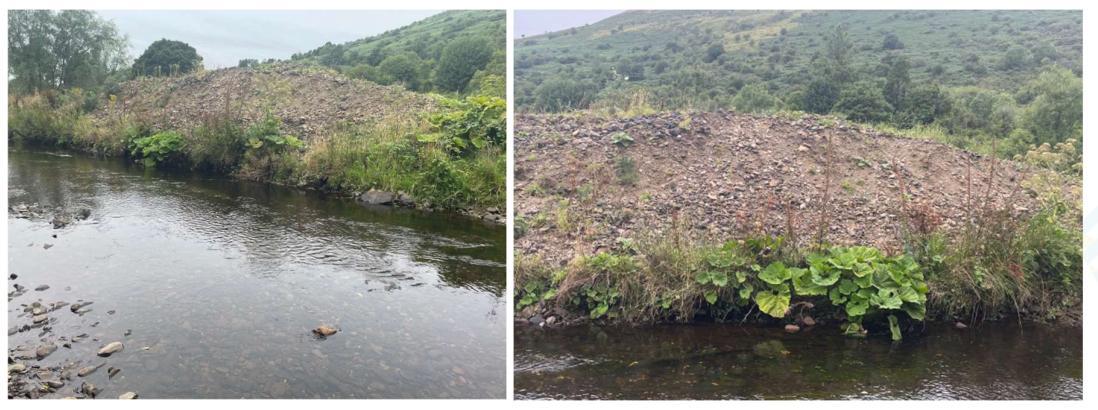
Figure 4-54 Shallow channel flow with large potentially dredged material store on right Bank.
