Lower Shannon Hydromorphology: **Fluvial Audit**

Final

June 2024

JBA Ireland for the Office of Public Works

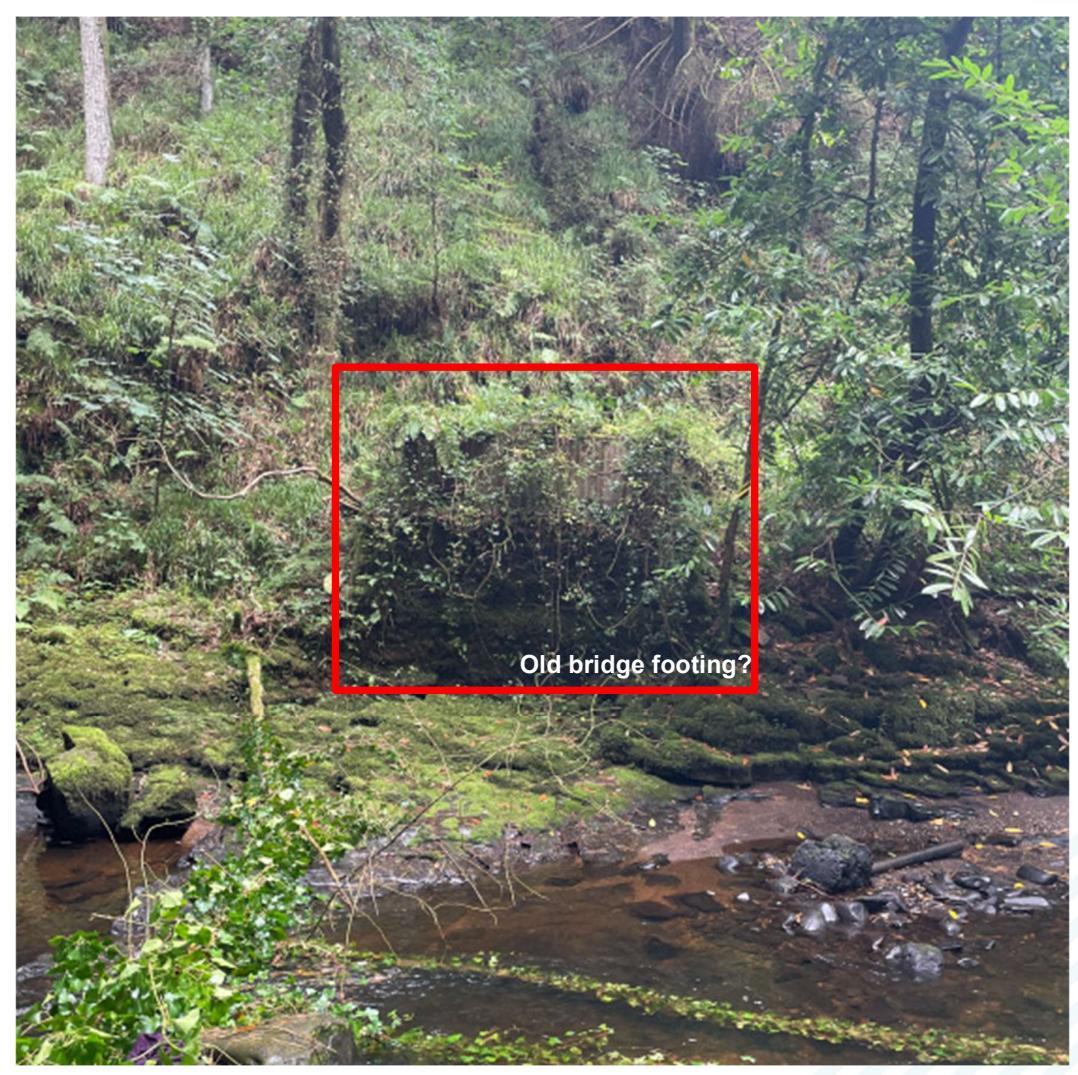
Figure 4-61 Although difficult to see, centre feature appears to be an old bridge footing indicating this reach may have historic mining usage.

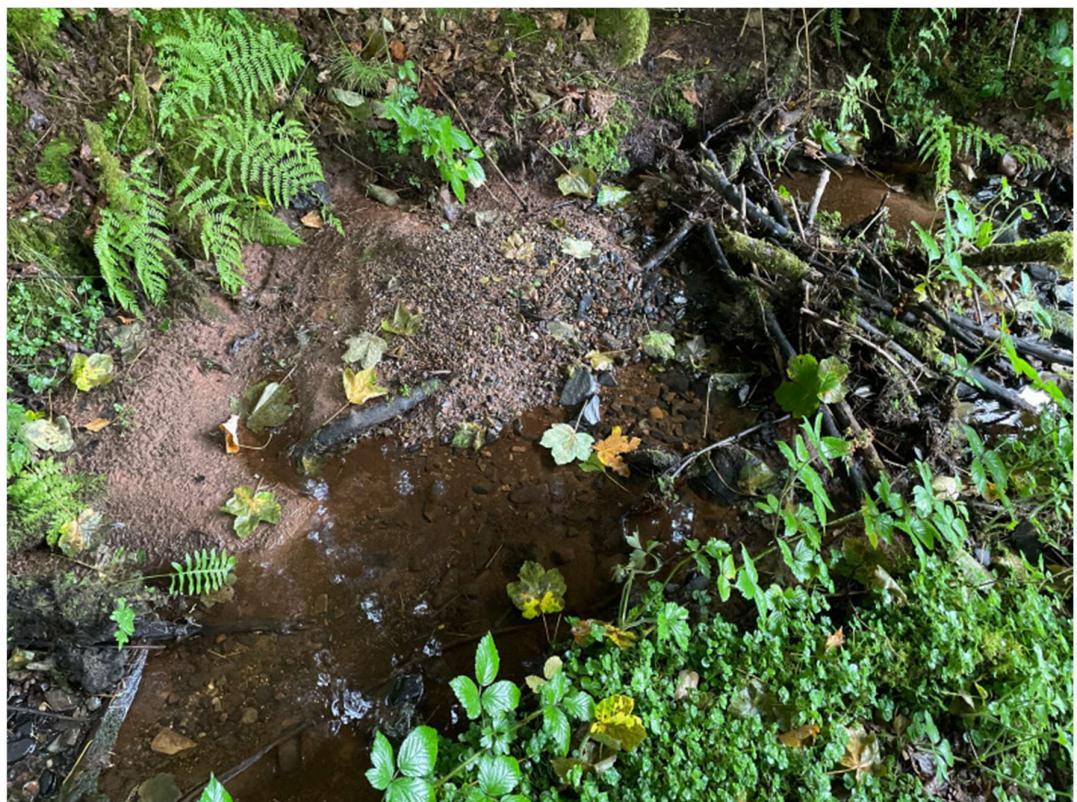
Figure 4-65 Small logjam with fine and fine-gravel deposition upstream.

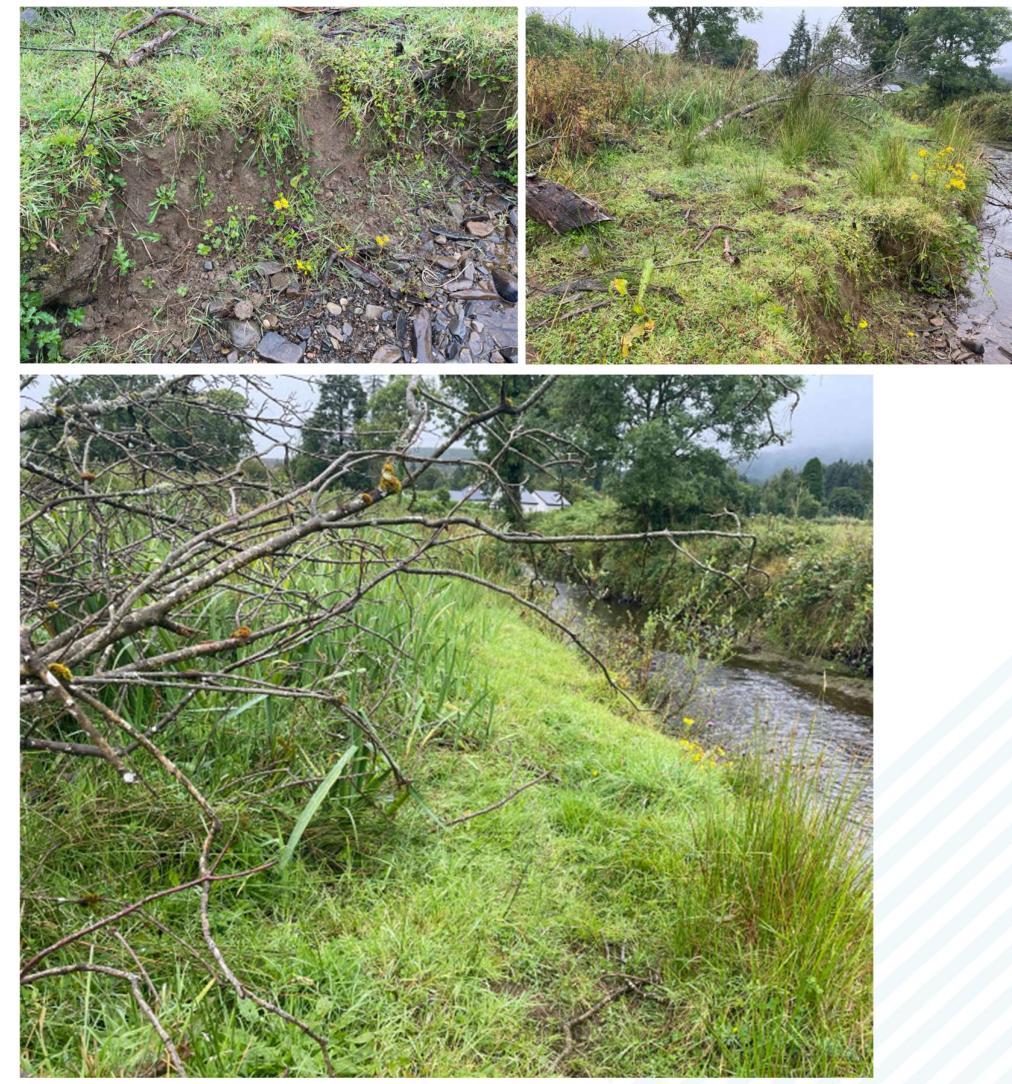
Figure 4-66 Overbank sandy-silty deposits. Some aquatic grass species visible.

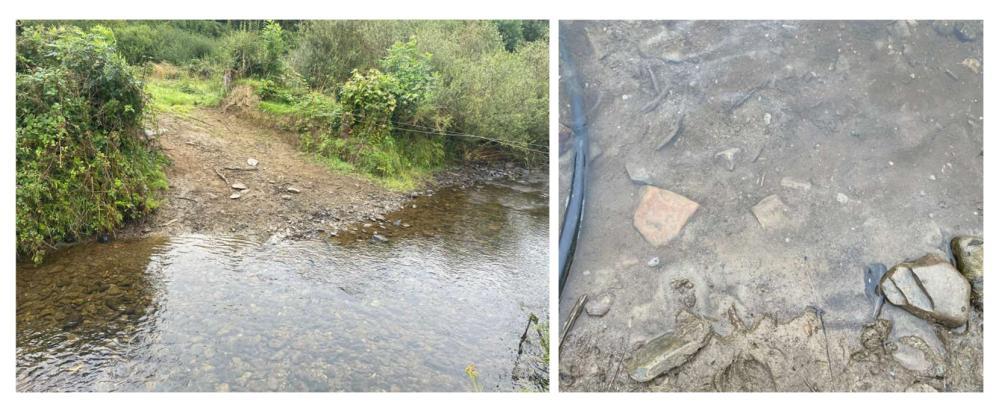
Figure 4-67 Bankside poaching to the River Annagh and Condition of Bed at Location.

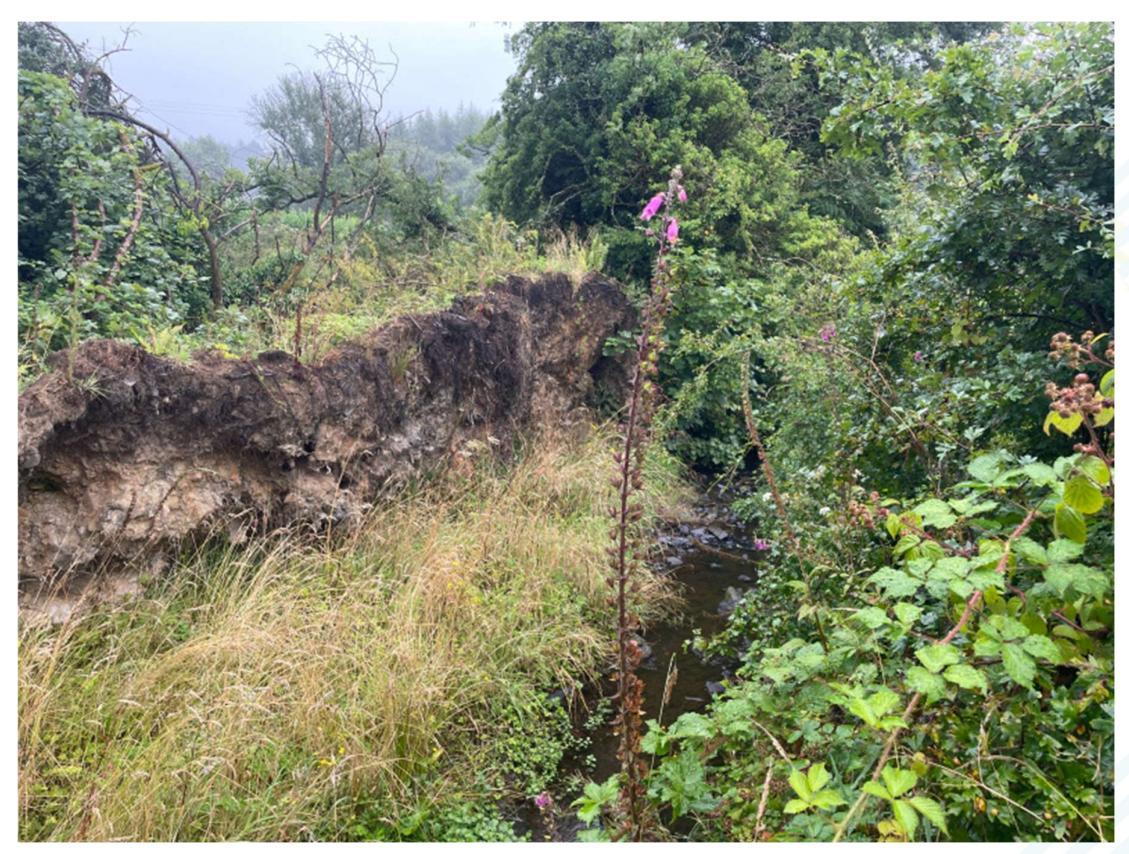
Figure 4-70 Tributary draining into Annagh with fine sediment and incision issues.

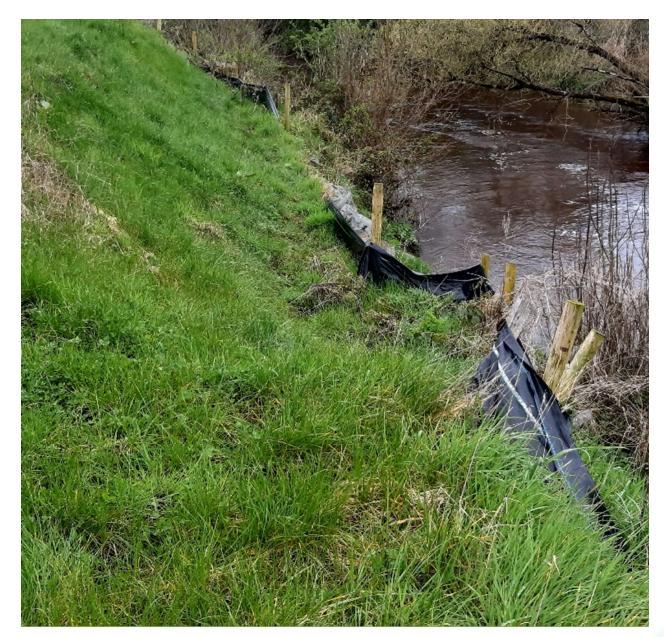
Figure 5-3 Bankside fencing/protection which is slipping into the River Newport.

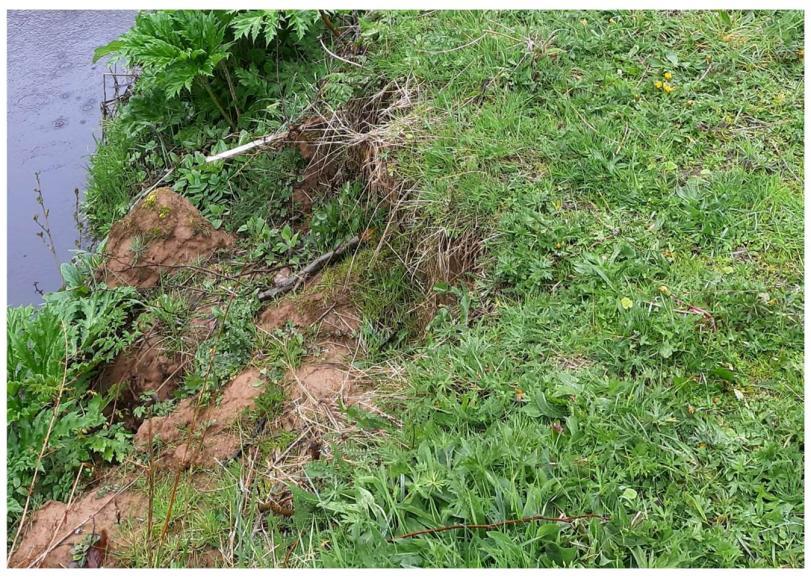
Figure 5-4 Bank Slippage happening on River Slievenohera.

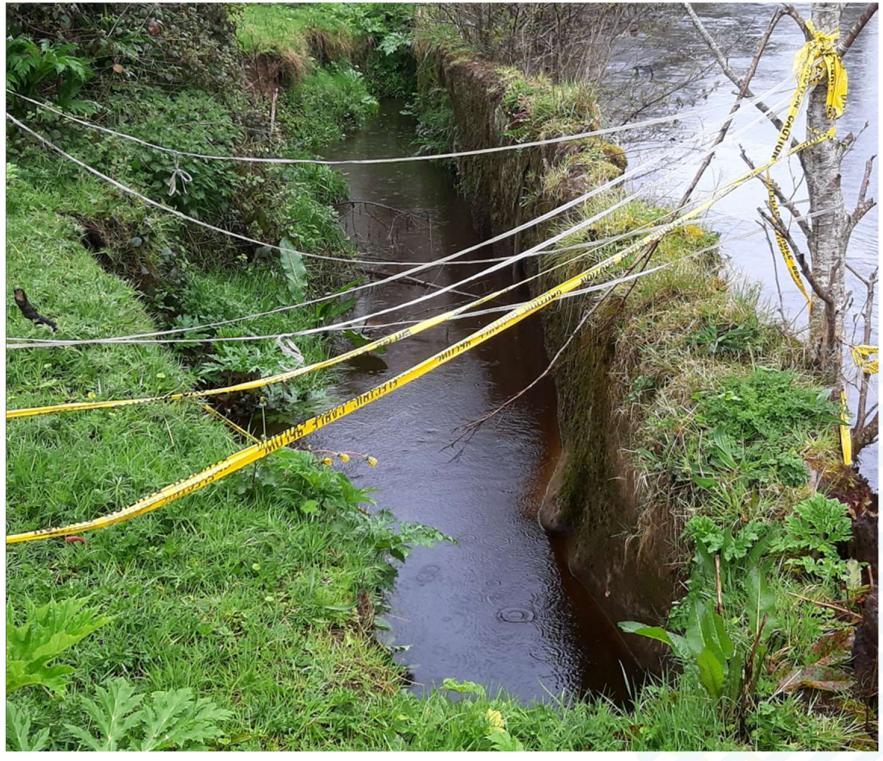
Figure 5-5 River Slievenohera has eroded behind failed timber ramparts.

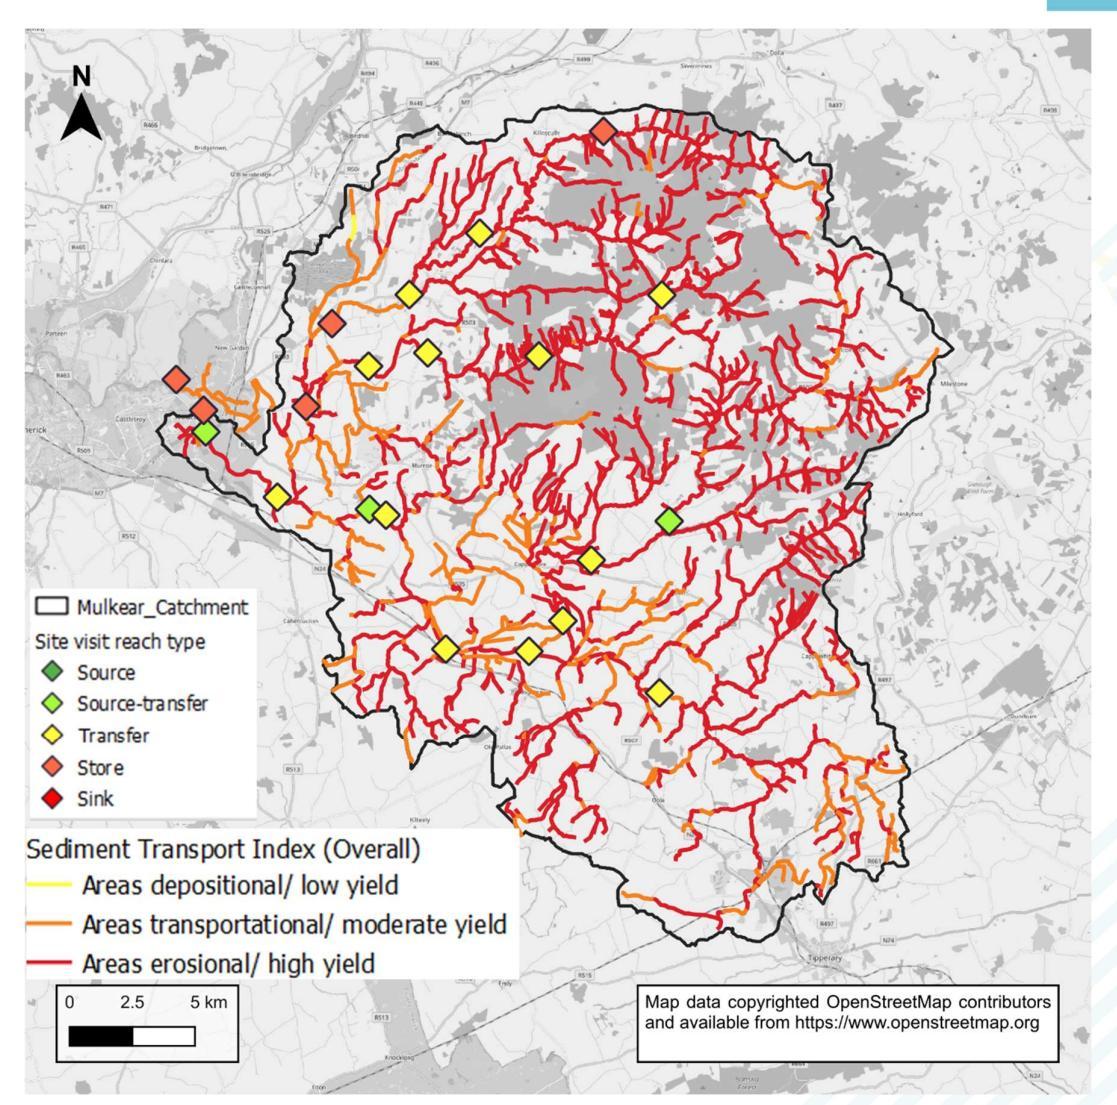
Figure 6-1 Potential for Sediment Transport and Supply across the Mulkear Catchment (Nb. Site visit reach classification is for normal flow conditions)

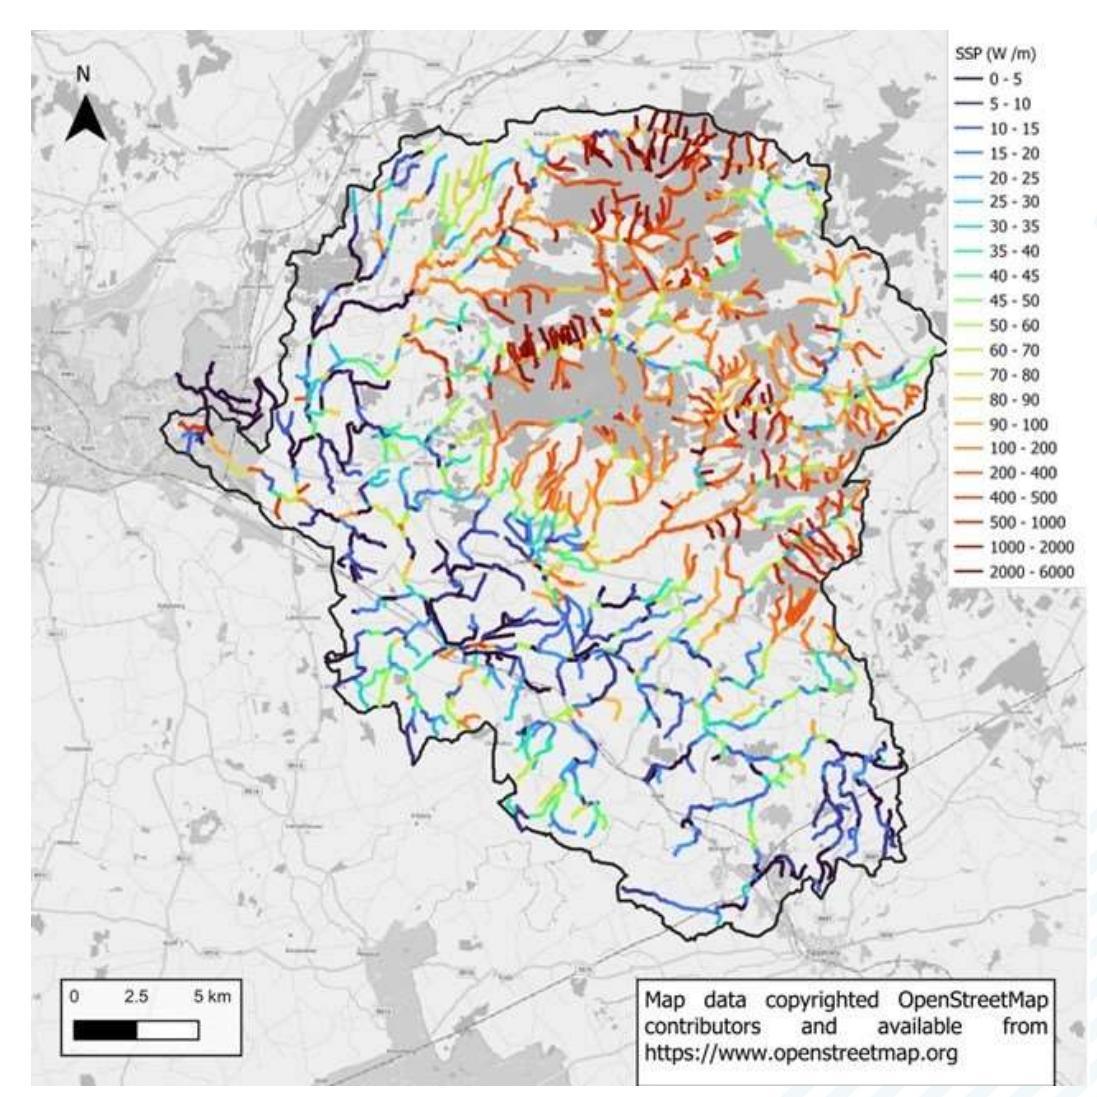
Figure A-1 Specific Stream Power calculated across the Mulkear catchment for the QMED flow (W/m).

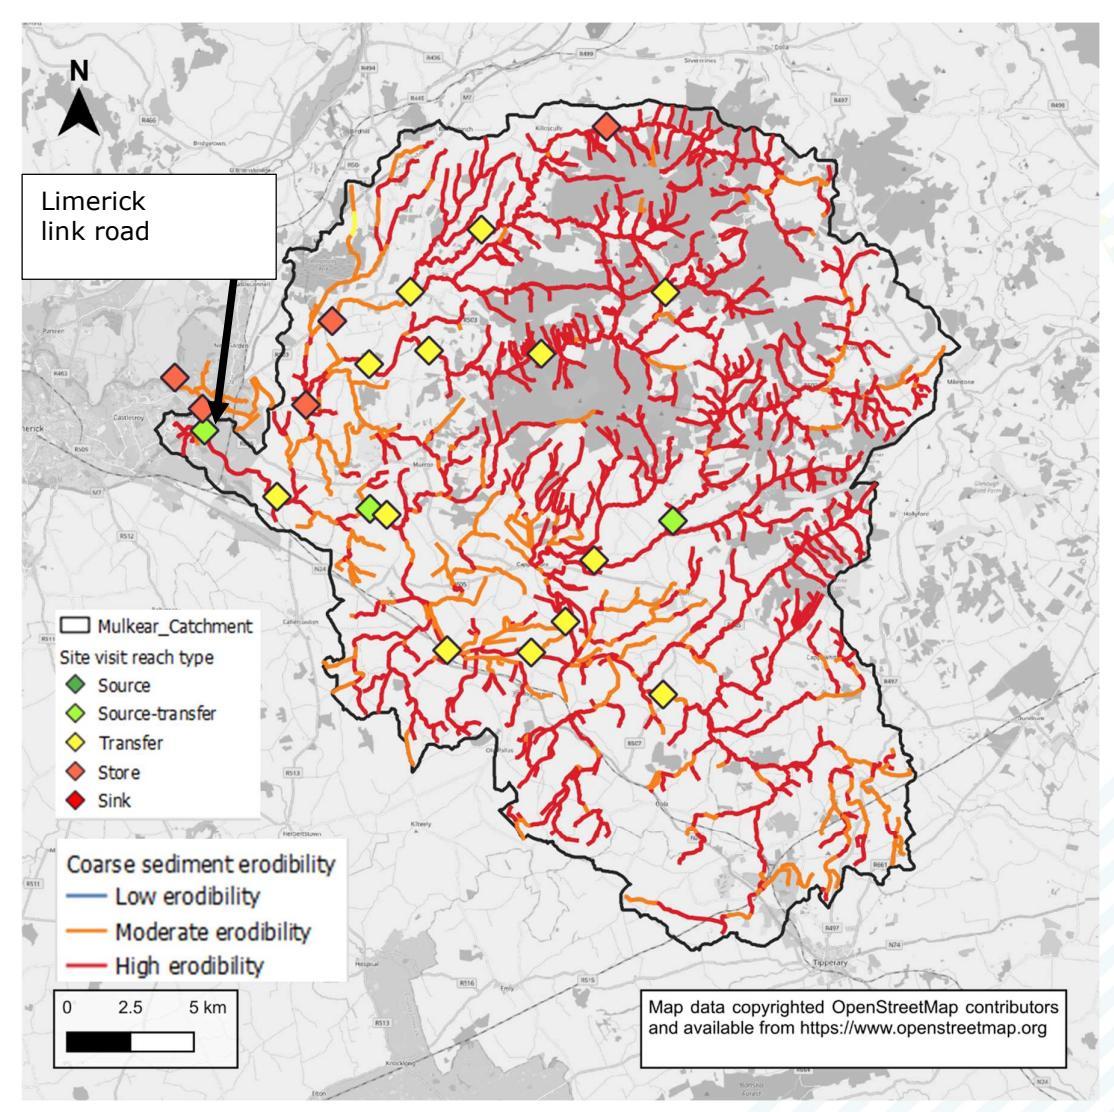
Figure A-3 Coarse sediment erodibility mapping, overlain with walkover observation typologies.

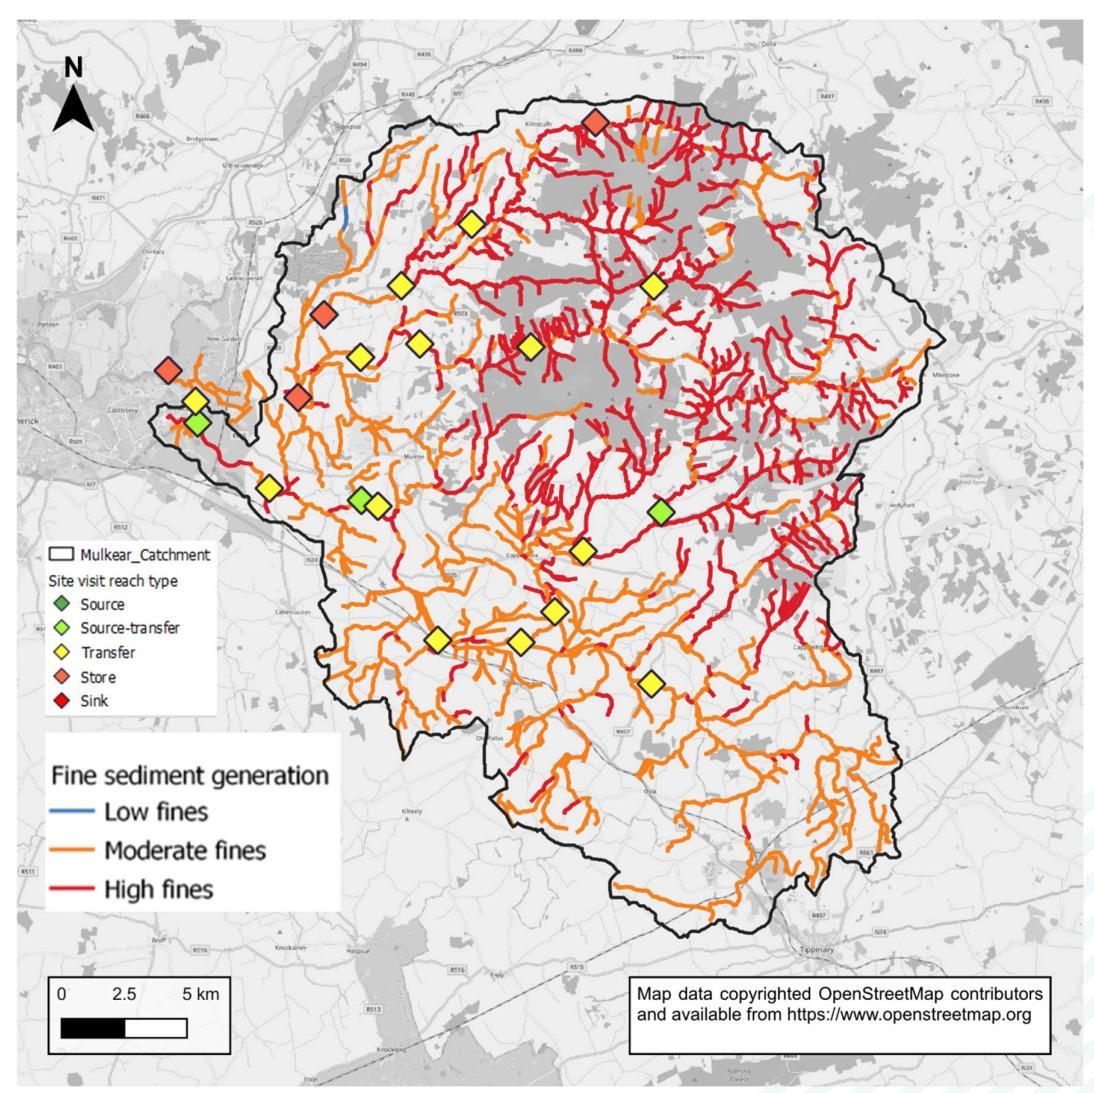
Figure A-4 Fine sediment generation reaches, site observations for fine sediment overlain.
