Lifeboat launch on passenger- and cruise vessels during a heel exceeding 20°

Assessment if today's regulations are enough to guarantee a safe and complete evacuation in case of an emergency

Diploma thesis in the Master Mariner Programme

REPORT NO. SK-18/16

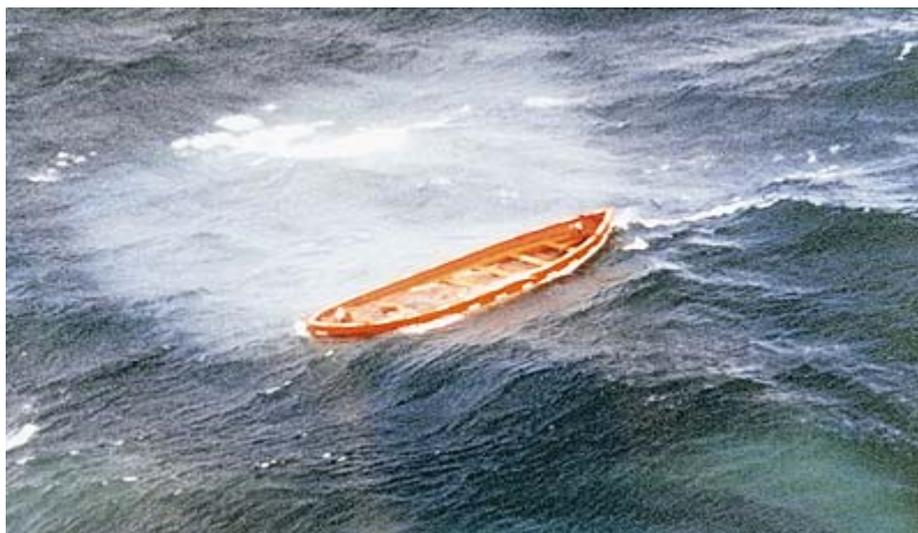
Figure 1. Lifeboat from M/S Estonia. (The Joint Accident Investigation Commission, 1997, ch. 17.7.1). Reprinted with permission.

Onboard the vessel panic spread as passengers tried to make their way towards higher decks and lifeboats, many were trapped in their cabins and were unable to save themselves (The Joint Accident Investigation Commission, 1997, ch. 1). Estonia was equipped with ten lifeboats but the crew was not able to launch a single one of them, the main reasons are believed to have been the rapidly increasing list and lack of time. Nine lifeboats would break off and float to the surface when she sank (*see picture 1*) (The Joint Accident Investigation Commission, 1997, ch. 17.7.1).

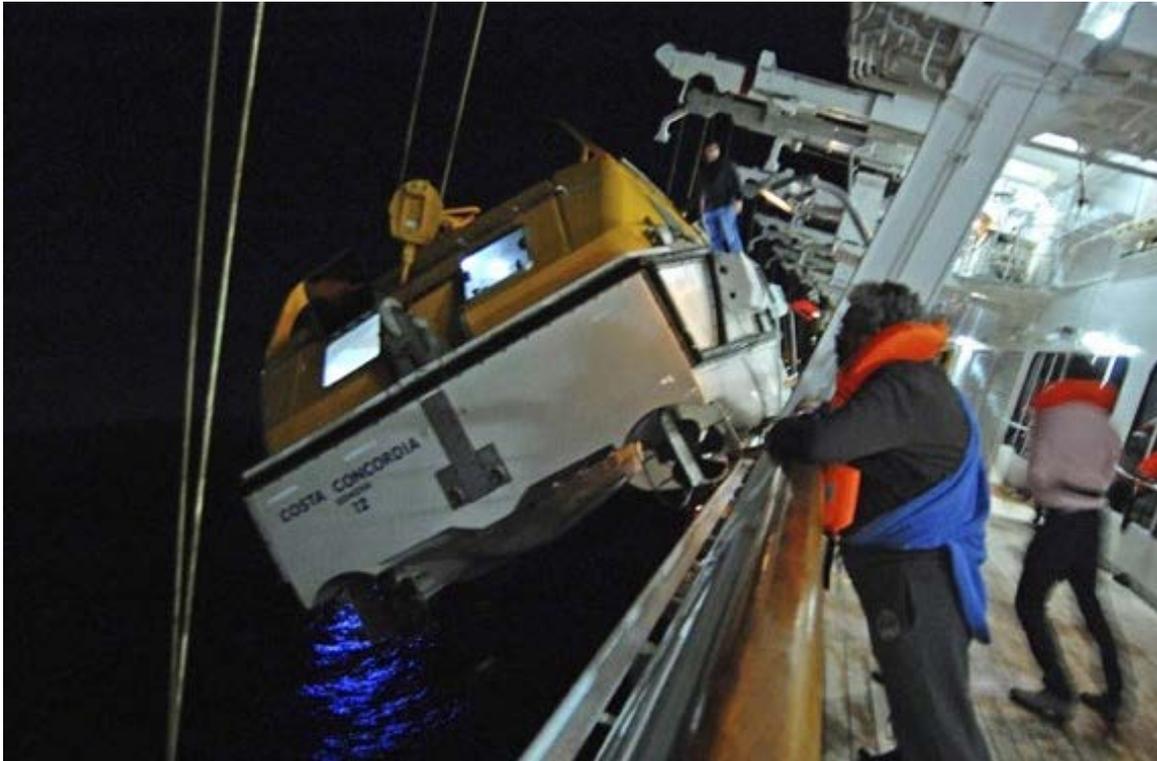
Figure 2. Failure to launch a lifeboat during the sinking of M/S Costa Concordia 2012 (MONALISA 2.0, Activity 3, Launching and Recovering System Design). Reprinted with permission.

As previously mentioned in this report, lifeboats must be able to be launched with a list up to 20°. In this case, the operation to launch the lifeboats began around 11 PM and the list was already close to 20°, only 11 minutes later it would reach 30°. This means that during the operation the list would increase more and be well over the limit. Resulting in 3 lifeboats being unable to be launched and equipment being used way beyond what it had been designed for (Italy's Ministry of Infrastructures and Transports, 2013, p. 88).

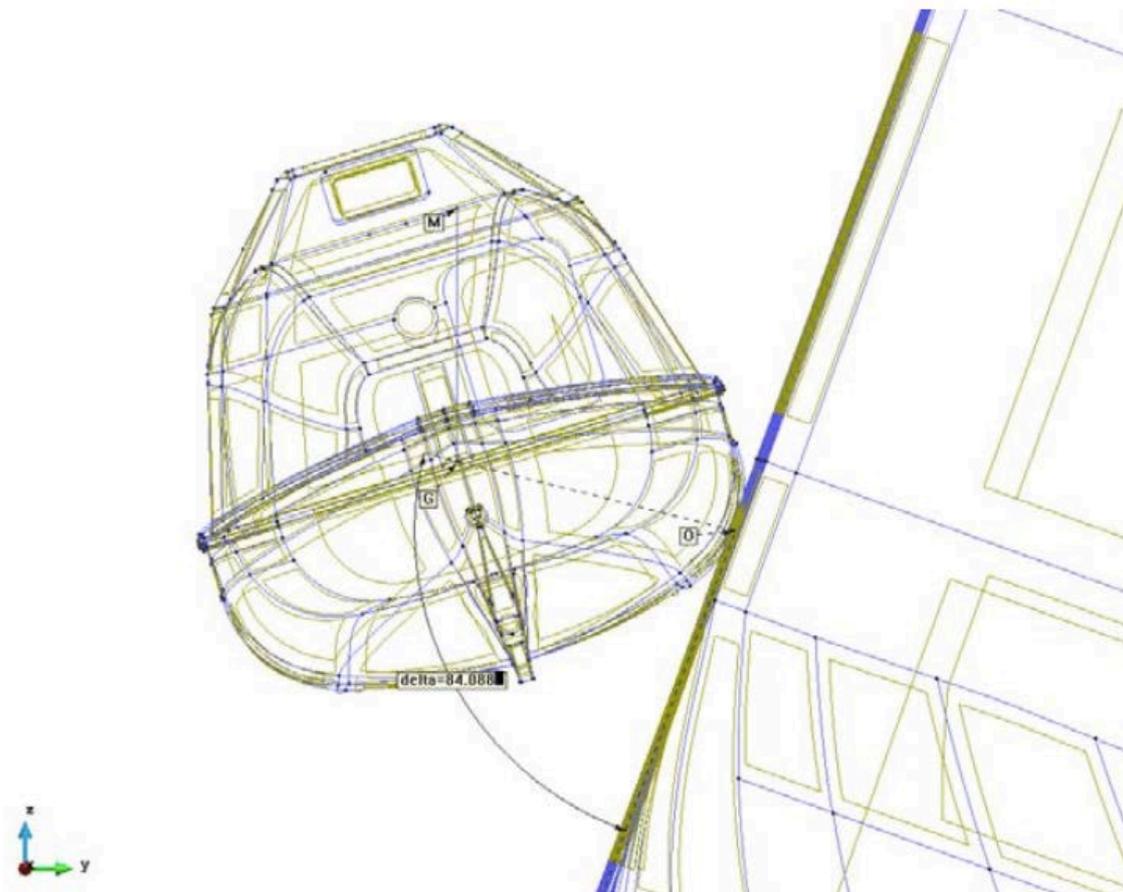
Figure 3. Simulation test done during the MONALISA, SES-project. (SES, System Validation). Reprinted with permission.

A ship's lifeboat launching equipment is not designed to work during a heel exceeding 20° . When this occurs, launching a lifeboat becomes a serious problem and it could dangerously damage the davits (SES, Launching and Recovering System Design, ch. 4.2). It may not be possible to get the lifeboat clear of the ship's side (see *picture. 2*) and the friction between the lifeboat and ship's side in combination with the angle may prevent it from sliding down (see *Picture. 3*).

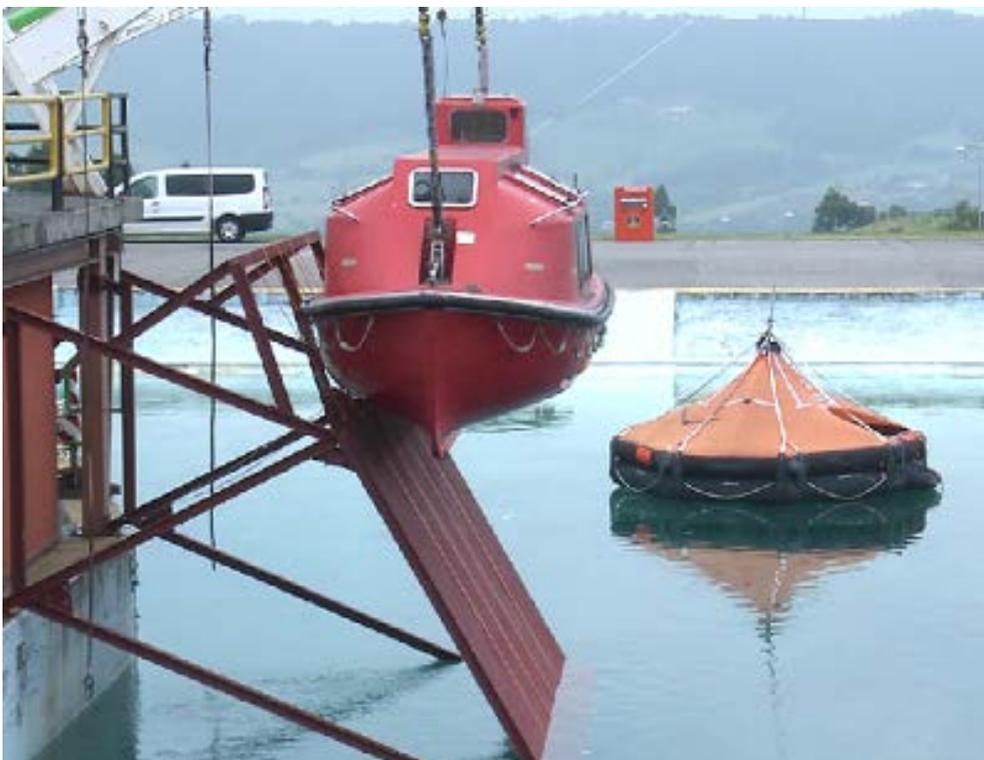
Figure 4. Tests done in basin at Centro Jovellanos in Gijon (SES, launching and recovery system design). Reprinted with permission.

The SES is as previously mentioned one of MONALISA 2.0’s projects and it focuses on what this report is about, the problems that appears with launching lifeboats when a damaged vessel is sinking with a list exceeding 20°. The SES project presents two cost beneficial solutions that can be applied to different types of vessels on their equipped systems with minimal adaptations. Both solutions shall be able to safely launch the lifeboats at heel conditions higher than 20° which is the current SOLAS rule. The solution should mainly be able to work on the ship’s side facing up from the water where there is a higher risk of not launching the lifeboats, referred to as the “upper side” in this report. This is also considered to be the safest side to launch a vessel’s lifeboats (SES, System Validation, ch. 4).

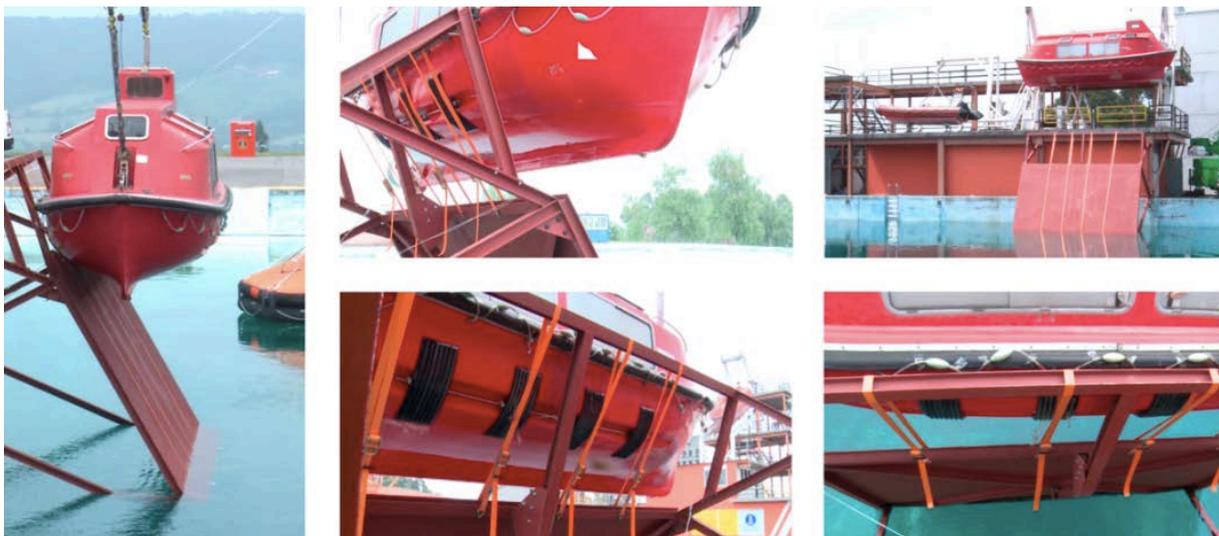
*Figure 5. Test with straps and sliding pads done during the MONALISA, SES project (SES, pilot application).
Reprinted with permission.*

The solution for davits is 2-3 straps attached from the vessel deck, with clamped devices (see picture. 4), to the lifeboat itself. When the davits move, either tilting conventional or telescopic movement, the straps tighten to keep the lifeboat clear from ships deck or railings.

The solution for decreasing friction between the lifeboat and the vessel's hull is sliding pads mounted on the lifeboats hull which will be placed without damaging the hull nor affecting the navigational capability of the lifeboat. The sliding pads are for the lifeboats situated on the "upper part" of the heeled vessel. To ensure a safe passage down the hull without getting stuck, nor the risky operation of heaving it back up.
