The fire resistance performance of two single leaf single acting doorsets when tested in accordance with BSEN 1634-1: 2014 and BSEN 1363-1: 2012

BMT/FEP/F14080 AR2

**Gianni Industries, Inc.**

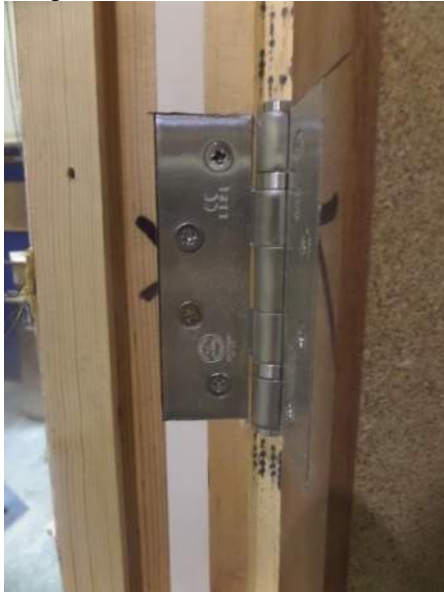
Hinge – doorset A

| | Make/type | Size (mm) | Location |
|---|---|---|---|
| Around hinge blade | Fully interrupted | - | Hinge blade fully interrupts seal in leaf edge |
| Under hinge blade | Interdens | 1 thick | Fitted under hinge blade on frame and leaf |

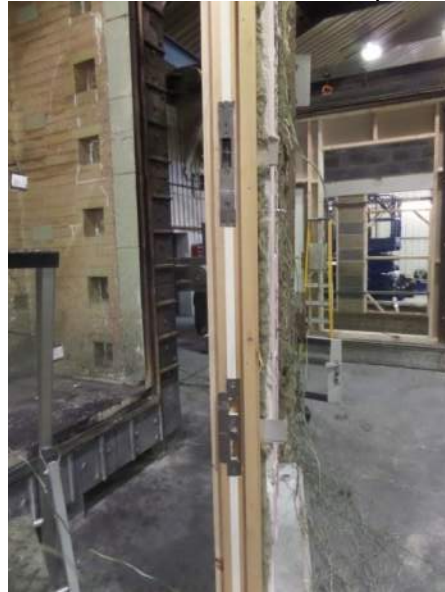
Middle and bottom latch keeps – doorset A

| | Make/type | Size (mm) | Location |
|---|---|---|---|
| Around middle and bottom latch keeps | Fully interrupted | - | Middle and bottom latch keeps fully interrupt seal in frame reveal |

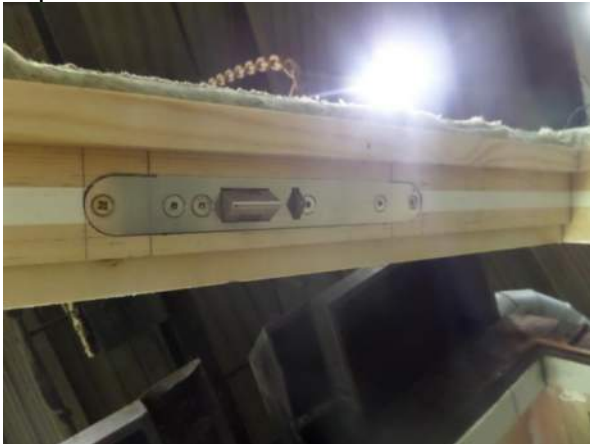
Top latch forend in frame head – doorset A

| | Make/type | Size (mm) | Location |
|---|---|---|---|
| Around latch forend – top latch only | Fully interrupted | - | Top latch forend fully interrupts seal |

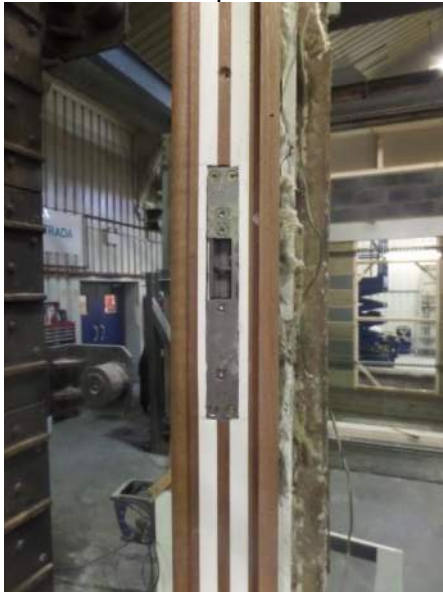
Middle latch keep – doorset B

| | Make/type | Size (mm) | Location |
|---|---|---|---|
| Around middle latch keep | Partially interrupted | - | Middle latch keep partially interrupts both seals with 7mm of the 1 <sup>st</sup> seal and 8mm of the 2 <sup>nd</sup> seal remaining continuous |

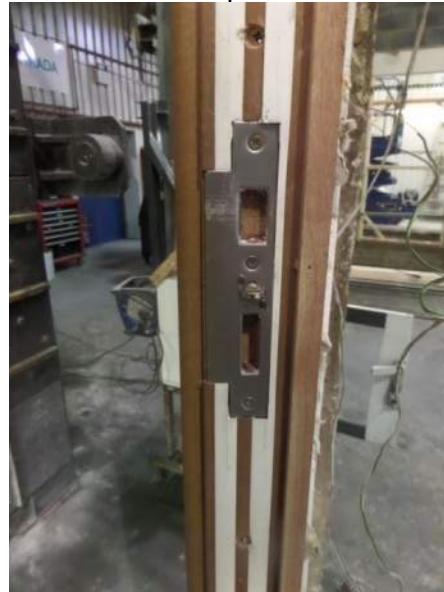
Bottom latch keep – doorset B

| | Make/type | Size (mm) | Location |
|---|---|---|---|
| Around bottom latch keep | Partially interrupted | - | Bottom latch keep fully interrupts 1 <sup>st</sup> seal and partially interrupts 2 <sup>nd</sup> seal with 4mm remaining continuous |

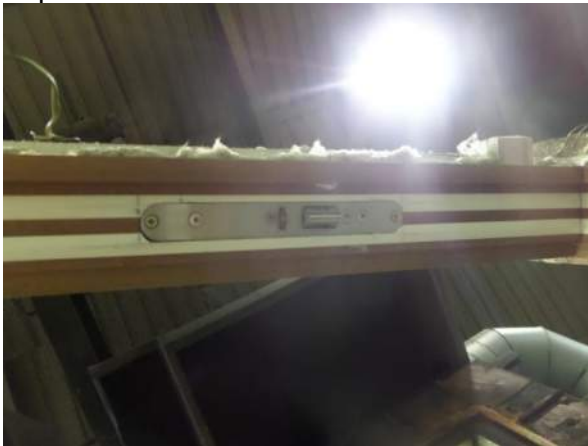
Top latch forend in frame head – doorset B

| | Make/type | Size (mm) | Location |
|---|---|---|---|
| Around latch forend – top latch only | Partially interrupted | - | Top latch forend partially interrupts both seals with 8mm of each remaining continuous |

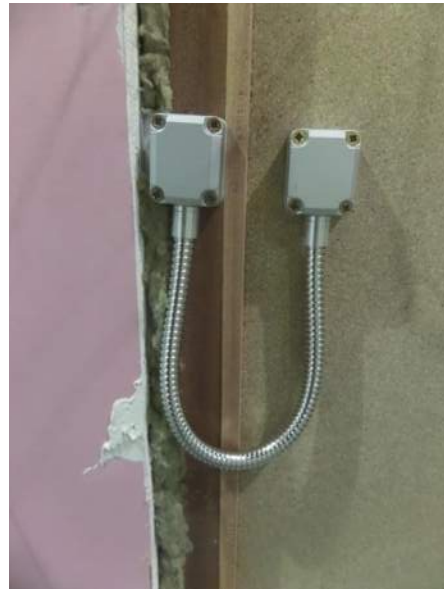
Cable chain connector – doorset B
