**Green Dale Management Plan**  
Figure 6.1 Masterplan

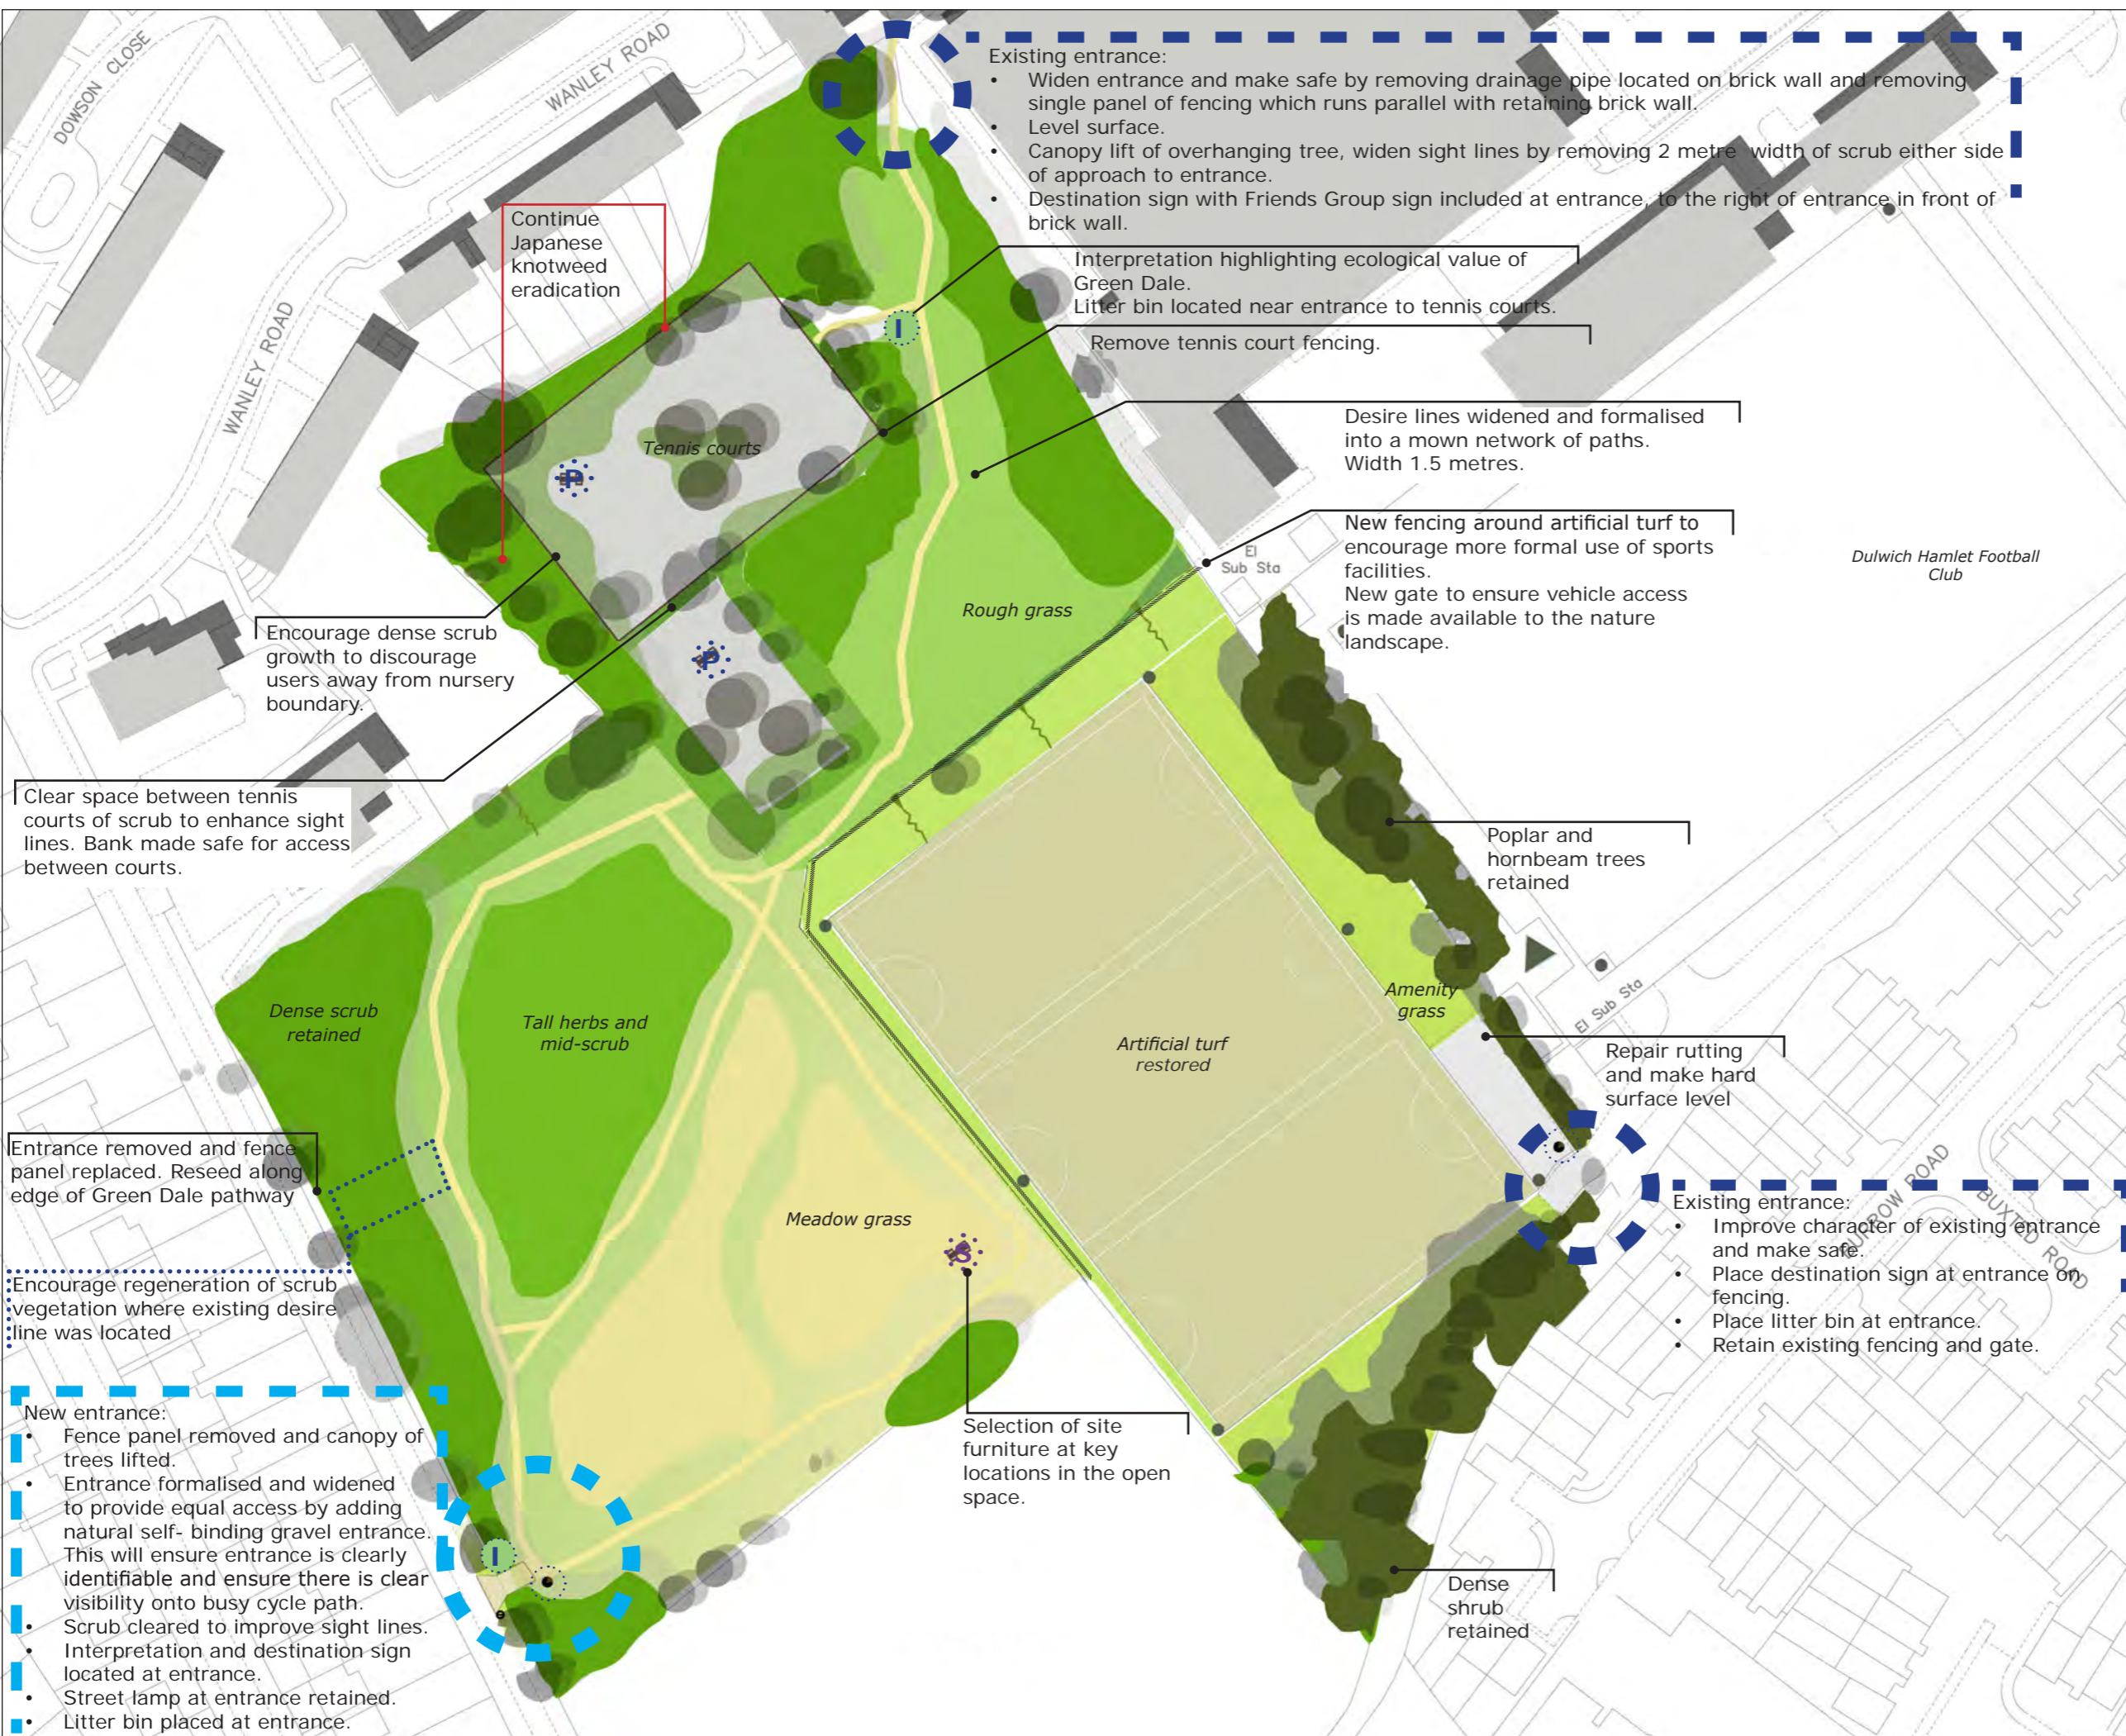
- Widen entrance and make safe by removing drainage pipe located on brick wall and removing single panel of fencing which runs parallel with retaining brick wall.
- Level surface.
- Canopy lift of overhanging tree, widen sight lines by removing 2 metre width of scrub either side of approach to entrance.
- Destination sign with Friends Group sign included at entrance, to the right of entrance in front of brick wall.

Interpretation highlighting ecological value of Green Dale.  
Litter bin located near entrance to tennis courts.

Remove tennis court fencing.

Desire lines widened and formalised into a mown network of paths.  
Width 1.5 metres.

New fencing around artificial turf to encourage more formal use of sports facilities.  
New gate to ensure vehicle access is made available to the nature landscape.

Encourage dense scrub growth to discourage users away from nursery boundary.

Clear space between tennis courts of scrub to enhance sight lines. Bank made safe for access between courts.

Repair rutting and make hard surface level

Entrance removed and fence panel replaced. Reseed along edge of Green Dale pathway

Encourage regeneration of scrub vegetation where existing desire line was located

- Fence panel removed and canopy of trees lifted.
- Entrance formalised and widened to provide equal access by adding natural self-binding gravel entrance. This will ensure entrance is clearly identifiable and ensure there is clear visibility onto busy cycle path.
- Scrub cleared to improve sight lines.
- Interpretation and destination sign located at entrance.
- Street lamp at entrance retained.
- Litter bin placed at entrance.

- Improve character of existing entrance and make safe.
- Place destination sign at entrance on fencing.
- Place litter bin at entrance.
- Retain existing fencing and gate.
