Oxfordshire Cotswold Garden Village, Eynsham

**Phase 1 Ground Condition Assessment
[Ground Stability, Phase 1 Contaminated Land
& Mineral (Sand and Gravel) Resources]**

On behalf of **Grosvenor Developments Ltd**

Project Ref: 39289/001 | Rev: 00 | Date: January 2019

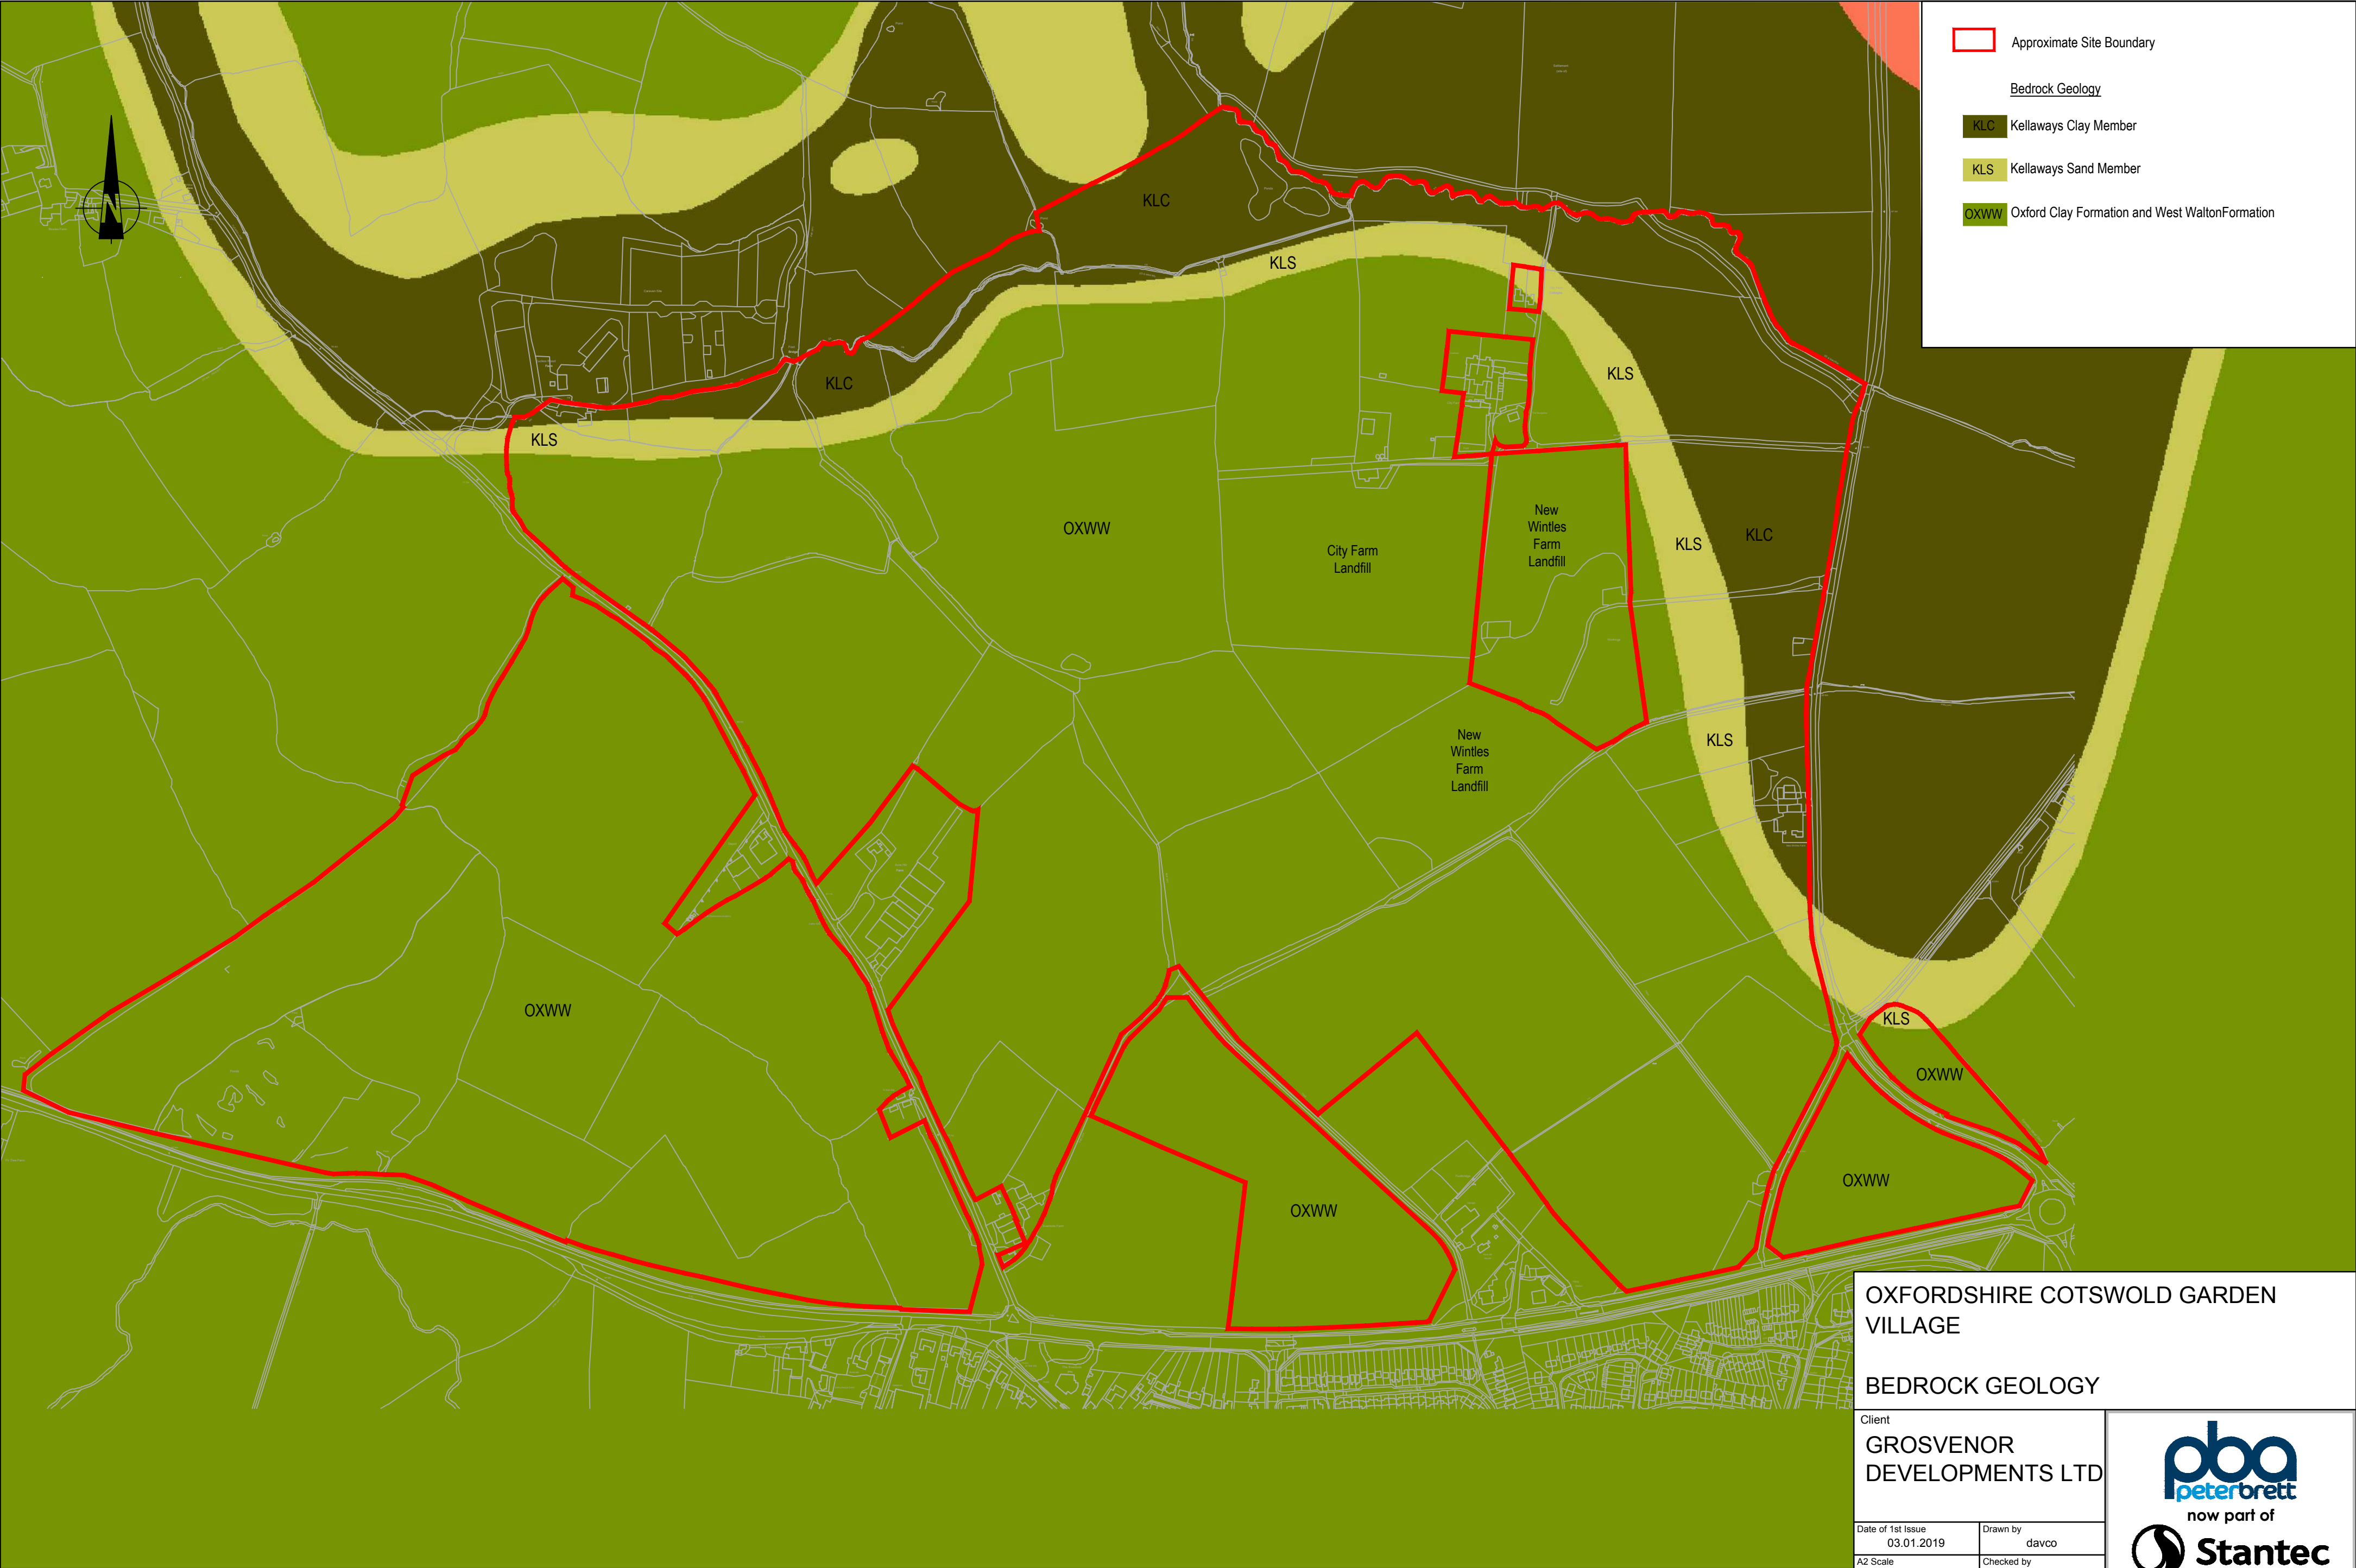
- Approximate Site Boundary
- Bedrock Geology
