RUDDING LANE PITCH IMPROVEMENT PLANS

SCHEDULE 1 - STRI INITIAL OBSERVATIONS ON PITCH 1 (PITCH 2,3 AND 4 TO FOLLOW)

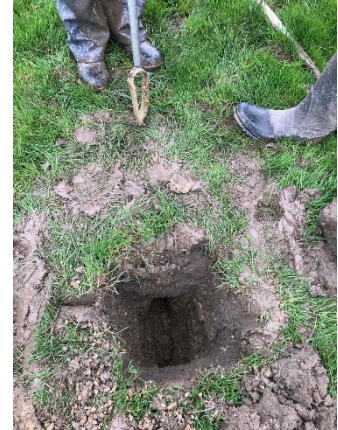
We managed to find the slit drains running across the pitch, but these were found to be severely capped and clearly not functioning as originally intended. The clean gravel at the base of the slits was found at a depth of around 130-150 mm below the surface and this extended to a depth of 180-200 mm below ground level (see attached Photo 1). Above the gravel, there was a layer of topsoil with no sign of the gravel or sand backfill remaining from the original installation.

It is clear that significant capping of the slits has occurred in recent years with topsoil being smeared over the tops of them owing to the action of player's boots and passing maintenance machinery. Another contributory factor will have been the intense activity of casting earthworms across the pitch, these producing casts which spread across the surface causing further capping of the slits. Below the surface, the burrowing action of the worms will also lead to a churning of the upper soil profile and mixing of the sand/gravel backfill within the tops of the slits, thereby destroying their integrity and function. The absence /shortage of sand topdressings on the pitch in recent years will have also exacerbated the situation.

With regard to carrying the proposed improvement works, it is clear from the investigation works that the connection of the playing surface to the porous backfill within the underlying pipe drains needs to be restored with the introduction of a new interconnecting network of slit drains and sand bands into the upper pitch profile. The original pipe drains are still functioning, as evidenced by the high volume of water which discharges from the drainage outfall following periods of intensive rainfall.

As discussed, our recommendation would now be to supplement what is left of the original slit drainage system by installing a series of new gravel/sand filled slit drains running across the width of the pitch at 1 m centres, parallel to and in between the existing slits. The slit drains would need to be cut to a depth of 300-350 mm to ensure a clean connection with the gravel above the lateral pipe drains. These would be supplemented by the introduction of sand bands running along the length of the pitch at 0.5 m centres using a machine called the Koro Topdrain or alternatively the GKB Drainmaster (see image below).

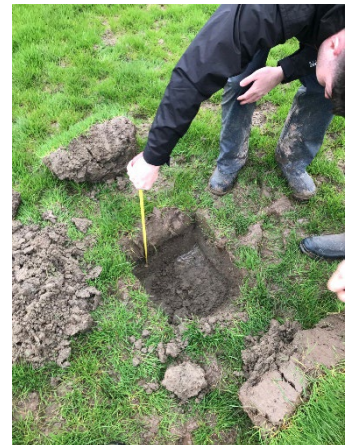
Whilst the slits were severely capped, it was noted that water could be seen weeping out of the exposed sections of gravel which indicated that they were still receiving some water within the lower part of the profile and having some limited drainage function.

The lateral drain lines were more difficult to locate, but we did manage to expose two separate sections across the pitch. A slightly coarser grade of gravel had been used to backfill the lateral drain trenches the upper portion of which had become contaminated with topsoil, although this became cleaner at depth. Where exposed, the depth of the gravel below the surface varied between 250- 300 mm (see attached Photo).

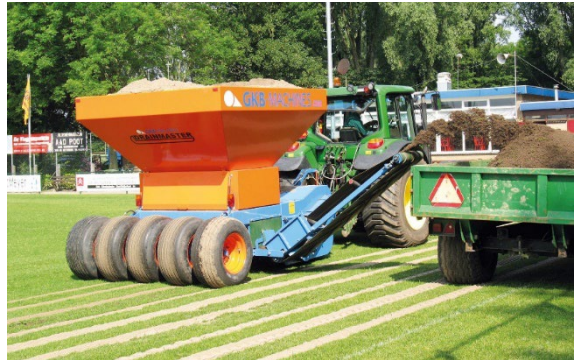
These machines excavate narrow excavated trenches 40 mm wide to a depth of 200 mm which are immediately backfilled with sand to the surface. The bands would connect with the gravel backfill in the new slit drains and what remains in the old slits. In addition, with the sand bands running along the length of the pitch, these will be more effective at intercepting surface water run off as it flows with the main fall across the pitch towards Ridding Lane.
