DEFENCE AREA 38

SIDLOW BRIDGE

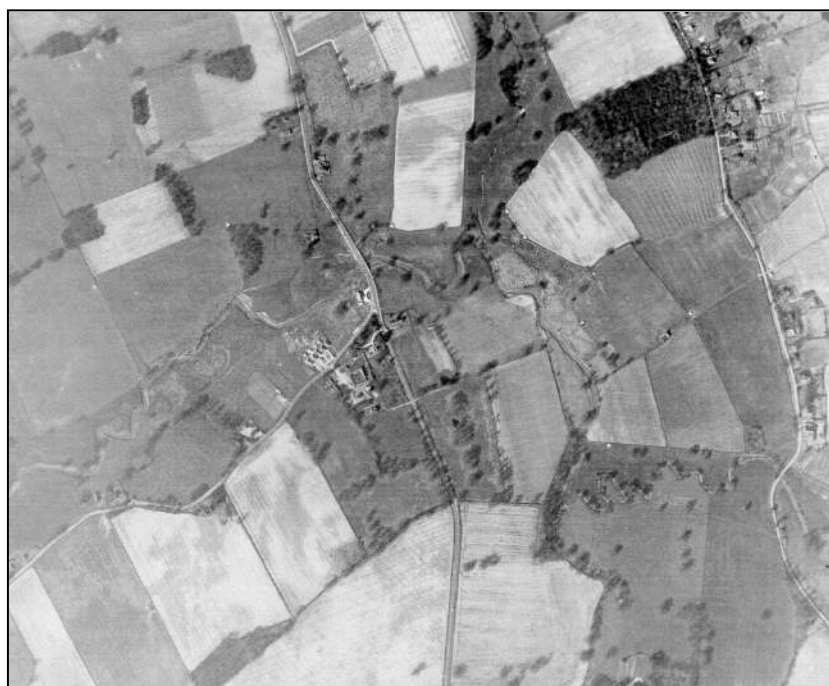
Fig. 1 - 1947 aerial photograph showing Sidlow Bridge at the centre, with the River Mole winding a course from the west to the south-east.

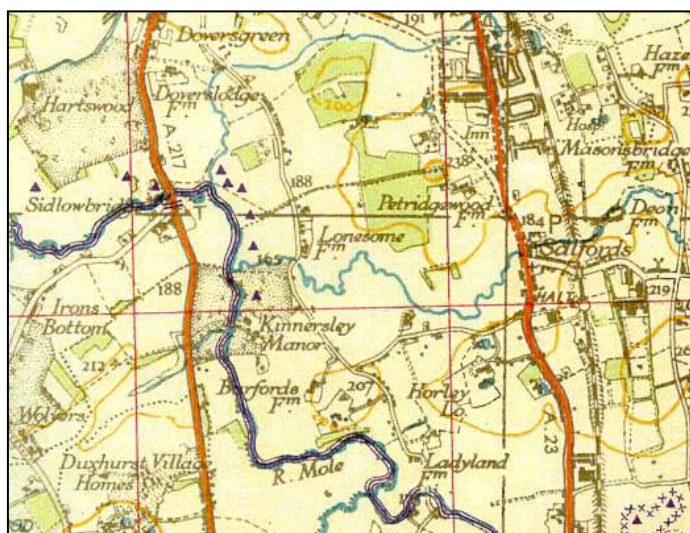
Fig. 2 - Portion of German map showing Sidlow Bridge and the defended course of the River Mole which was strengthened as the principal anti-tank obstacle.³

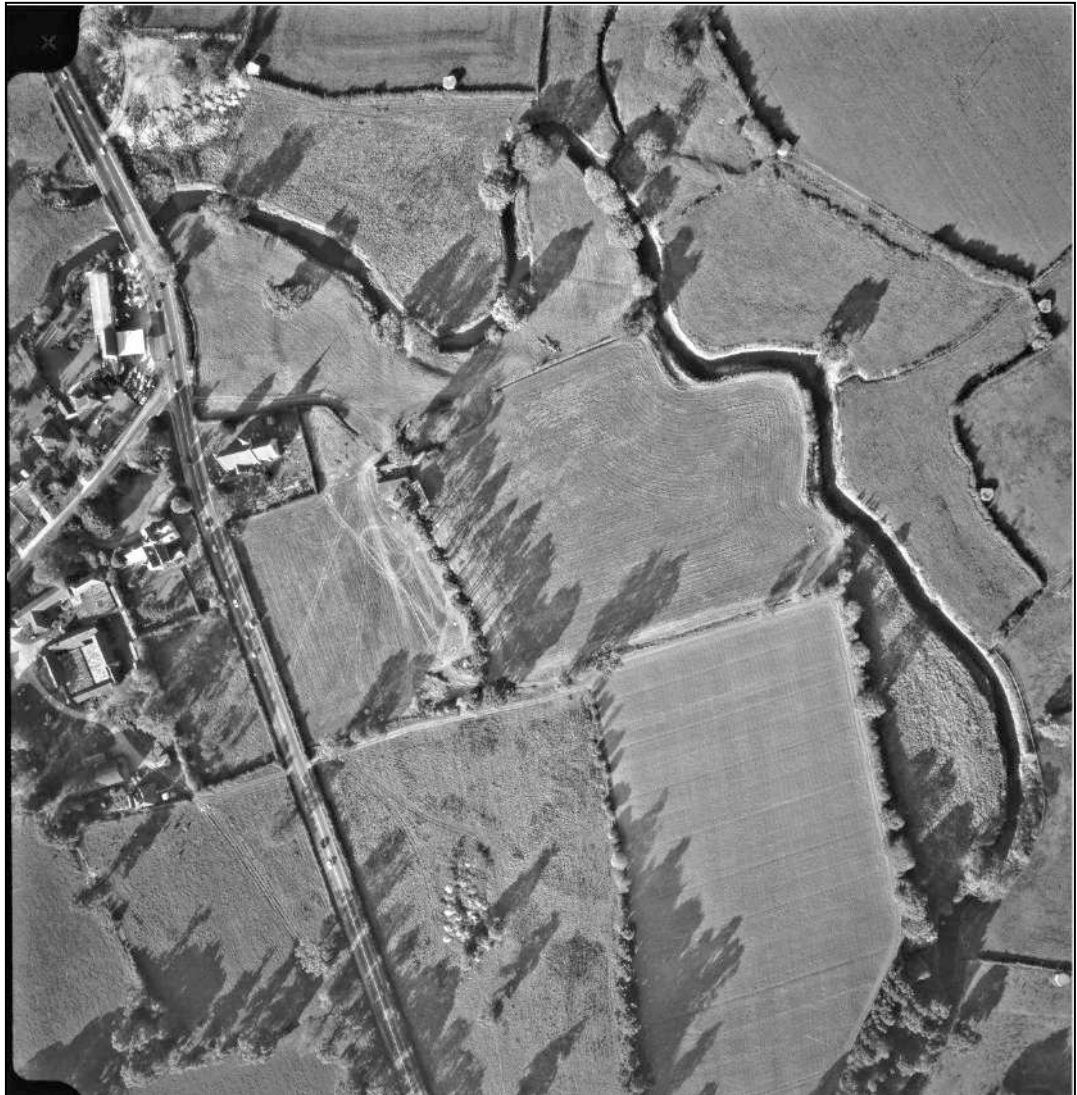
Fig. 3 - Aerial photograph taken in 1969 showing Sidlow Bridge [upper left] and pillboxes following the course of the river towards the south-east.

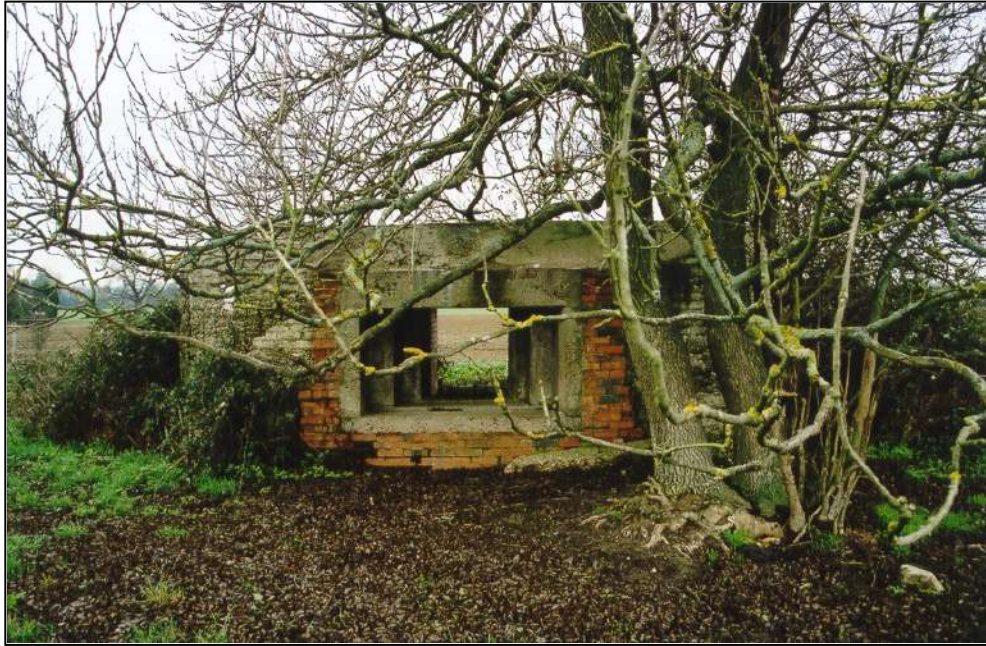
The run of infantry type 24 pillboxes to the east of Sidlow Bridge, together with a 6pdr. anti-tank gun emplacement, is complete. Although one or two are now in poor condition, with substantial portions of their exterior brick shuttering lost, none has been destroyed. The anti-tank gun emplacement [UORN 2458] is in a messy condition, being used as a cattle shelter, and is of the same type and design as others to be found on the GHQ Line in Surrey and Kent [see, for example, UORN 2434, within Defence Area 16 - Penshurst]. The circular holdfast to mount the 6pdr. gun is still in position.

Fig. 4 - UORN 2458: anti-tank gun emplacement mounting a 6pdr. gun firing towards Sidlow Bridge.

The condition of the pillboxes and anti-tank gun emplacement closest to the bridge is poor, and attention should be given to removing their overgrowth and preventing their use by cattle and (apparently) by squatters.

3. That consideration be given to clearing overgrowth from the defence structures close to Sidlow Bridge and preventing their use as cattle shelters, although continuing interior access for public inspection would be desirable.

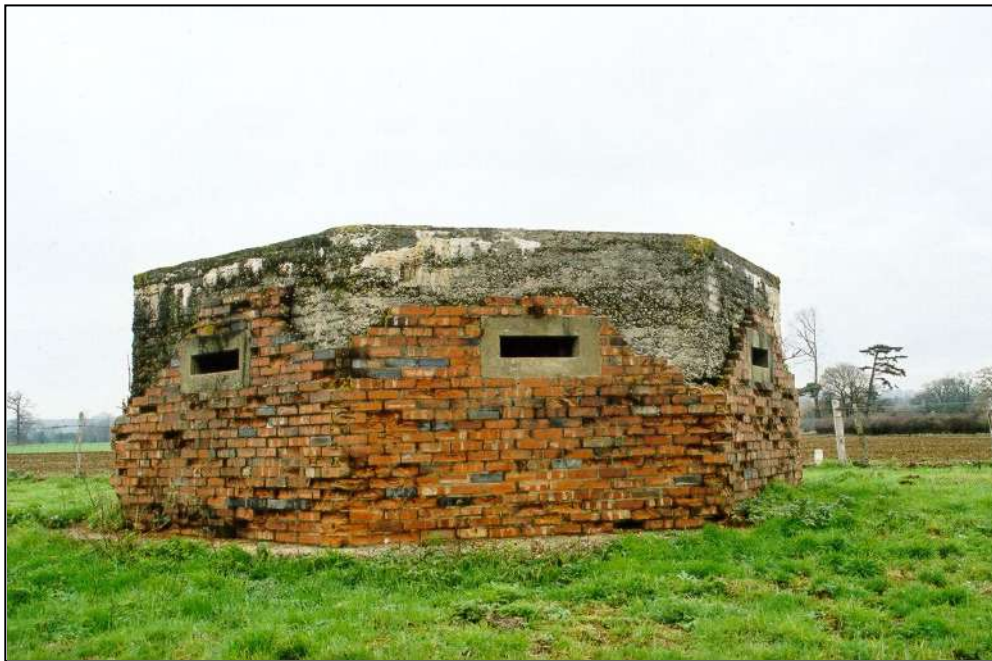
Two type 24 pillboxes [UORNs 2475 and 2476] stand in line with the anti-tank gun emplacement, being sited on a low ridge above the river. To the north can be seen a tall pillbox positioned on a low hill that dominates the skyline [UORN 2481]. Further type 24 pillboxes, some badly overgrown, stand alongside the footpath that runs towards White Owl Farm (built since the war). North of this farm at the corner

Fig. 5 - UORN 2476: type 24 infantry pillbox with large sections of brick shuttering apparently deliberately removed.

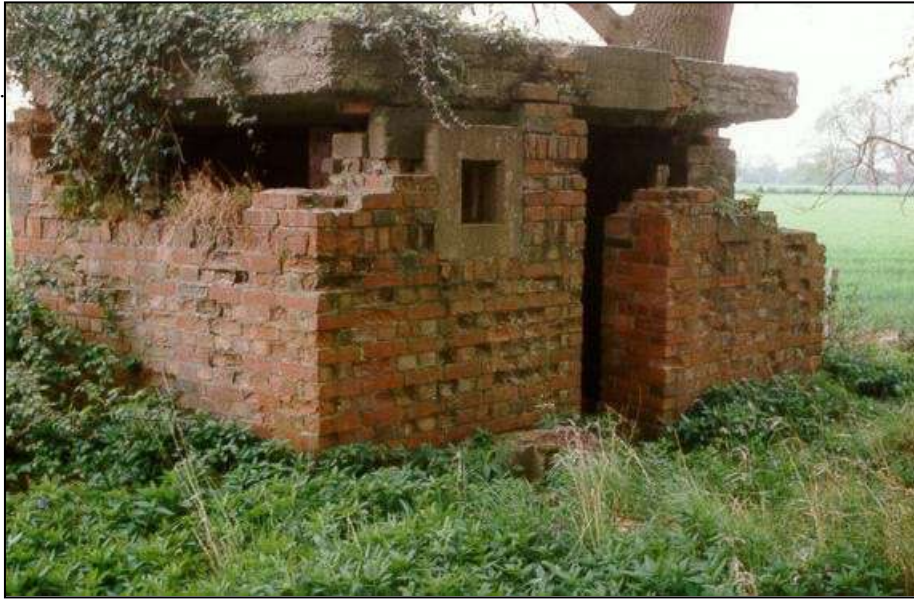
of a wood, and with no public access, is a damaged all-brick pillbox with pre-cast embrasure surrounds [UORN 2467].

Fig. 6 - UORN 2467: an all-brick pillbox with pre-cast embrasure surrounds, in very bad condition.

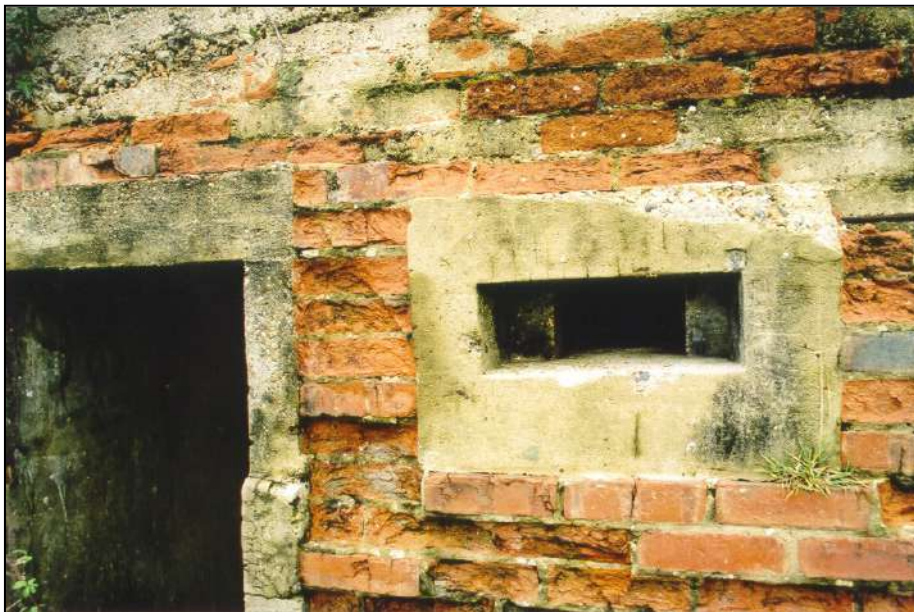
Fig. 7 - UORN 2477: an embrasure of a reinforced concrete, brick-shuttered pillbox.

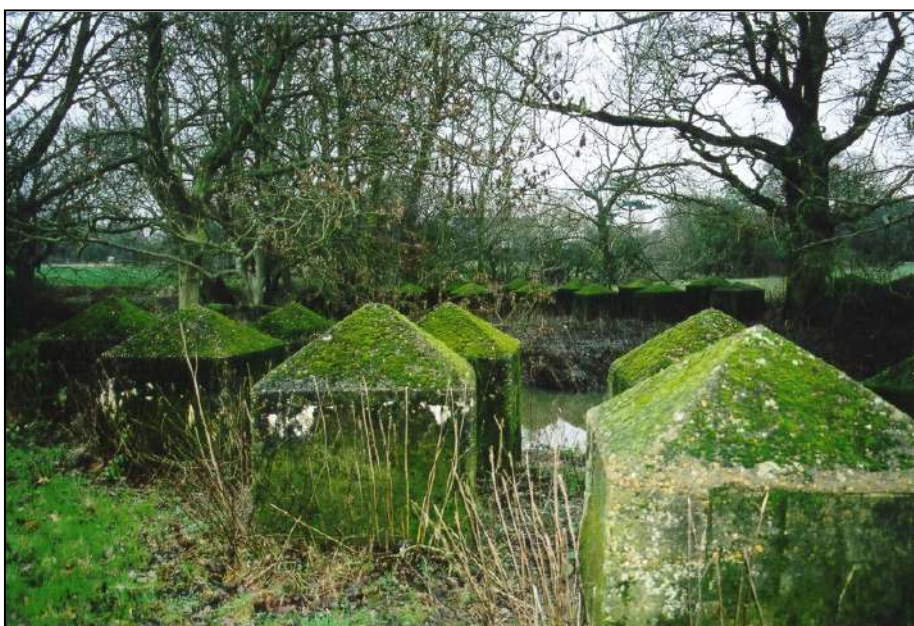
Further to the south are more infantry pillboxes, one [UORN 2469] positioned within the loop of a side stream from the river. Close by, the banks of the Mole were evidently not considered sufficiently steep or high to serve as an effective anti-tank barrier for they were reinforced by over thirty pyramidal-topped concrete cubes on both sides of the river [UORN 2455]. These form a remarkable survival in a remote location and show what the cubes at Sidlow Bridge, removed in the 1950s, would have looked like. The river banks may also have been cut vertically and revetted in places, although there is no surviving evidence of this.

Fig. 8 - UORN 2455: anti-tank cubes strengthening the banks of the River Mole as an obstacle to enemy armoured vehicles.
