## Verification Report No.: NGBEC25008861502

Sample Name: Smart Travel Adapter

Tested Basic Model No.: ETWF4006

Verification Requested: With reference to RoHS Directive (EU) 2015/863 amending 2011/65/EU.

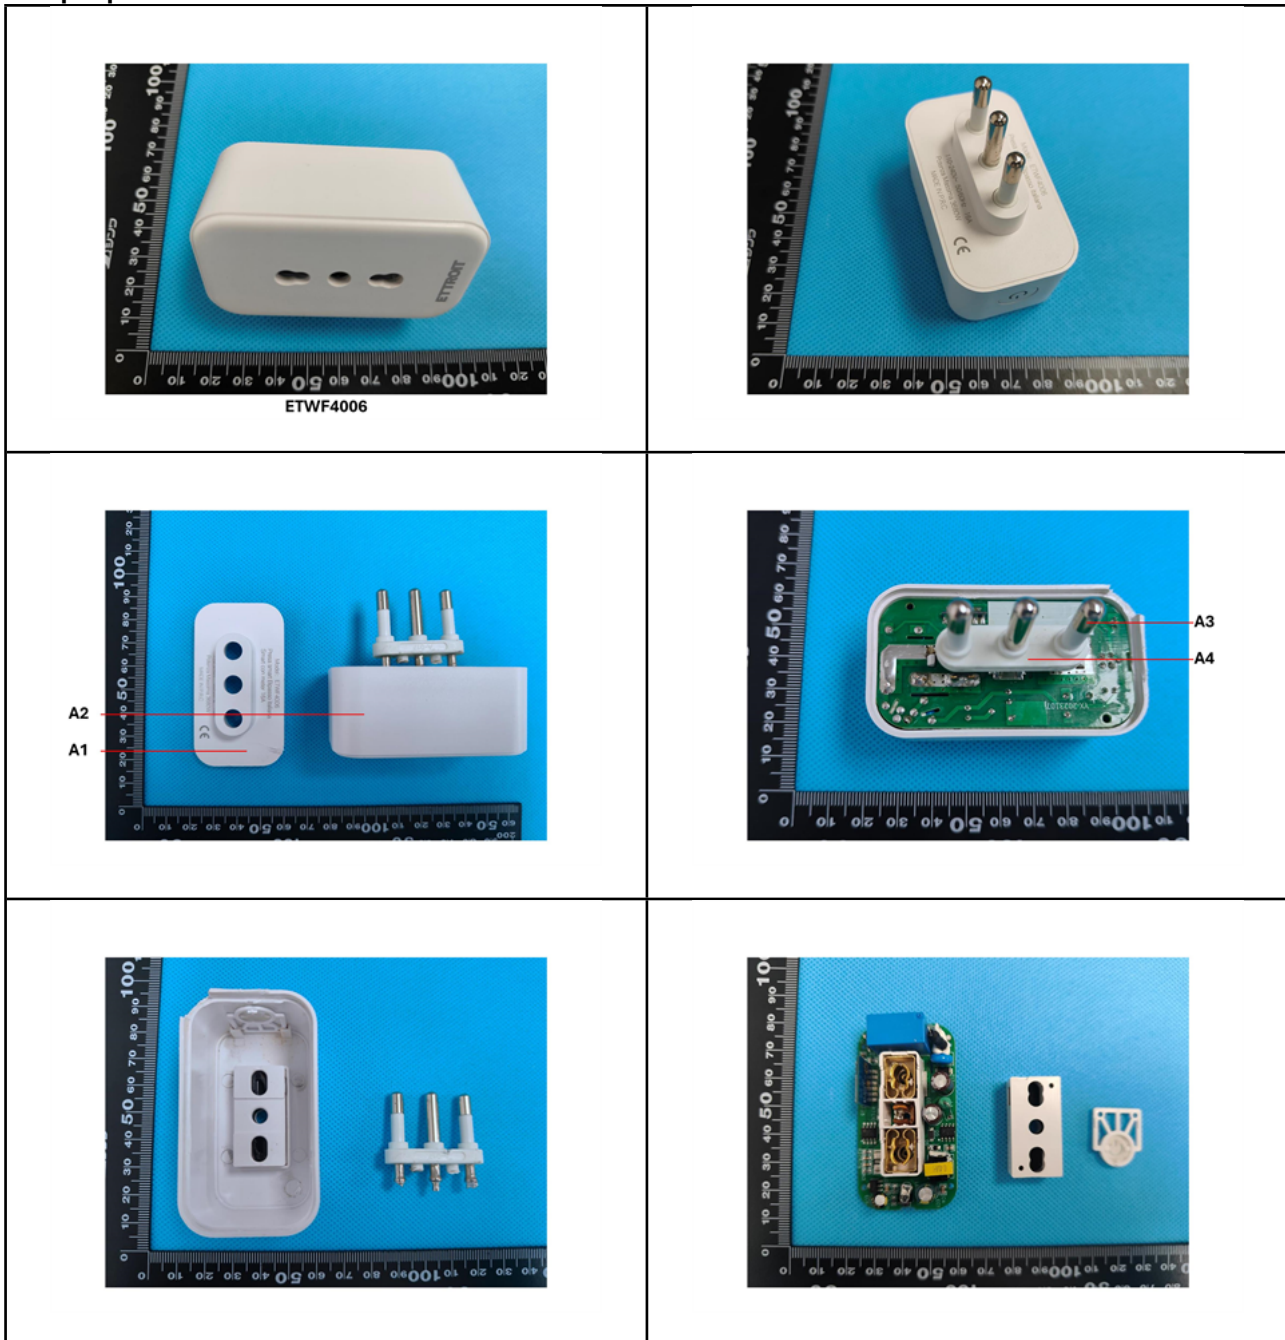
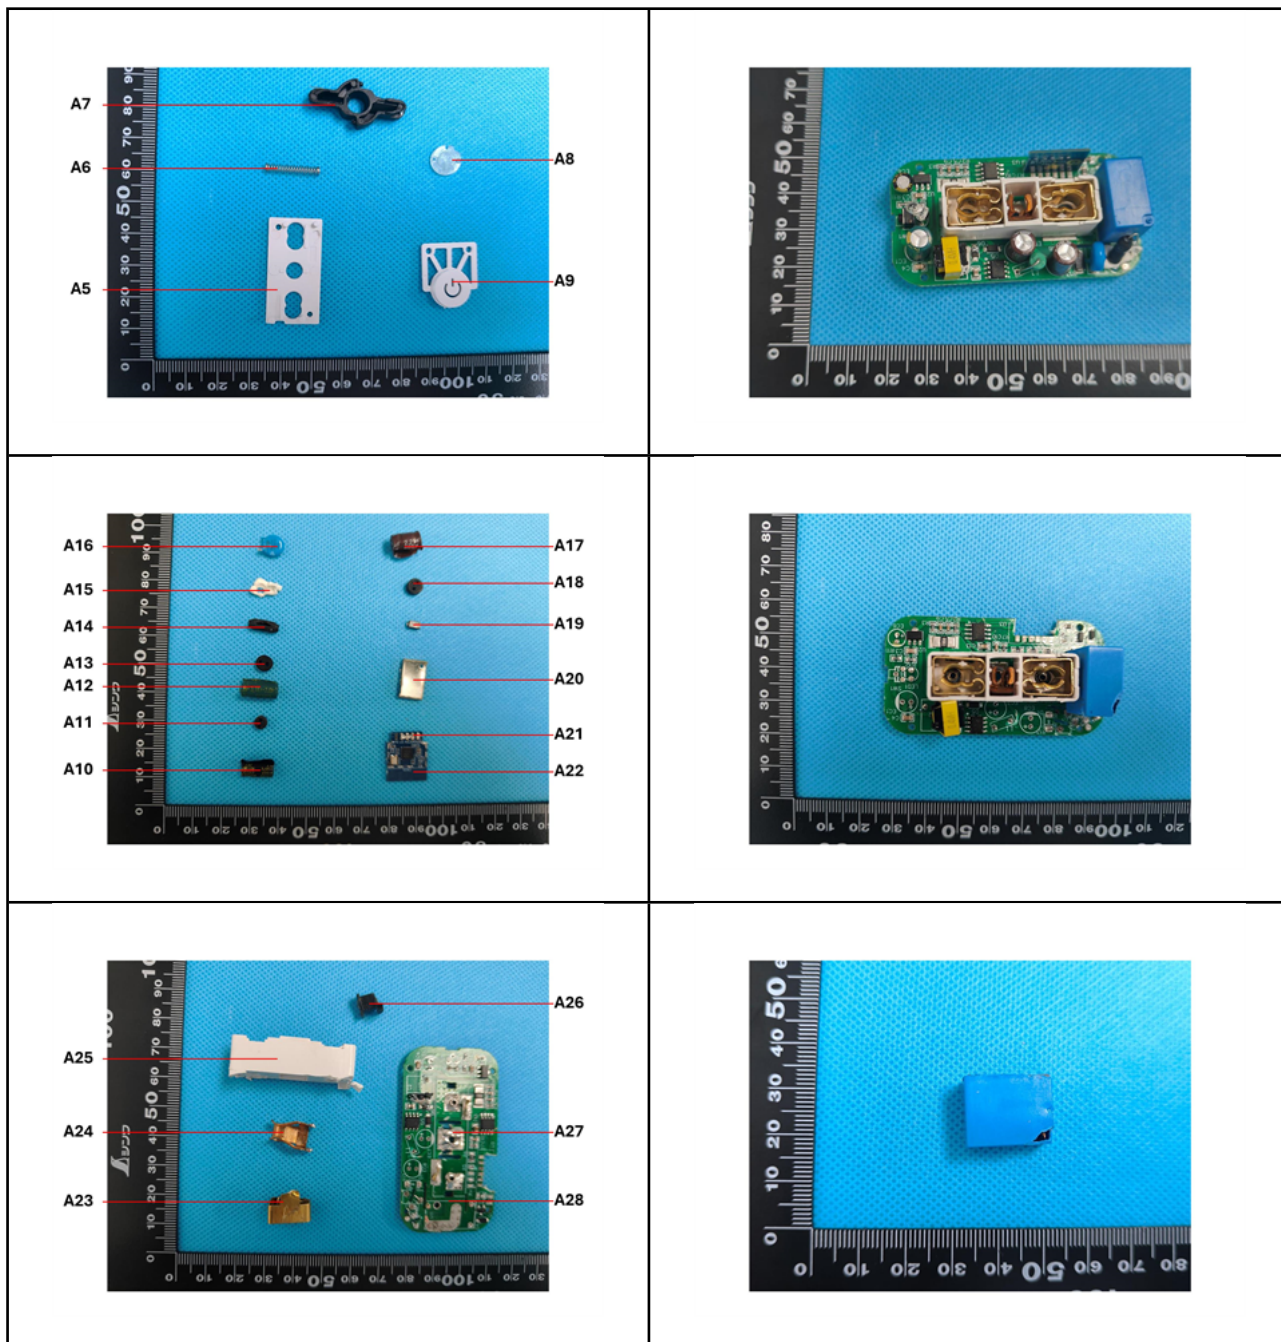
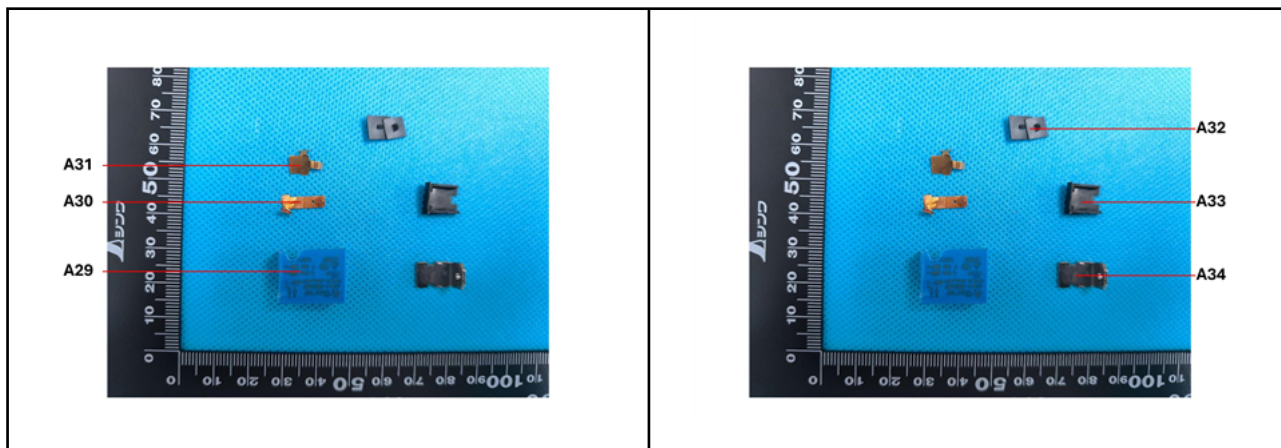
**Sample photos:**

1. With reference to IEC 62321-2:2021, disassembly and disjointment were performed for the submitted samples.
2. With reference to IEC 62321-1:2013, tests were performed for the samples indicated by the photos in this report.
  - (1) With reference to IEC 62321-3-1:2013, screening by EDXRF spectroscopy.
  - (2) Wet chemical test method: With reference to IEC 62321-4:2013+A1:2017, IEC62321-5:2013, IEC 62321-7-1:2015, IEC 62321-7-2:2017, IEC 62321-12:2023, IEC 62321-6:2015 and IEC62321-8:2017 , analyzed by ICP-OES,UV-Vis and GC-MS.

**Verification Part Description:**
