Sample Name: Smart Socket

Tested Basic Model No.: MTWF2102

SGS Job No.: NBP25-010227

Verification Requested: With reference to RoHS Directive (EU) 2015/863 amending 2011/65/EU.

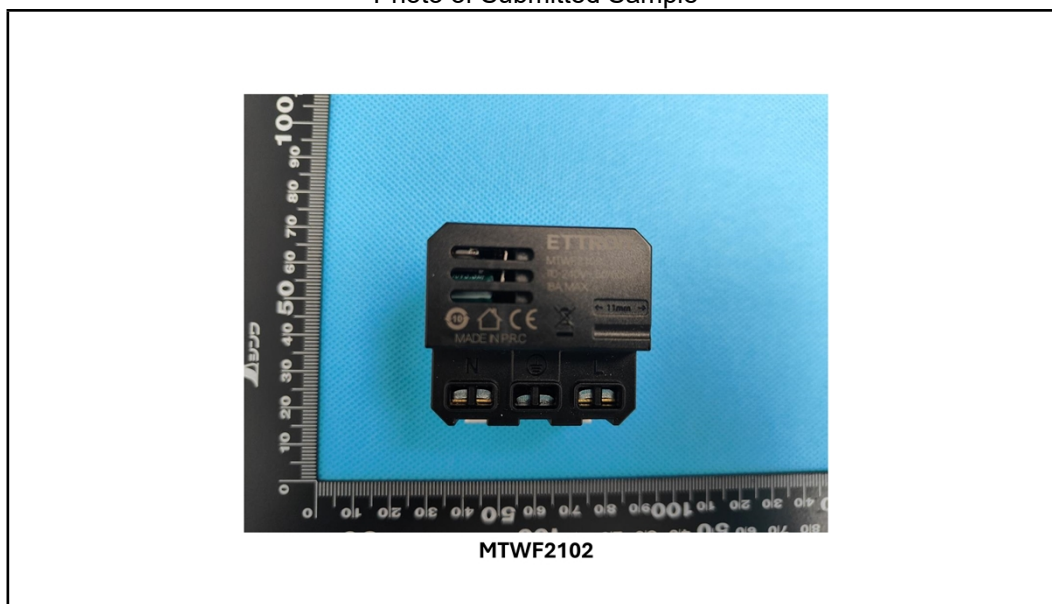
MTWF2102

Photo of Submitted Sample

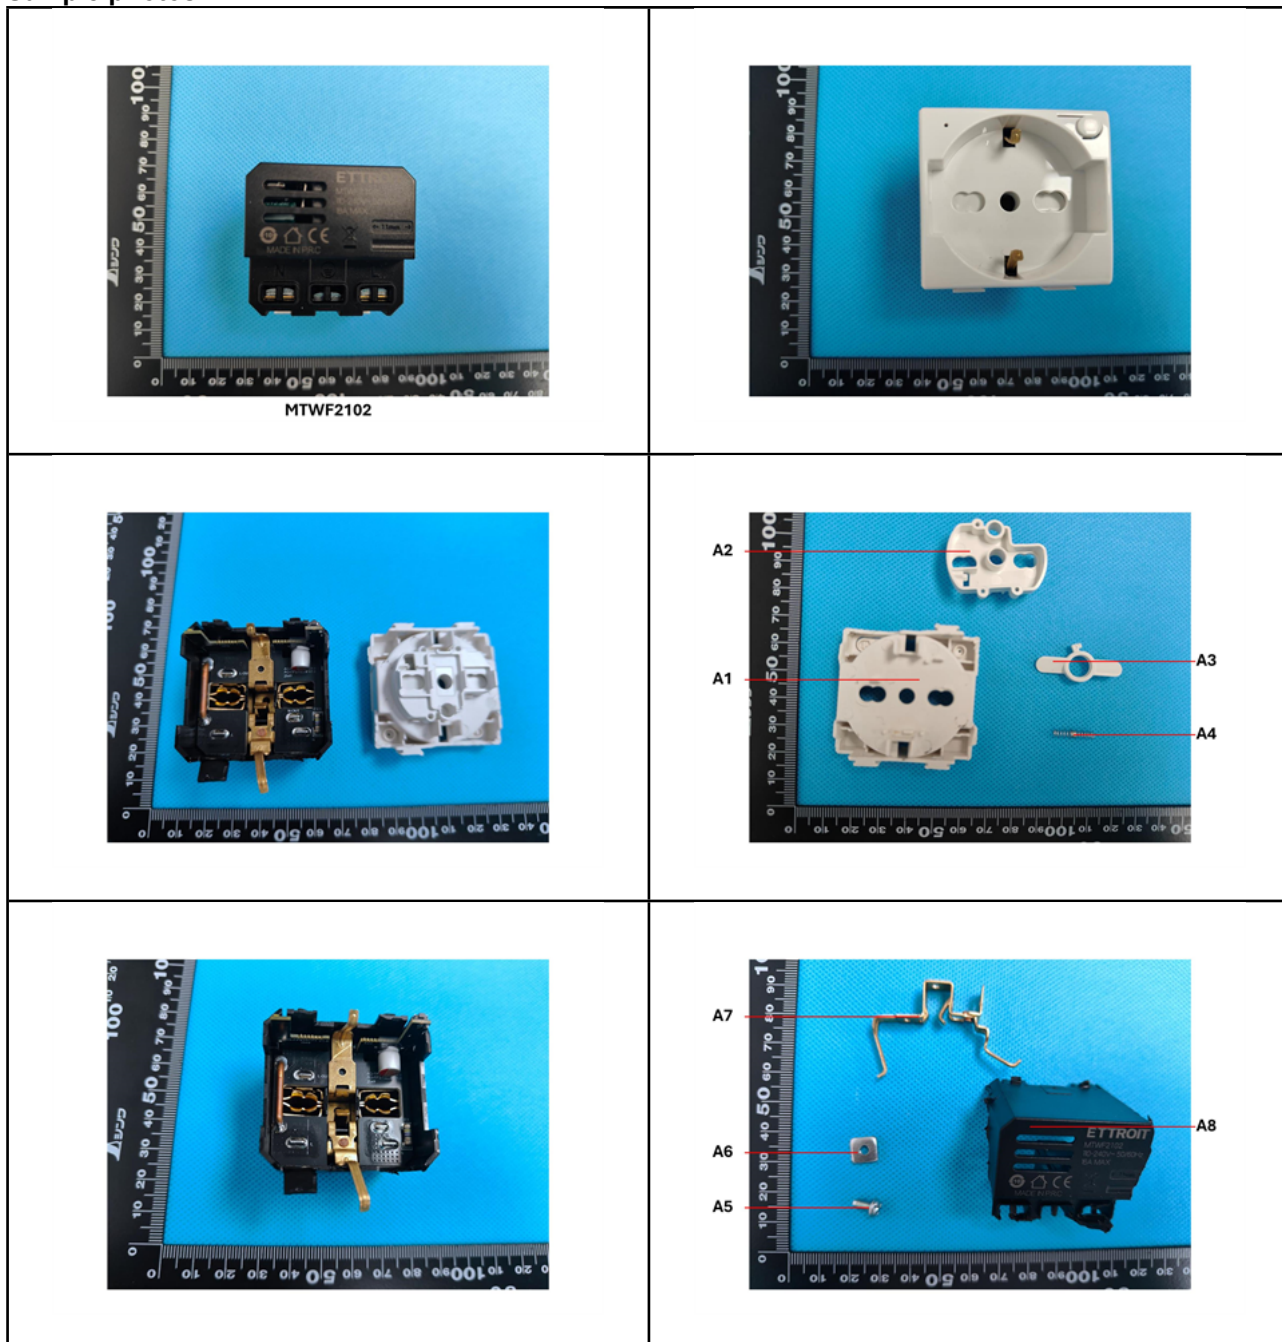
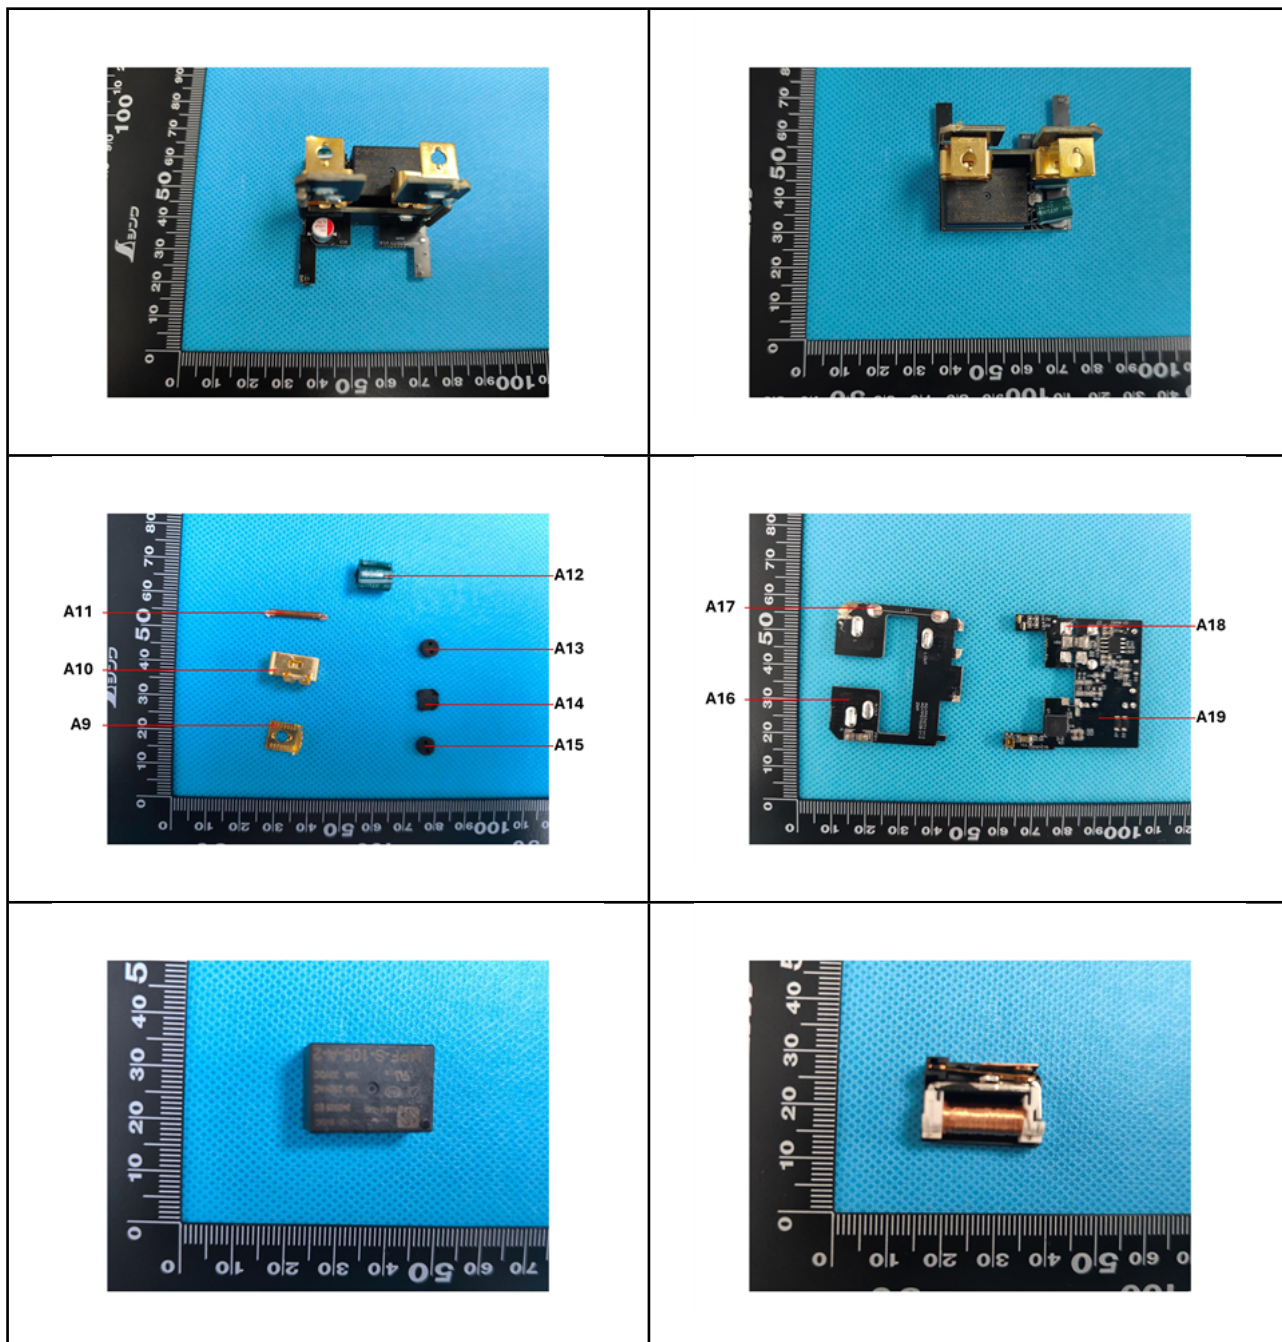
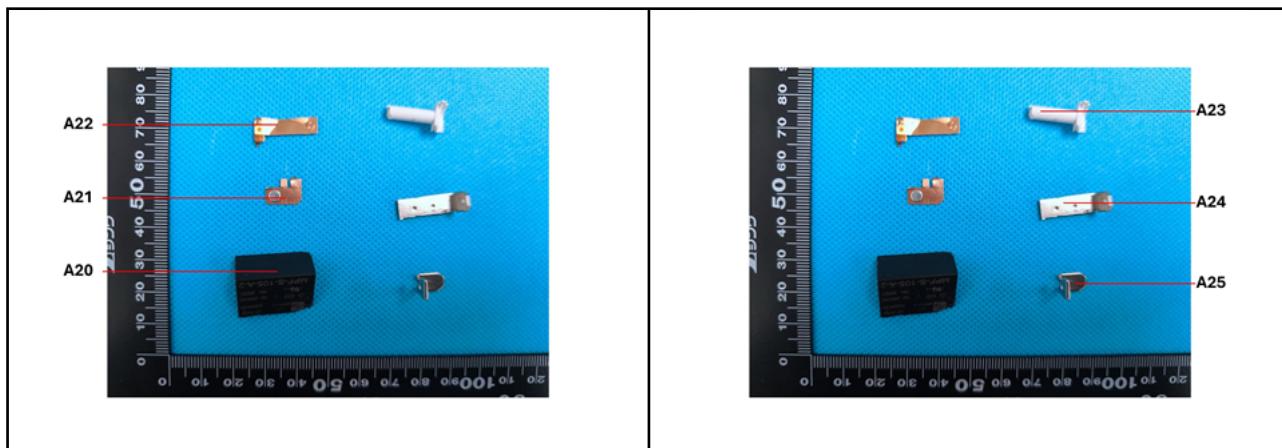
Sample photos:

1. With reference to IEC 62321-2:2021, disassembly and disjointment were performed for the submitted samples.
2. With reference to IEC 62321-1:2013, tests were performed for the samples indicated by the photos in this report.
  - (1) With reference to IEC 62321-3-1:2013, screening by EDXRF spectroscopy.
  - (2) Wet chemical test method: With reference to IEC 62321-4:2013+A1:2017, IEC62321-5:2013, IEC 62321-7-1:2015, IEC 62321-7-2:2017, IEC 62321-12:2023, IEC 62321-6:2015 and IEC62321-8:2017 , analyzed by ICP-OES,UV-Vis and GC-MS.

In accordance with the result of material risk assessment, the following disjointed parts in the submitted sample have been verified. (Unless otherwise specified, the unit is mg/kg).
