# FOODLUBE XT CHAIN FLUID – OVERCOMING CARBONISATION

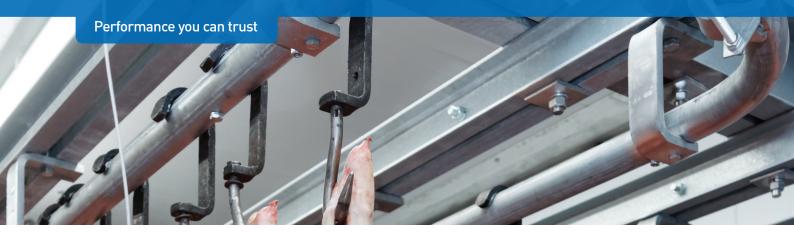
The high temperature generated was causing carbonisation on the chains. This results in reduced lubrication; the chain oil cannot reach the areas of the chain it needs to. Reduced lubrication means increased wear of the chain. Premature wearing of the chain leads to a higher number of chain overhauls and consequently higher costs to the business. On top of the cost of replacing chains, there are all the associated costs. For example;

There were no carbon deposits nor varnishing found on the chain when FOODLUBE XT Chain Fluid was used. The use of FOODLUBE XT Chain Fluid will increase the life span of the chain considerably resulting in less downtime for maintenance and reducing the amount spent on replacement chains.
