## APPLICATION NOTE

# Smarter Maintenance in Modern Cement Plants with Flir Acoustic Imaging

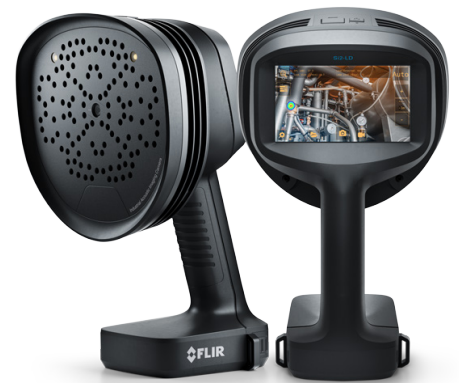
*FLIR Si2-LD™ Industrial Acoustic Imaging Camera for Pressurized Leak Detection and Mechanical Fault Detection*

It is for this reason that Flir has developed the **Si2-LD** handheld acoustic camera. Equipped with highly sensitive MEMS microphones, the camera pinpoints leaks in compressed air systems while displaying a 12 MP image on a 5-inch, 1280 x 720 color screen. For noisy environments, the camera's bandpass filtering allows users to isolate leaks with precision by manually selecting the frequency range, even in challenging industrial settings.

The **Si2-LD** detects sounds from 2–130 kHz, identifying even the smallest leaks. For example, a leak as tiny as 0.007 liters per minute can be detected from 2.5 meters away, and larger leaks can be located from up to 130 meters. This allows maintenance teams to safely inspect hard-to-access areas, including high-temperature zones, without risking personnel safety.

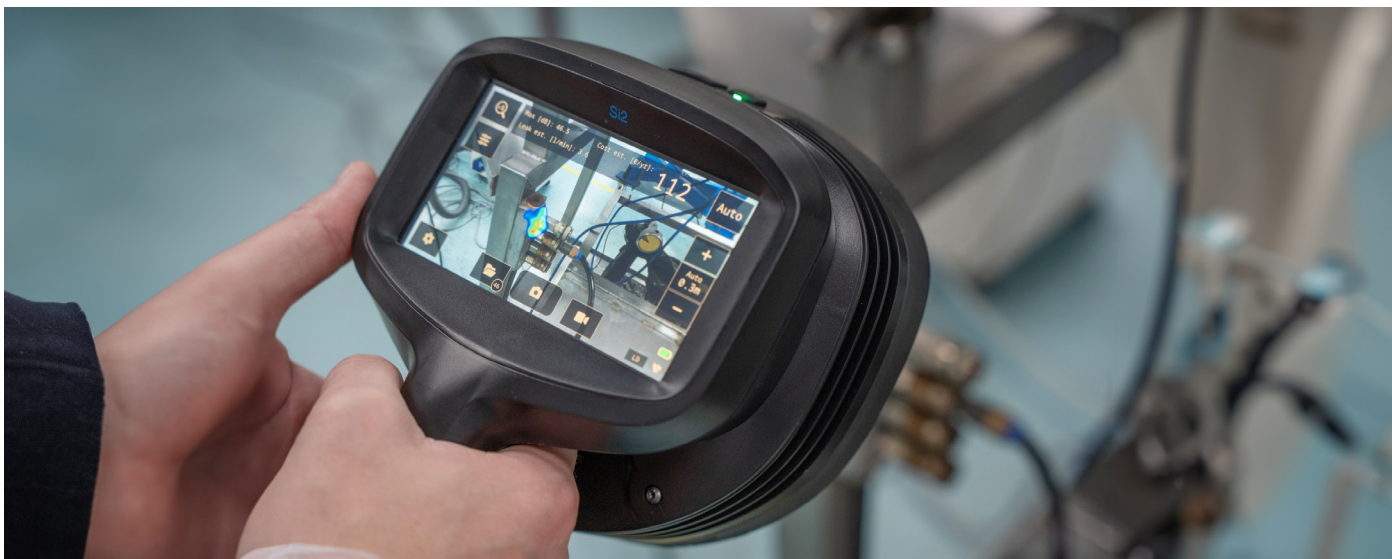
The FLIR Si2-LD delivers real-time analytics, including leak size and cost estimates, enabling immediate field insights to support efficient cement production operations.

Once an inspection is complete, the camera's onboard leak size quantification software helps prioritize repairs by potential energy loss, ensuring the most significant leaks are addressed first. Recognizing that plant environments often restrict external drives and Wi-Fi access, Flir provides a data cable accessory that connects the camera directly to a PC or laptop, allowing easy transfer of image files without network or security issues.
