Hybrid corrosion protection of a prestressed concrete bridge

C Christodoulou¹, C Goodier², S Austin², J Webb¹, G Glass³

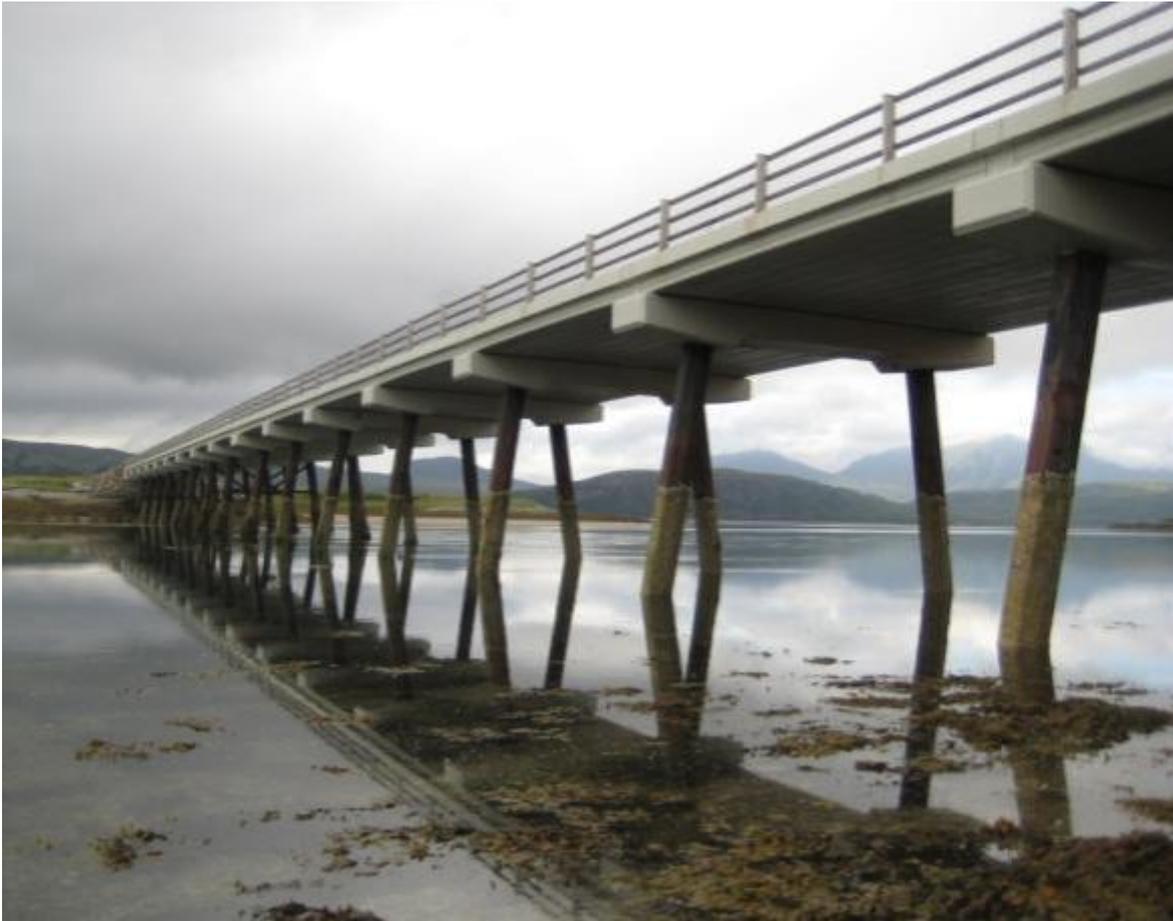
The Kyle of Tongue Bridge in Sutherland, Northern Scotland carries the A838 road across the estuary of Tongue (Figure 1). It opened in 1970 and has an overall span of 184m and consists of 18 approximately equal simply supported spans. The bridge width is 8.5m consisting of a single 5.5m wide carriageway with two lanes and 1.2m and 1.8m wide footpaths.

Figure 1: General view of the Kyle of Tongue bridge

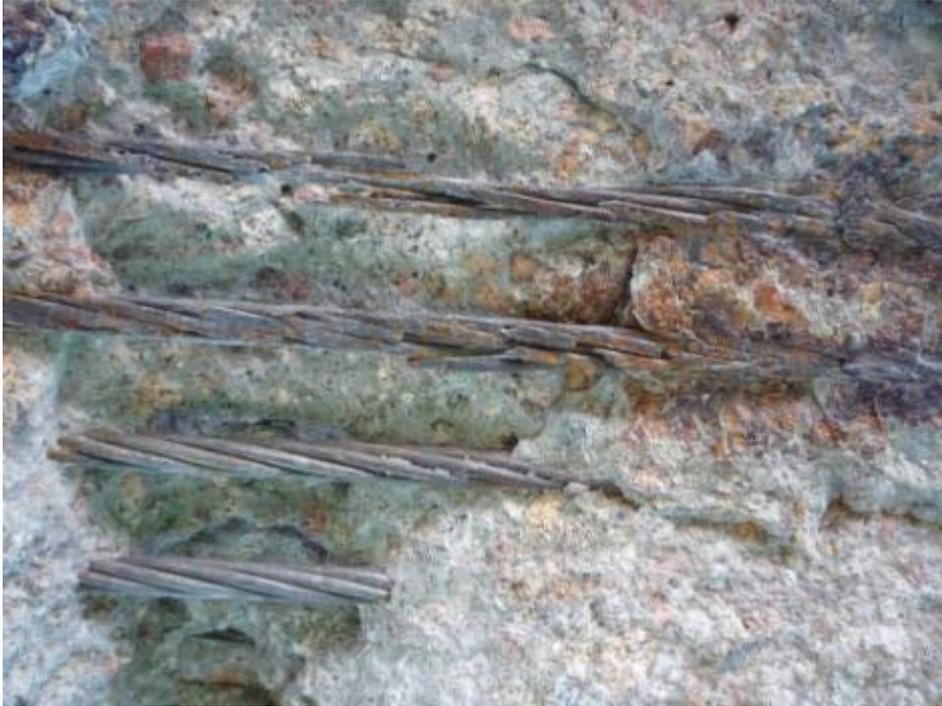
- widespread chloride contamination
- chloride induced deterioration of the prestressed concrete beams (Figure 3)
- chloride induced deterioration of the reinforced concrete crossbeams (Figure 4)

Figure 3: Typical chloride induced deterioration of the prestressed concrete beams

Chloride sampling throughout the structure indicated chloride concentrations exceeding 1% by weight of cement at the depth of reinforcement which indicates a high risk of corrosion (Design Manual Roads Bridges 1990). In some cases, chloride concentrations exceeded 2% by weight of cement. With regards to carbonation, depths were generally low and there were no instances where they reached the depth of the steel.

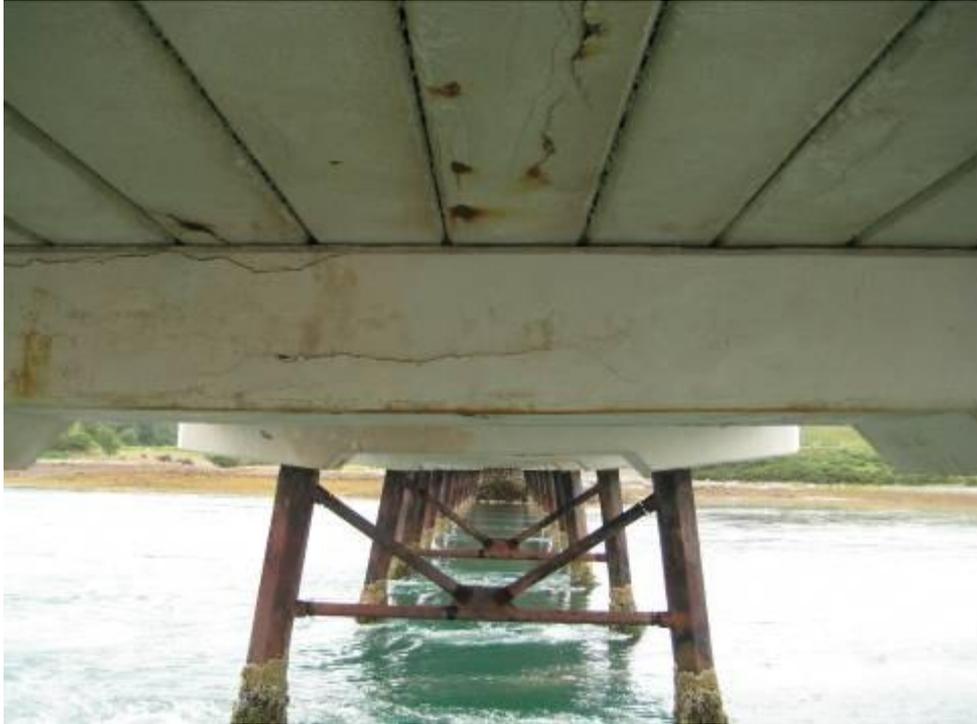
Figure 4: Typical chloride induced deterioration of the bridge

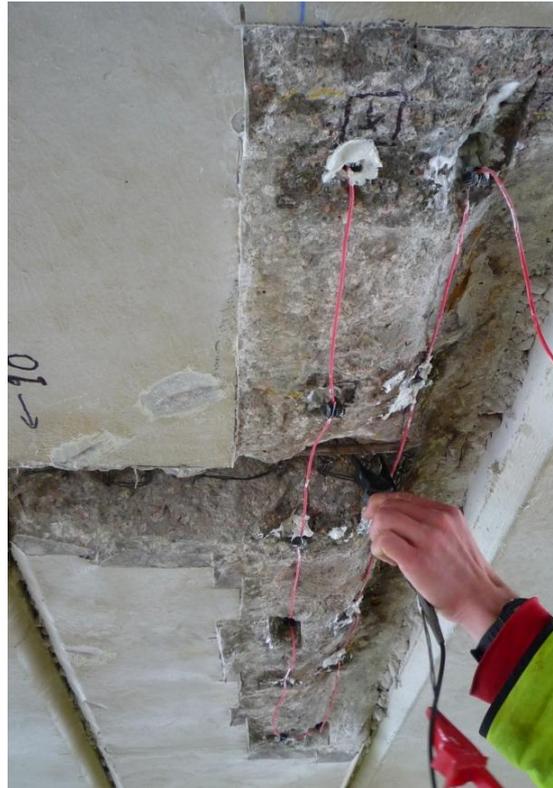
Only physically deteriorated concrete was removed from the prestressed concrete beams. Hybrid anodes 18mm in diameter and 37mm long were installed in drilled cavities between the prestressing tendons of the beams. The pre-drilled cavities were filled with proprietary low strength mortar to fully cover the anodes and provide separation from the repair concrete (Figure 6).

The hybrid anodes included an integral titanium wire to facilitate the delivery of an impressed current and were connected in a series for each repair. Each series of anodes for the individual repairs was terminated in a junction box which also facilitated a connection to the steel reinforcement. This provided a convenient location to connect them to the temporary power supply for delivering the initial current treatment and later connecting them together in a galvanic cell.

Figure 6: Hybrid anode installation on a prestressed concrete beam
