38th WEDC International Conference, Loughborough University, UK, 2015

**Solid waste management in refugee camps:
a case study from Myanmar**

REFEREED PAPER 2101

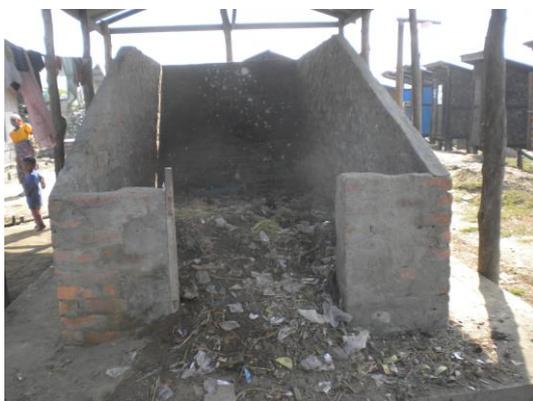
Photograph 1. Three-sided concrete collection point in OTG1

- In OTG 1 the adoption of a 3-sided concrete collection point proved unsuccessful. After the construction of the collection points, there was no safeguarding of land around the structure, which meant that new additional shelters were built closer and closer to them, as observed during field surveys. Moreover, the construction of the collection point was not supported by a regular collection system. Waste was, therefore, not removed in a timely fashion and IDPs complained that the collection points were producing bad smells and attracting rodents and insects. It was also observed that waste tended to be disposed close to the entrance of the collection points, as typically happens with this type of system.

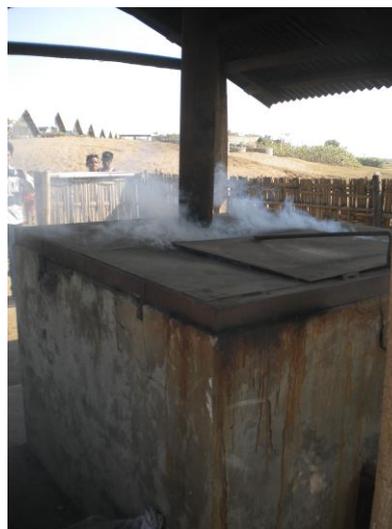
Photograph 2. Malfunctioning two-chamber incinerator used in one of the IDP camps

Incineration was the most widespread method of final disposal. Small-scale incineration is usually only recommended as an emergency solution when no other process is applicable or for the treatment of specific waste streams. In addition, incinerators used in the camps were often not designed and built according to best practice. As a consequence, even when the incinerators were provided with two chambers, smoke was often released directly from the first chamber, bypassing the treatment process and emitted at head height, as witnessed during field surveys. This also increased the likelihood of incomplete combustion processes taking place. Another issue was linked with the location of the incinerators. Due to land pressure issues, additional shelters were often built too close to the incinerators, increasing health risks for the population and potentially also creating fire hazards. Moreover, representatives of INGOs reported that incinerators had not been tested during the rainy season, when it was likely that their operation was going to be more difficult. Finally, appropriate pits for the disposal of ashes had not been identified.
