Artificial recharge of groundwater by injection well

Laxman Kharal, Nepal

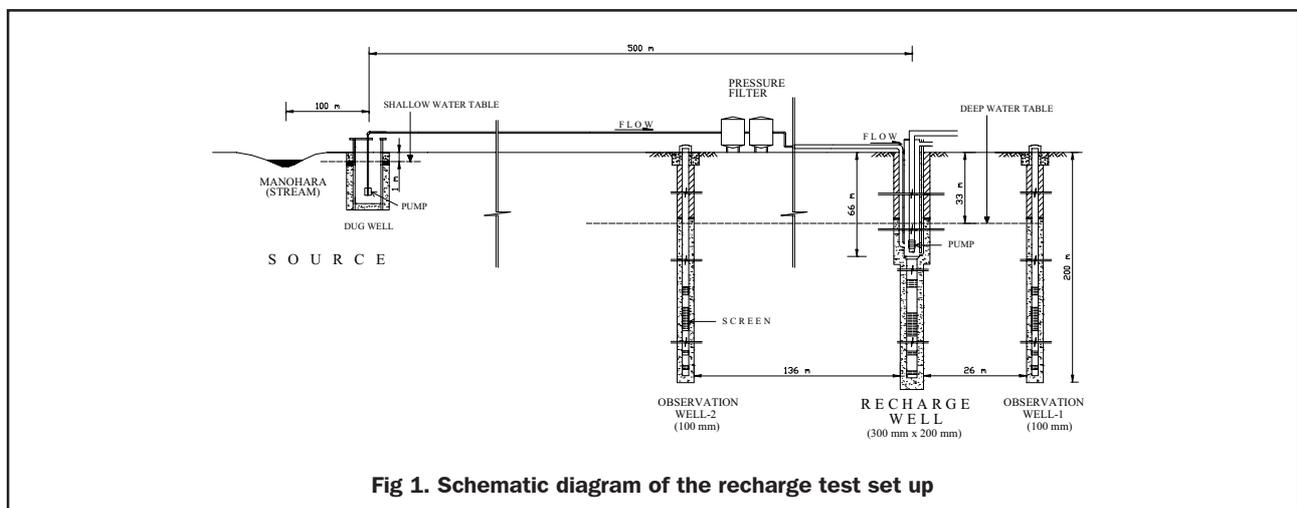
A schematic diagram of the recharge test set up is given here as figure-1. The source of water is the Manohara stream. A five-meter deep dug well with a diameter of two-meter

Fig 1. Schematic diagram of the recharge test set up

constructed at a distance of 100 meters from the Manohara stream collects the shallow water which is at a depth of about 1 meter below the ground level. The dug well water is pumped by a submersible pump through 100 mm diameter galvanized iron pipe to the pressure filter water treatment plant installed in the premises of the recharge well at a distance of 500 meters from the dug well. The treated water from the pressure filter is injected in to the adjacent recharge well.

The recharge well is 200 meter deep. The upper 66 meter is of diameter 300 mm and the rest of 200 mm with four stainless steel continuous screens totaling 30 meter below 123 m depth covering the deep confined aquifer intercepted by the well. The static water level in the recharge well is 33 meter below the GL. In order to avoid free fall and splashing of the recharge water while it enters in to the recharge well, the inlet pipe is joined to the recharge well below the static water level at a depth of 50 meter below the GL. A submersible pump is installed in the recharge well which is used for the purpose of back washing the well and carrying out pumping test for calculating the well and aquifer characteristics that indicate the efficiency of the well at different times during course of the recharge test – a decrease in the well efficiency indicating decline in recharge capacity of the well.

Two observation wells at 26 and 136 meters from the recharge well have been installed for monitoring the changes in water level and quality. The observation wells are of diameter 100 mm and depth 200 meters with the screens at locations similar to that of the recharge well.
