Conon House Ringed Earthwork

Site type – Ringed Earthwork

Parish – Urquhart and Wester Logie

NGR – centred on NH 5320 5372

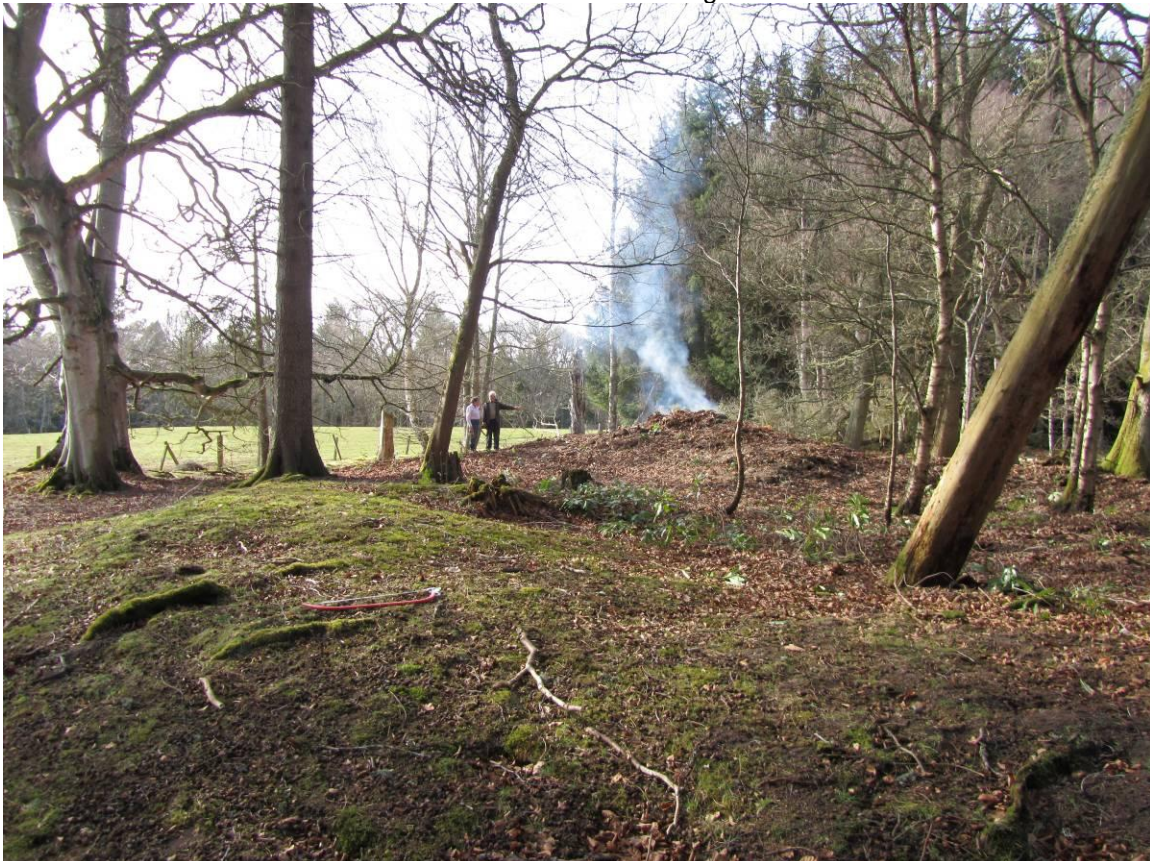
The south part of the site viewed from the east following rhododendron clearing, the SE bank is in the foreground

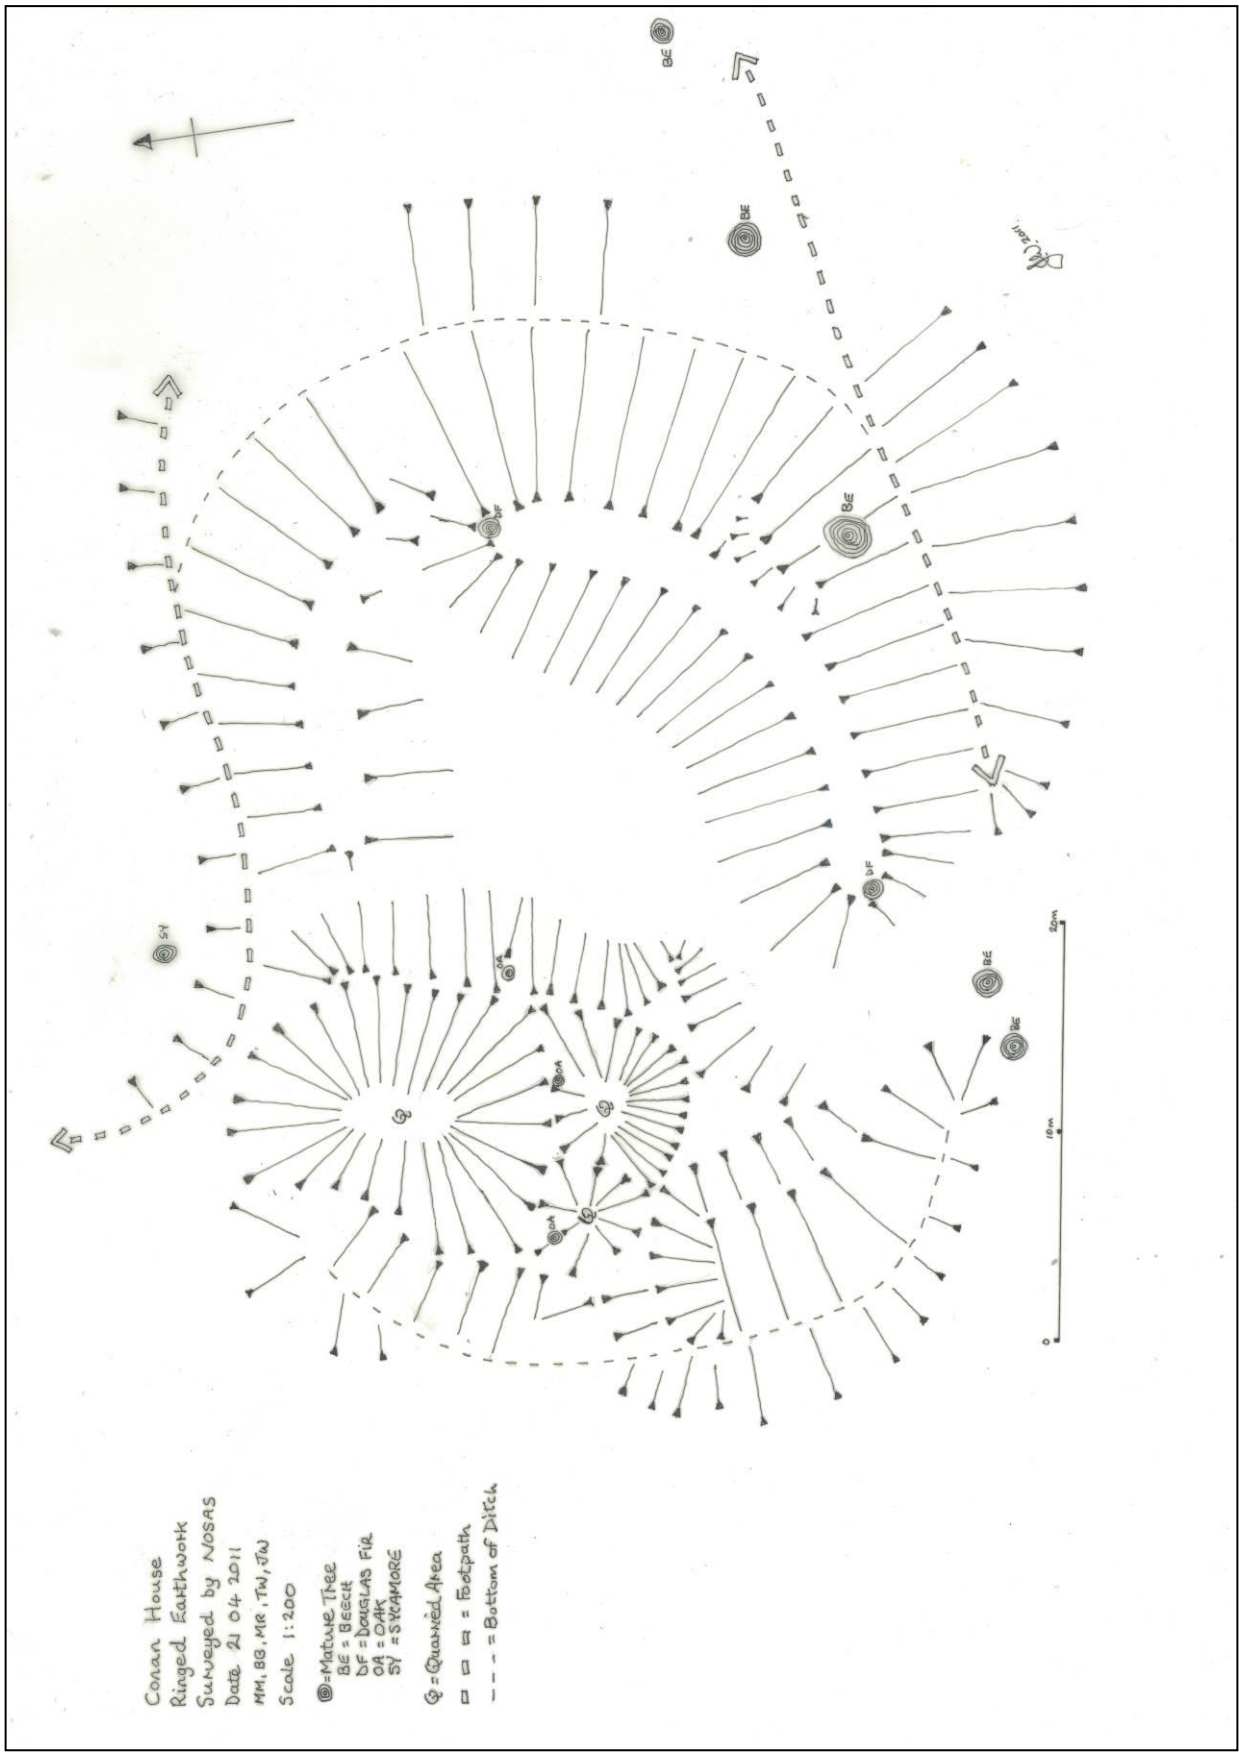
The site is roughly circular and 50m in diameter overall. At least half of the site has been grossly disturbed and only an arc of at least one third of the original earthwork remains on the SE side; the west part of the site has seen much activity with excavated hollows and prominent mounds of dumped material containing stones and charcoal rich material. The site comprises an internal bank, 8m broad x 1m high, with a possible entrance, 2m in width, in the east and an external ditch of about 4m width. It can be estimated from this arc that the complete site would have been 30m in diameter from top of bank to top of bank.

Surveyed using planetables 21.04. 2011 by members of NOSAS
