North Clyde Archaeological Society
Military Project 2015 >
On going report updated as work commences

Rosneath Home Farm Military Installations
Tam Ward. September 2016

*The remains of Heavy Anti Aircraft gun batteries (HAA) along with control rooms and ancillary buildings, surviving in the area of operations of the NCAS are currently being researched, surveyed and recorded by photography as part of NCAS **Military Project**. This report deals with the site at Rosneath Home Farm, near the village of Rosneath on the Gareloch.*

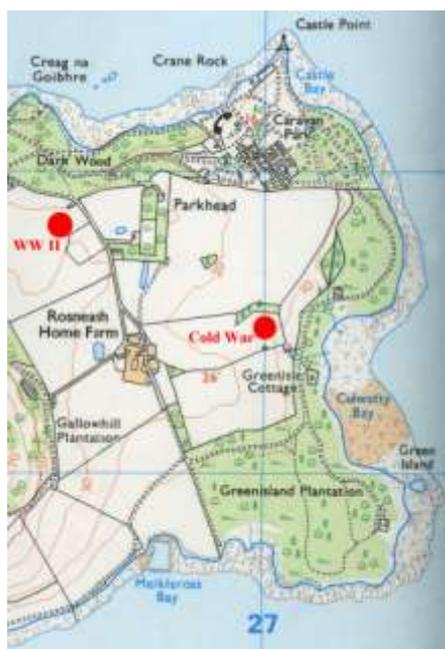
Fig 1. Location at southern tip of Rosneath Peninsula, showing both WW II and Cold War HAA gun sites.

Nothing remains of the HAA gun installation of Rosneath Home Farm where interestingly, a well preserved Cold War HAA gun site (Fig 1) also exists (Maidment 2015).

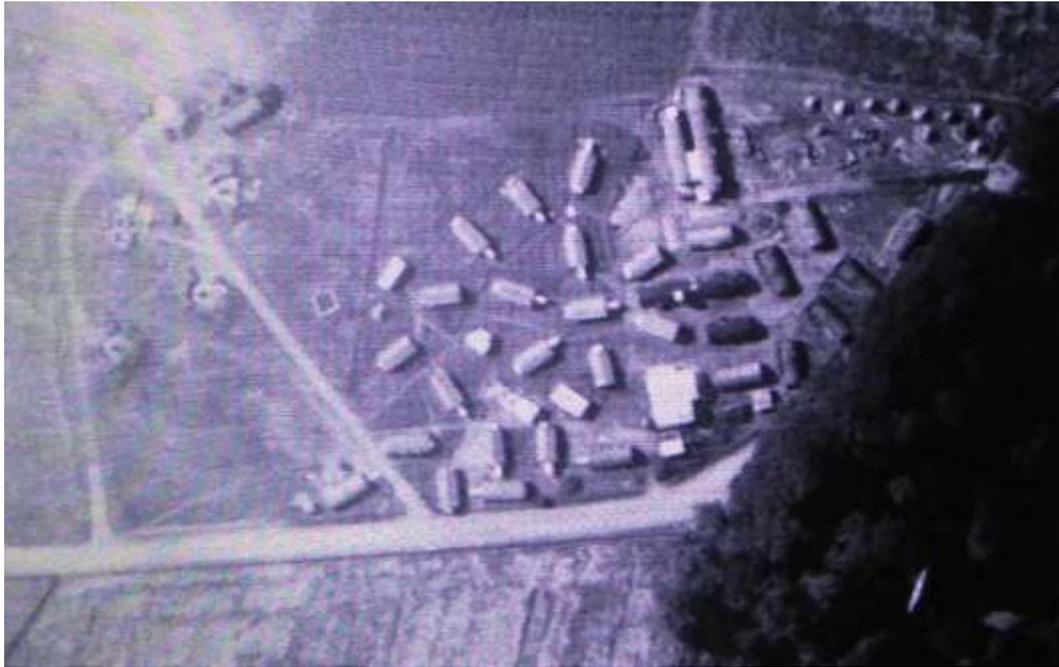
Camp site. Pl 1.

Pl 1. Showing WW II HAA camp and guns location

The camp area consists of at least thirty eight buildings most of which appear to be the standard size huts, however one double Nissen type building on the west side is much longer and a large flat roofed building lies beside the bend in the road. The buildings are arranged in a rather ad hoc manner but a central one is surrounded by six others. A possible water cistern lies between the camp and the gun area.

Neither the four gun positions nor the central Command Post are well defined in the photograph but at least their position can be appreciated.

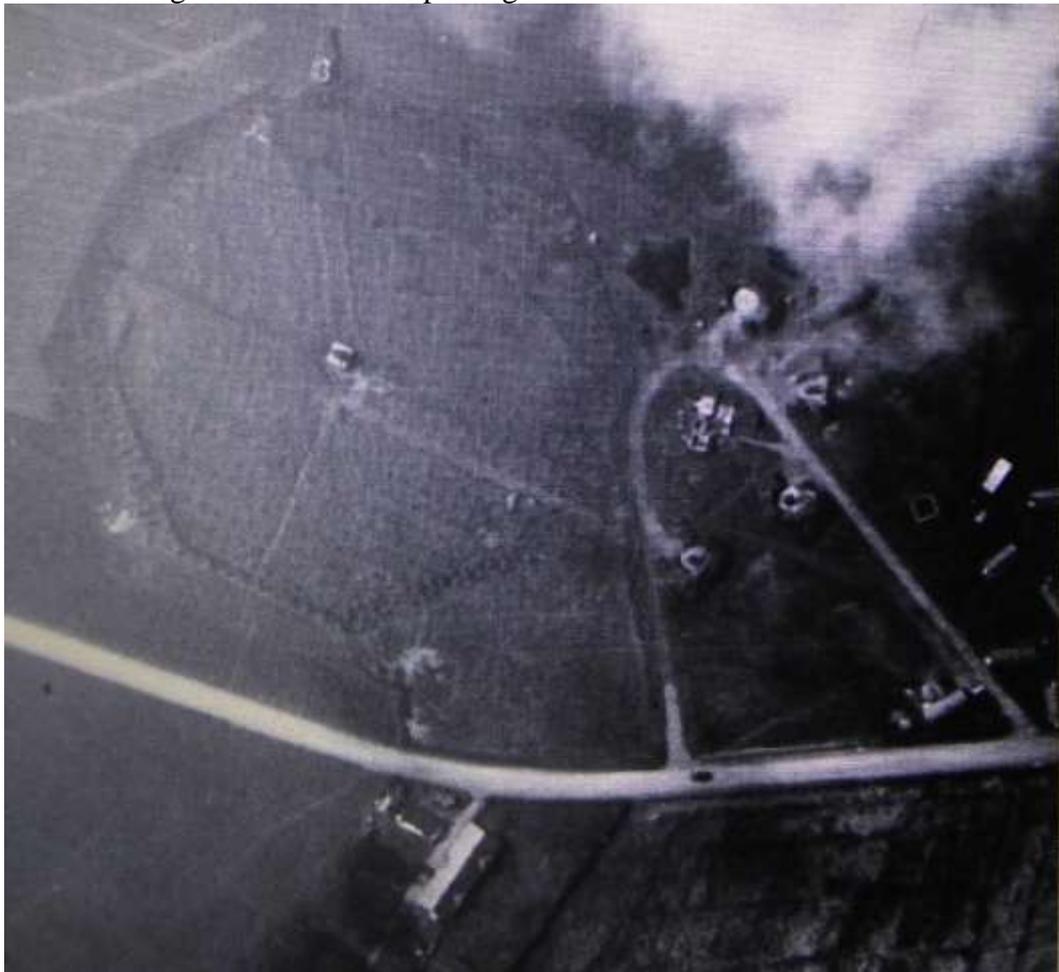
Radar mat area. Pl 2.

Pl 2. Showing WW II radar mat area with radar mount and also guns and Command Post locations.

The radar mat area is similarly easily discernable in the photograph and shows some interesting details. The typical hexagonal layout is seen and a central base for the radar equipment is also visible, interestingly it does not have a ramp and does not appear to have been equipped with one, the access road to it does not run directly to it as is seen at other sites where a radar van would be pulled up a ramp and onto the raised platform. The road turns at a right angle near the platform and this suggests that a fixed radar installation may have been installed here, and it is possibly shown in the photograph.

The entire area was chicken wire supported of fence posts about five feet above ground, hence the need for the radar to be elevated above the mesh. The photograph clearly shows the grid arrangement of stobs supporting the wire mesh.

The cottage in the photograph still exists allowing for easy site recognition on the ground. The site was previously improved agricultural ground and has been efficiently returned to that purpose.
