# GROUNDWATER STUDY

**Glass Bottle Manufacturing Plant - Vereeniging**  
Prepared for: The South African Breweries (Pty)  
Limited (SAB)

SLR Project No.: 720.19124.00005  
Report No.: 01  
Revision No.: 02  
August 2018

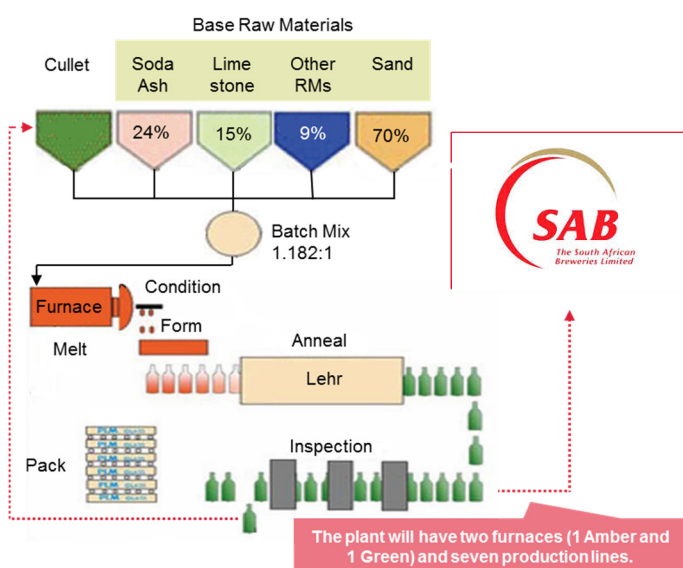
Figure 1-1: Conceptual Process

The proposed glass bottle manufacturing plant would produce green and amber coloured bottles. The facility would comprise a batch plant, main manufacturing building and warehouse. The conceptual process flow diagram of the proposed project is illustrated in

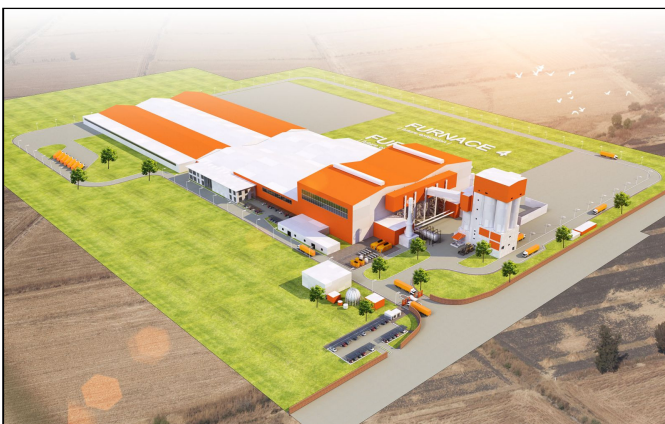
**Figure 1-2: Proposed Main Manufacturing Building**

The main manufacturing building (see Figure 1-2 below) would comprise a single large covered hall, approximately 45 000 m<sup>2</sup> in extent. The building consists of three areas (named the Furnace, Hot End and Cold End areas) in which, the glass is melted, formed into bottles and inspected for quality and defects.

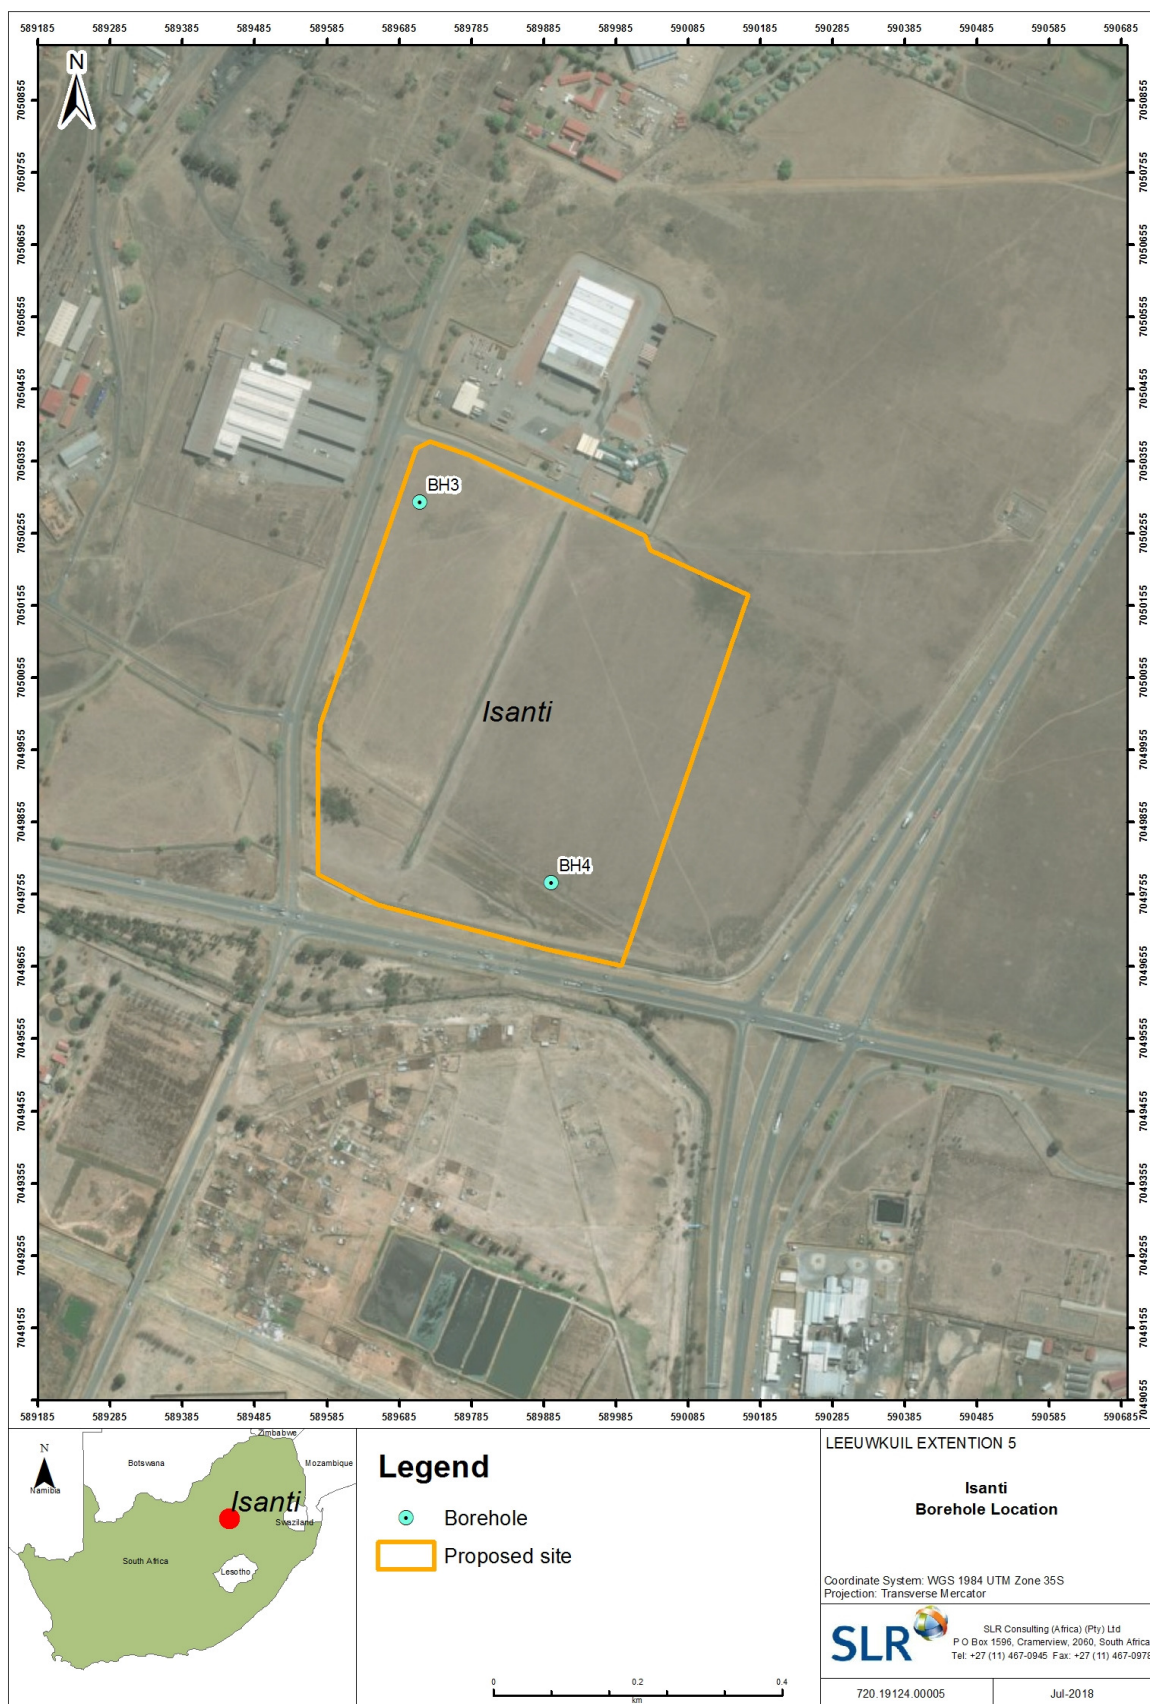
Figure 4-2 Location of monitoring boreholes BH3 and BH4, west of Vereeniging

Table 4-1 provides details of the completed two boreholes. Borehole logs are presented in Appendix B.
