# **CONSOLIDATED FINANCIAL PROVISIONING REPORT**

**WEST WITS MINING PROJECT**

**DMR Reference Number:  
GP 30/5/1/2/2 (10073) MR**

**FINANCIAL PROVISIONING REPORT  
FOR**

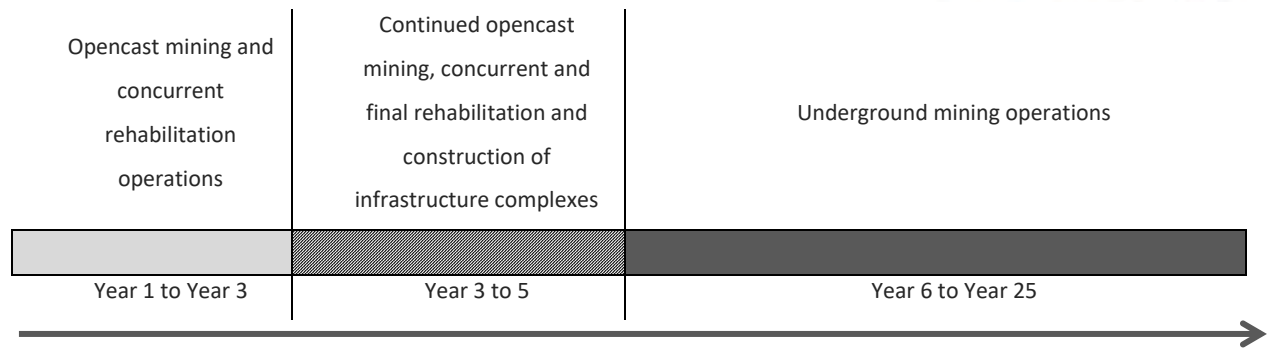
The expected life of mine for the open pit operations (inclusive of rehabilitation) is five (5) years and 20 years for the underground operations (see diagram below). The pits would be mined in a phased approach with each pit taking between six and 16 months to be mined and rehabilitated.

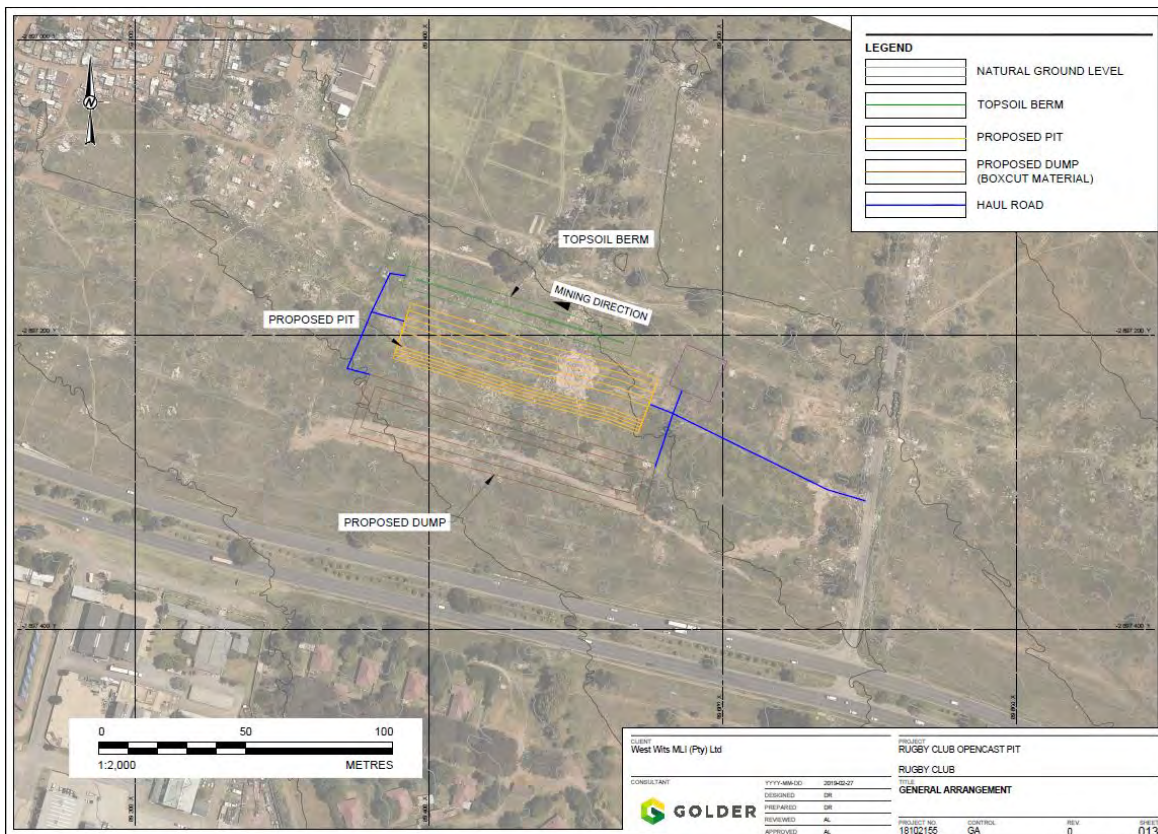
Figure 2: General arrangement plan: Rugby Club main reef open pit

The general layout plans for each pit has the following aspects (Figure 2 to Figure 6)

- Opencast pit and mining direction (refer to Figure 7 - Figure 12 for the concurrent backfill and final void positions);
- Topsoil berm;
- Overburden stockpile,
- Platform area; and
- The planned haul roads.

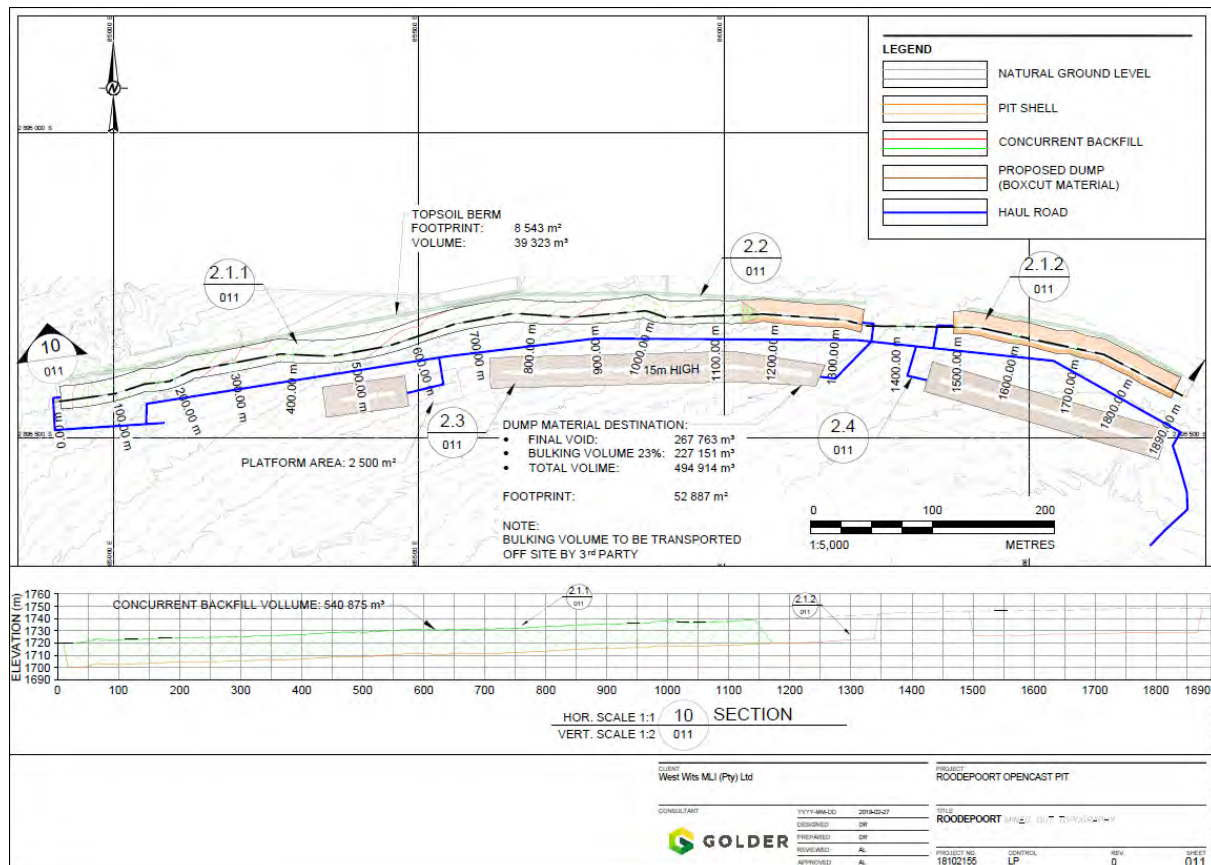
Figure 9: Roodepoort main reef pit predicted mined out landform

- Rugby club main reef pit - Figure 7 and Figure 9
- Roodepoort main reef open pit - Figure 9 and Figure 10;
- 11 shaft main reef open pit - Figure 11 and Figure 12;
- Mona Lisa bird reef open pit - Figure 13 and Figure 14; and
- Kimberley East reef pit 1.59 ha - Figure 15 and Figure 16.

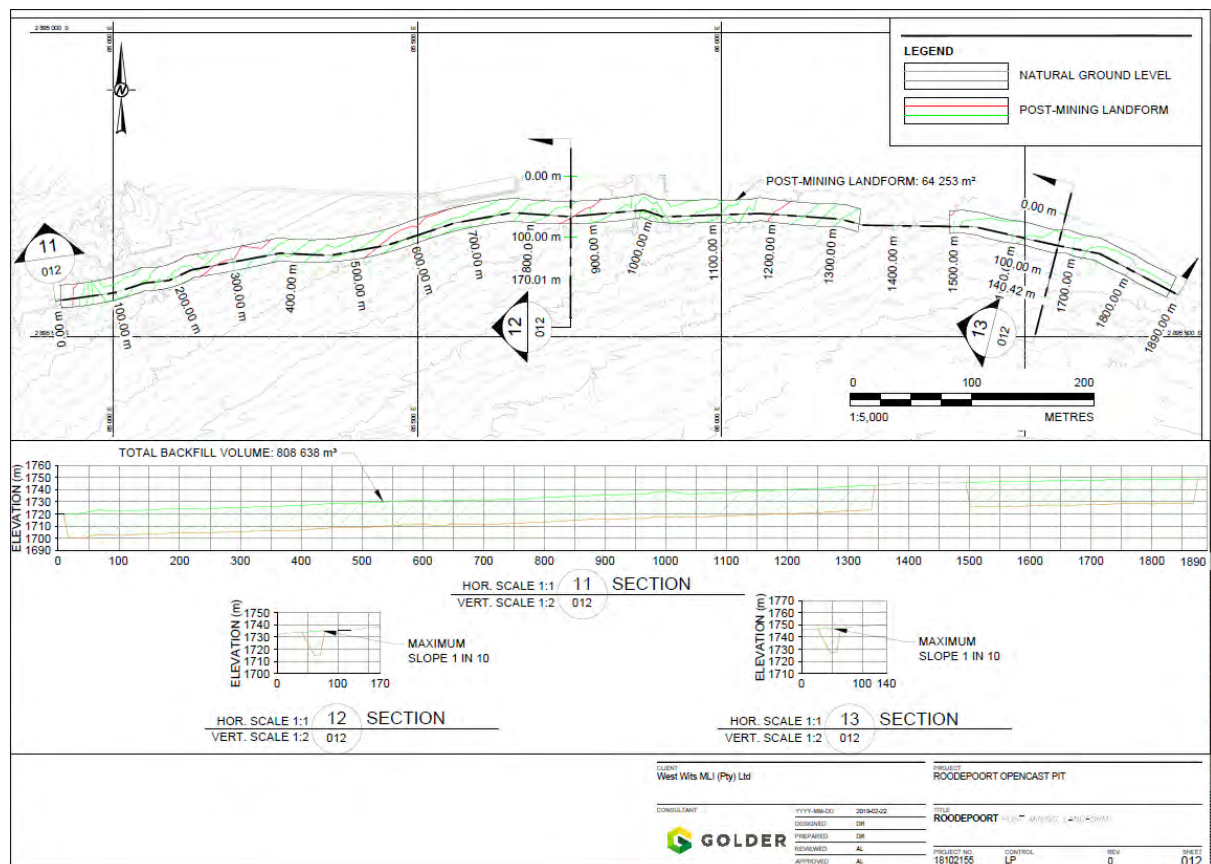
Figure 10: Roodepoort main reef pit predicted post mining landform

- Backfill the final void utilizing the adjacent overburden stockpile to construct a post mining landform (Figure 8, Figure 10, Figure 12, Figure 14 and Figure 16);
- Replace topsoil from the berm across the backfilled pit and cleared stockpile footprint; and
- Rehabilitate all affected areas, excluding haul roads.

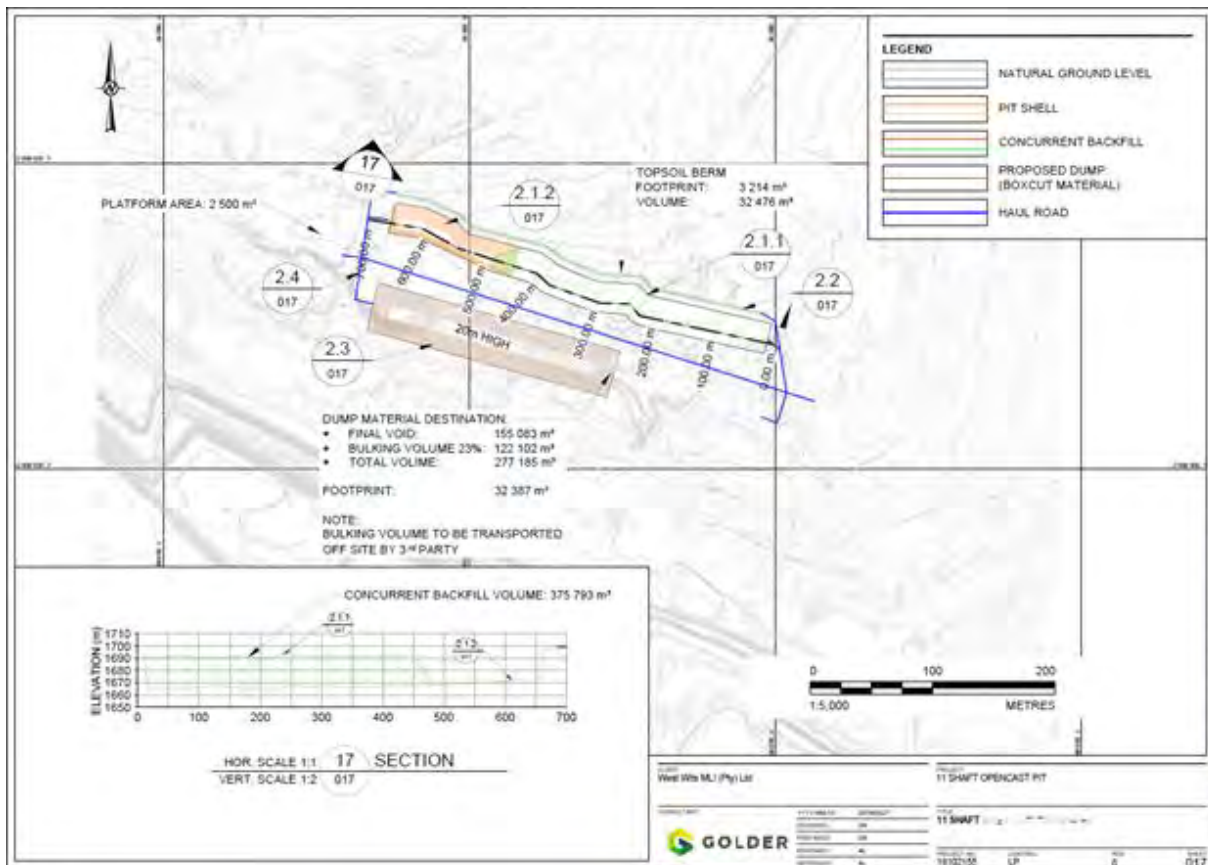
Figure 11: 11 Shaft main reef pit predicted mined out landform

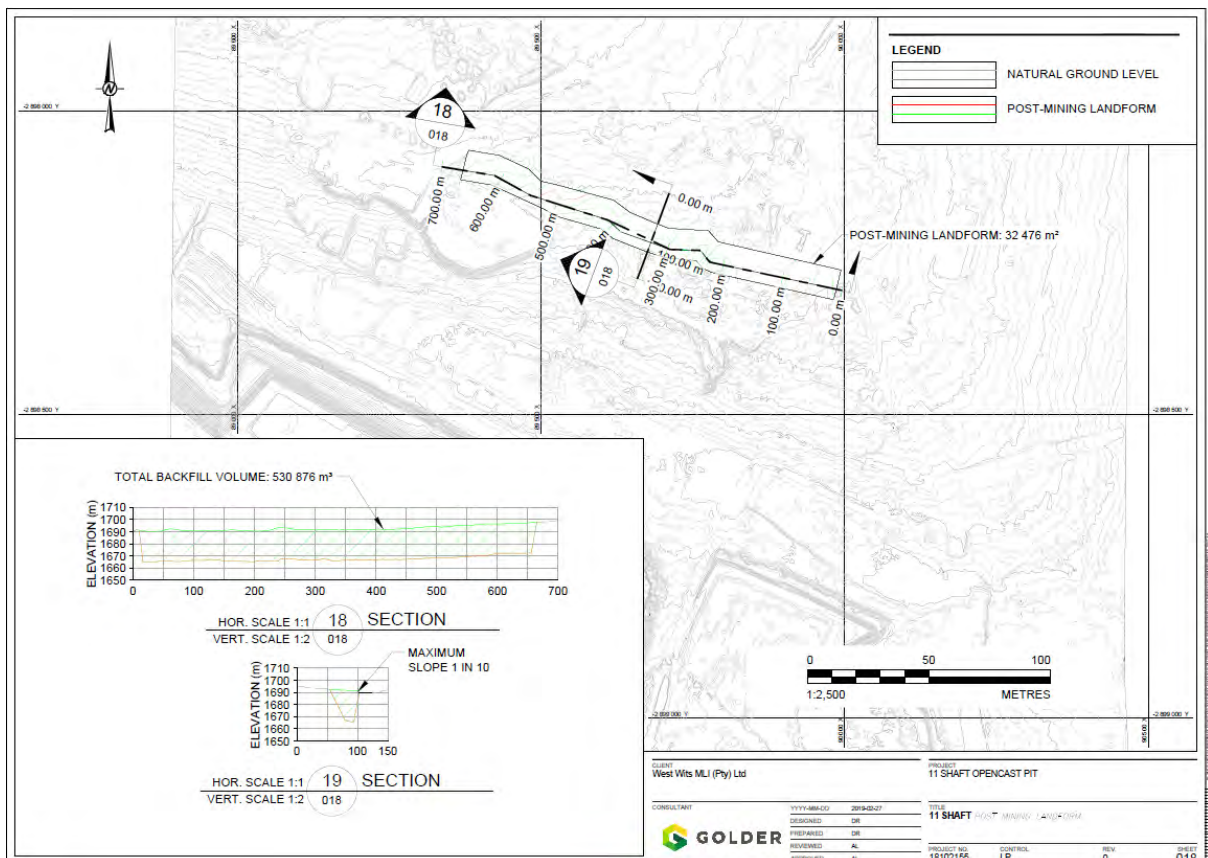
Figure 12: 11 Shaft main reef pit predicted post mining landform

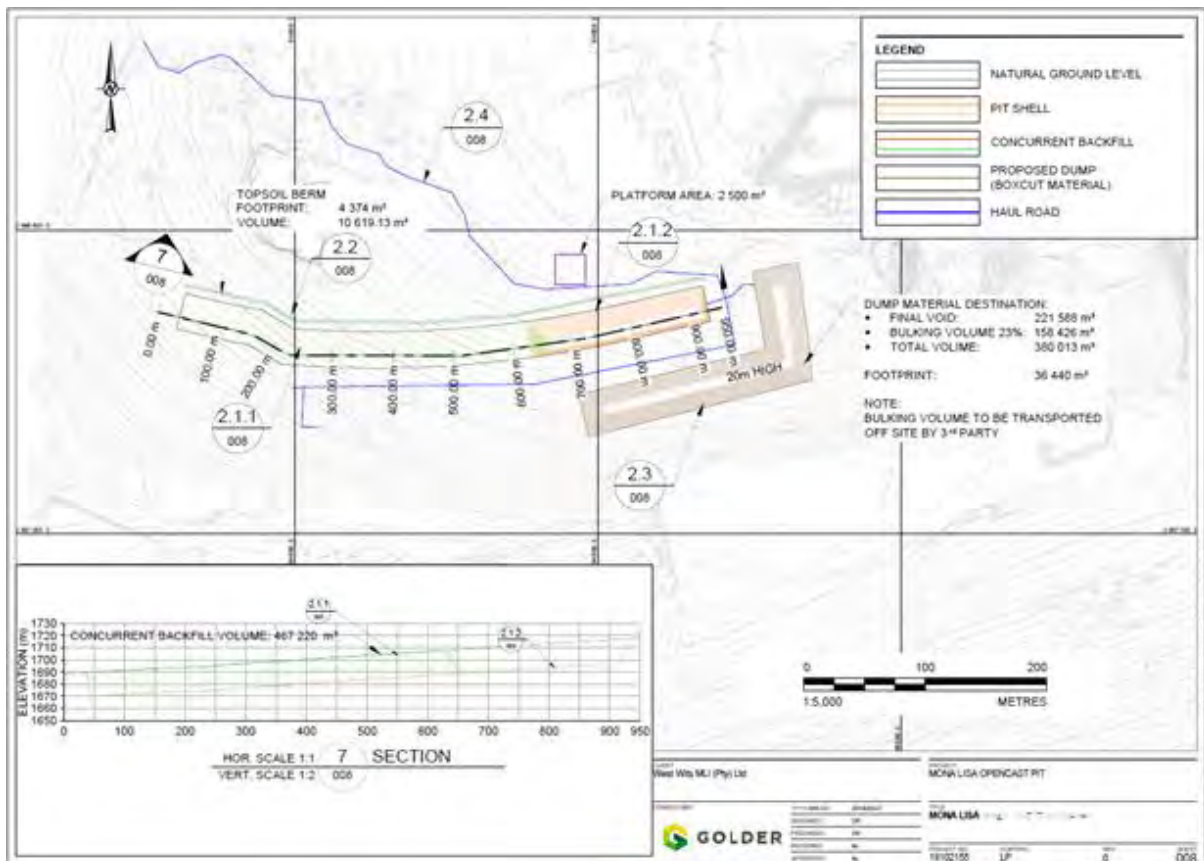
Figure 13: Monalisa bird main reef pit predicted mined out landform

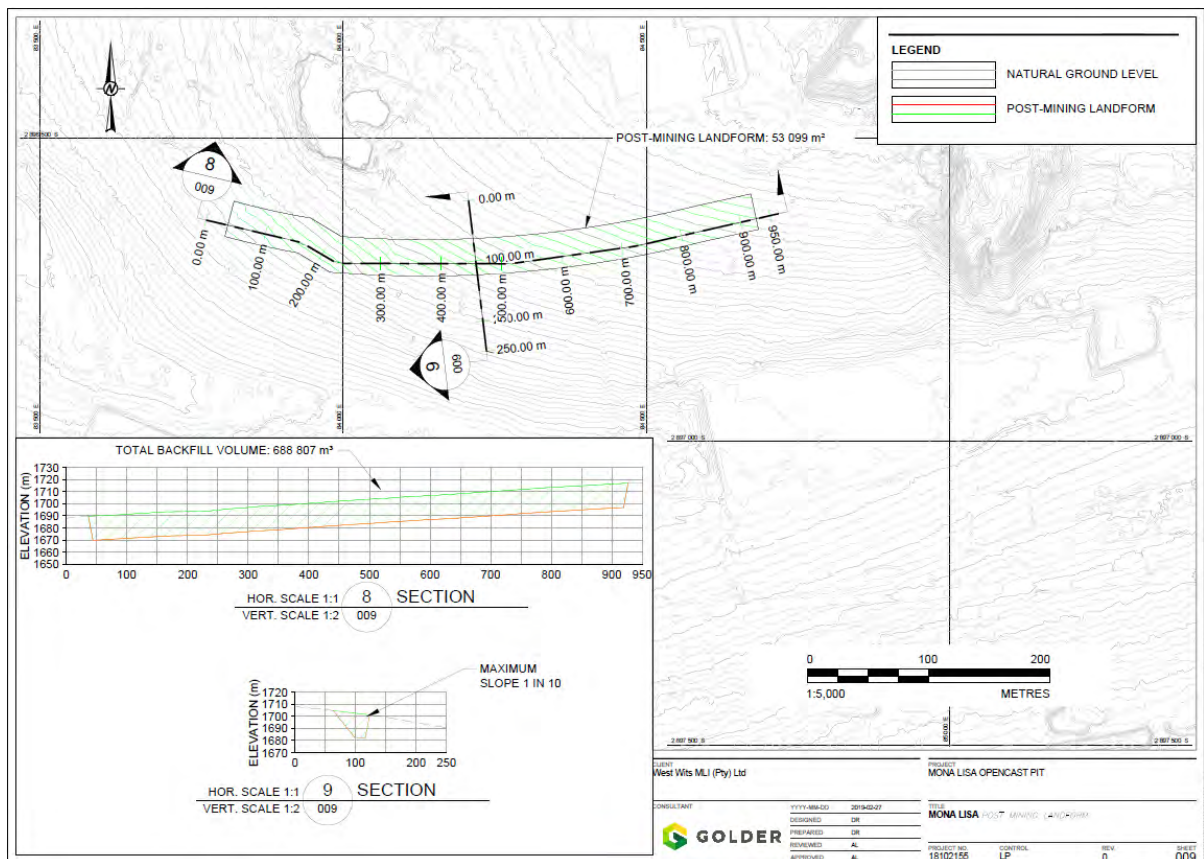
Figure 14: Monalisa bird reef pit predicted post mining landform

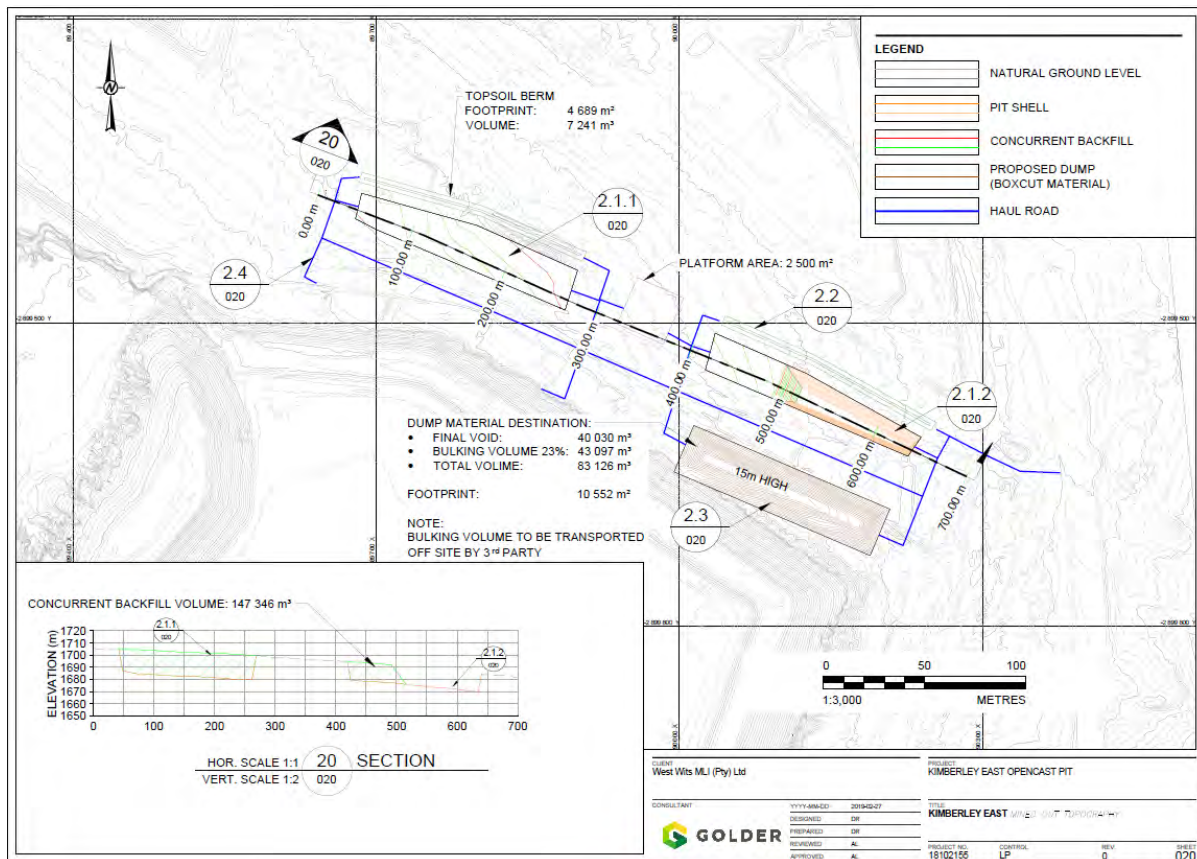
Figure 15: Kimberley East reef pit predicted mined out landform

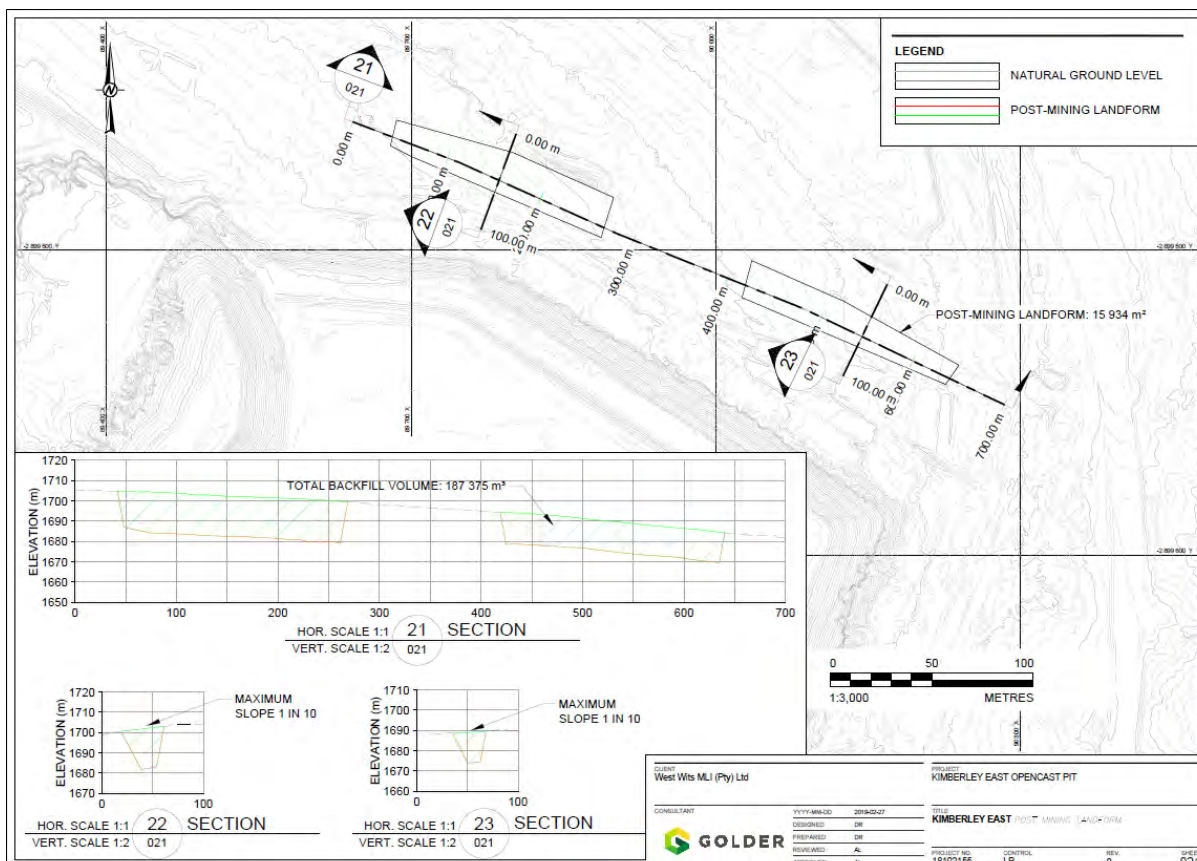
Figure 16: Kimberley East reef pit predicted post mining landform

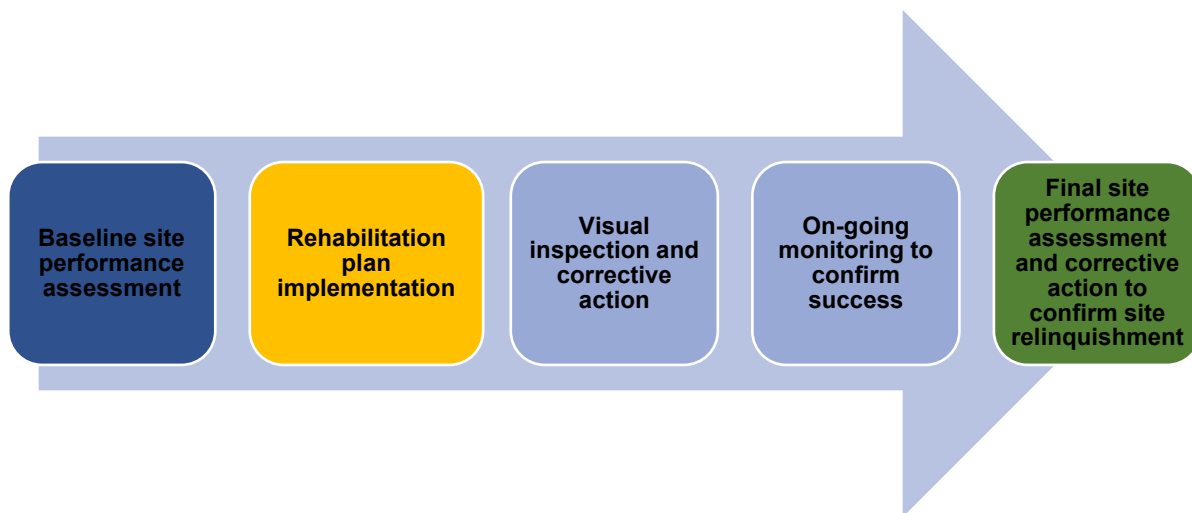
It is envisaged that a five-year demonstration period will be required for surface and ground water quality to confirm success of closure (included in the operational monitoring programme for the underground operation). A period of three years is proposed for the demonstration of successful rehabilitation. Following the completion of earthworks and vegetation establishment, a visual inspection will be undertaken to inform corrective action required, if needed. Thereafter, ongoing monitoring and corrective action as per Table 6 will be undertaken.

Figure 17: Final rehabilitation plan roll out and performance monitoring
