**ENVIRONMENTAL SCREENING FOR:**

**BUILDING 2 AND EXTERNAL LANDSCAPING  
LEEDS CITY OFFICE PARK  
HOLBECK  
LEEDS  
LS11 5BD**

**CANADA LIFE LIMITED**

**PROJECT REF: 7951**

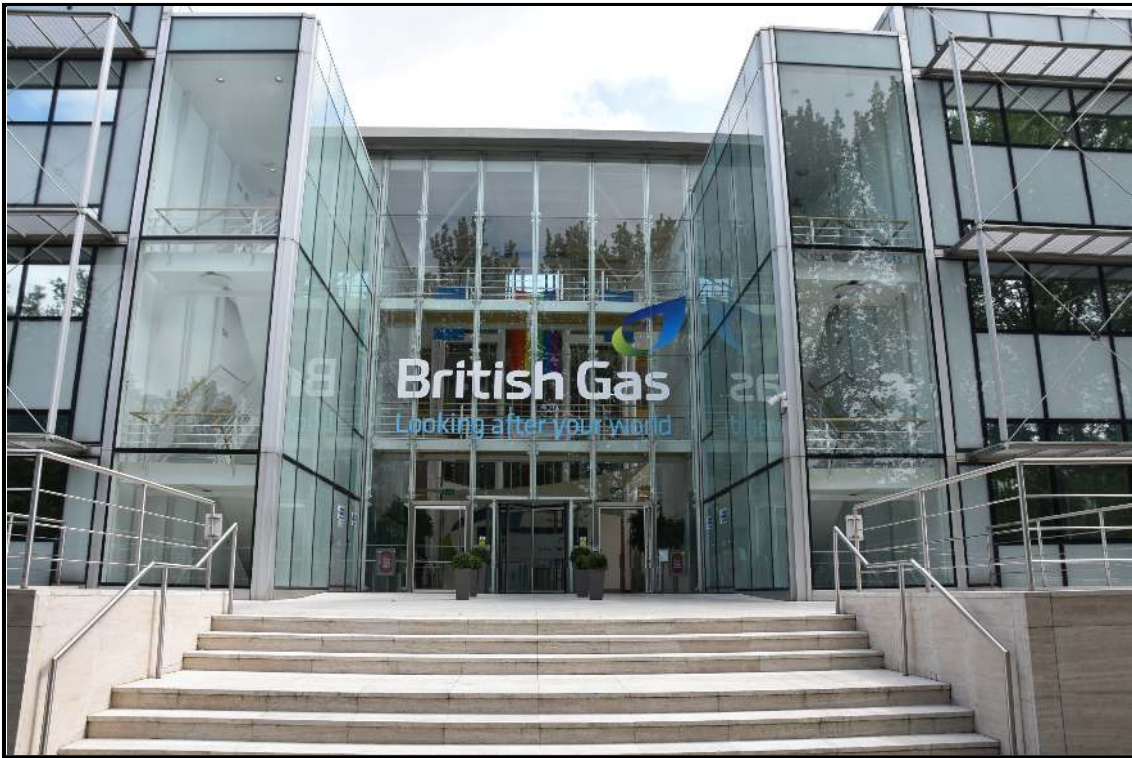
**Plate 1 Main entrance**

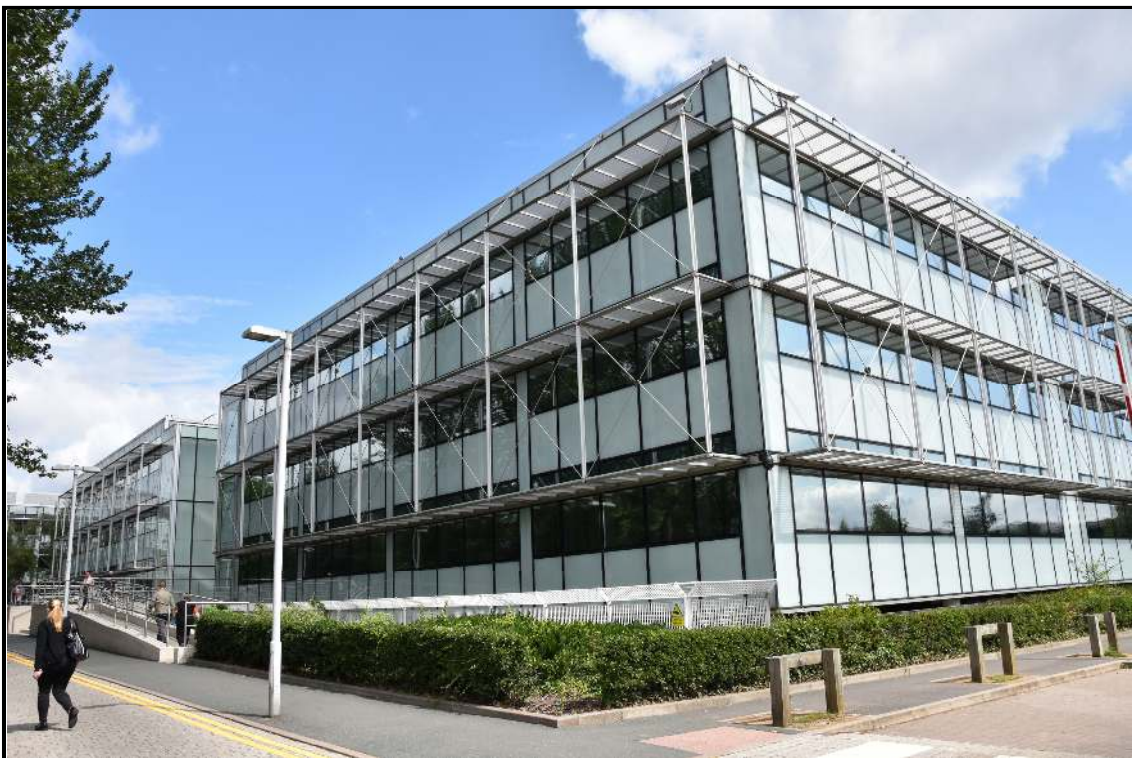
**Plate 2 Western elevation**

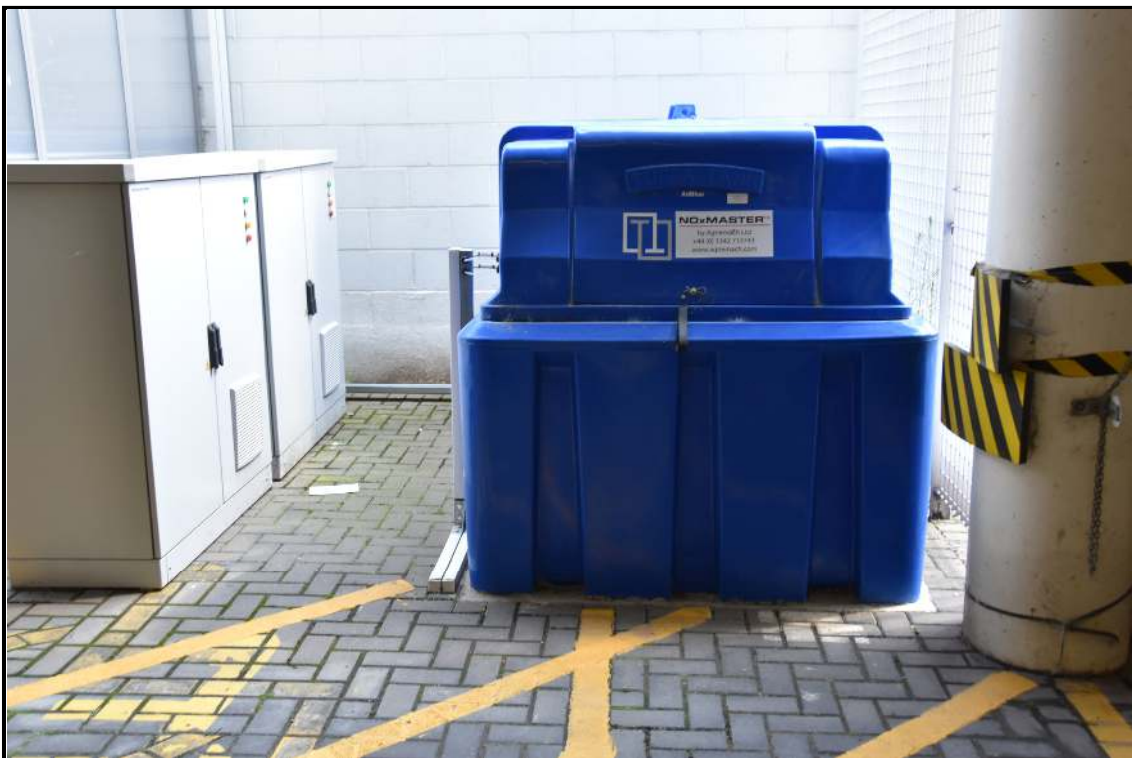
**Plate 8 Modern Adblue tank**

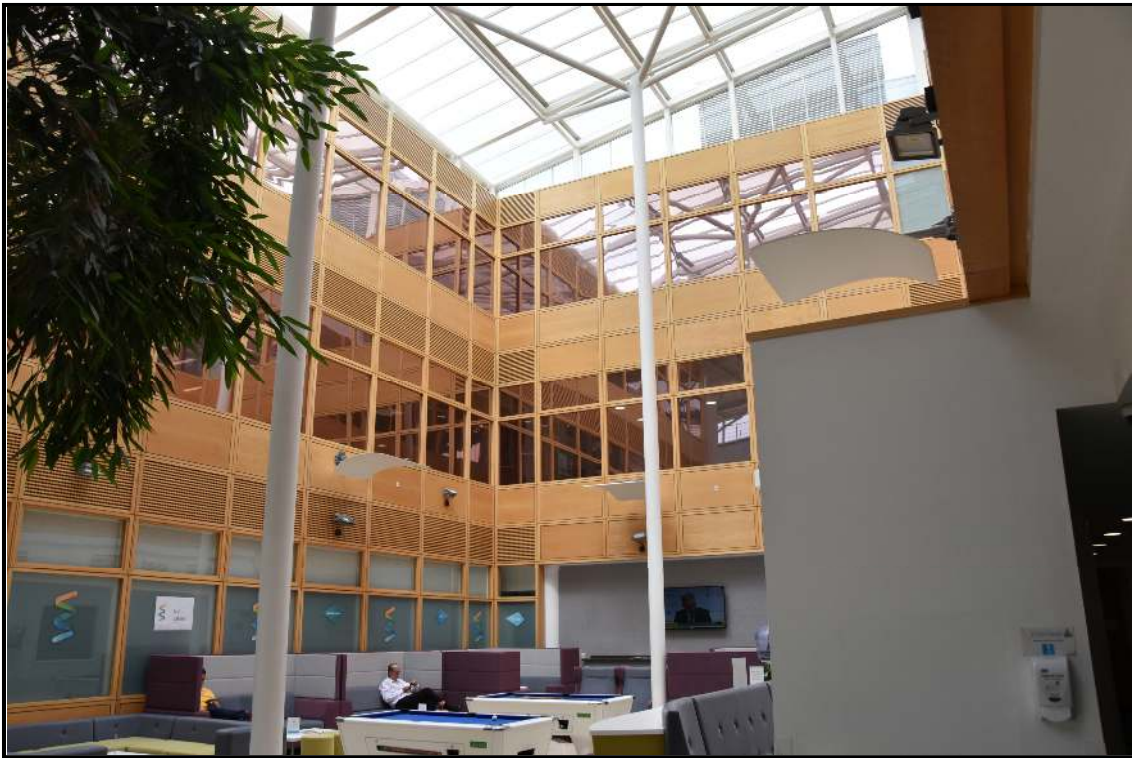
Plate 11 Central atrium

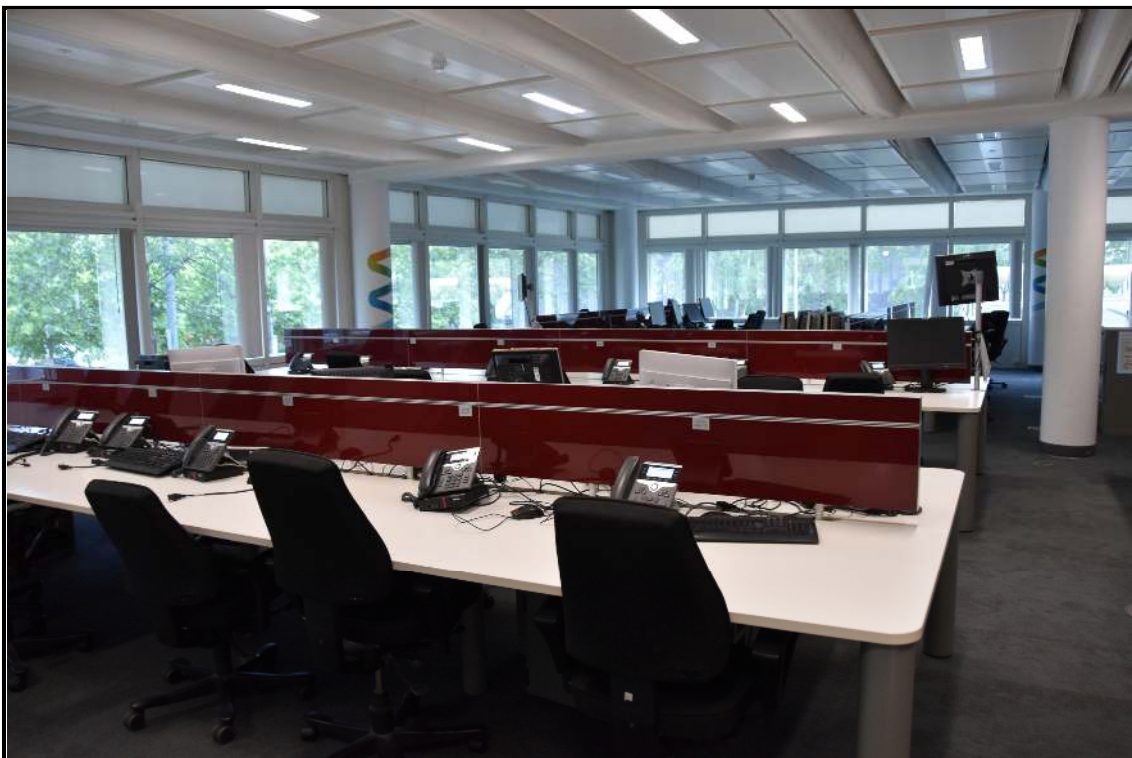
Plate 12 Typical floor

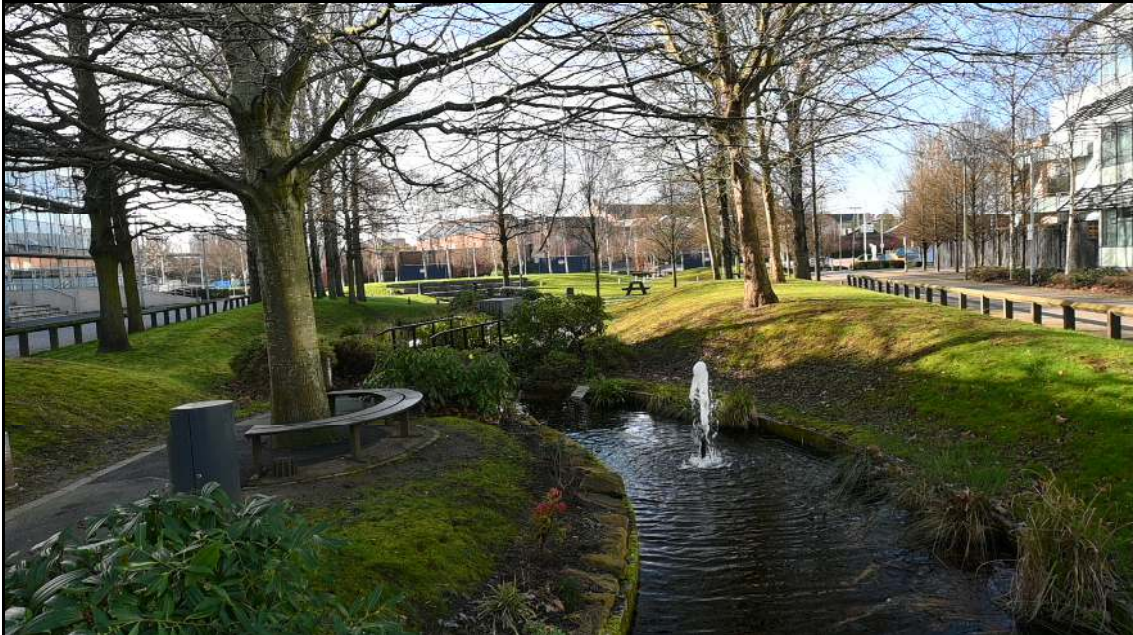
**Plate 1 Central Pond feature**

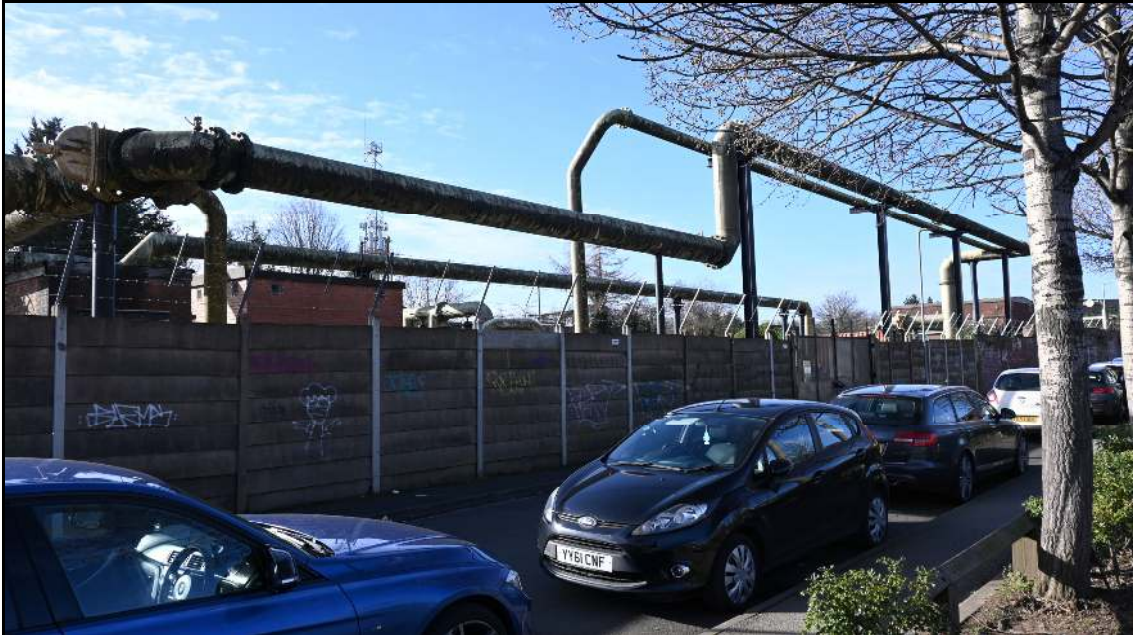
**Plate 3 Neighbouring Transco Infrastructure**

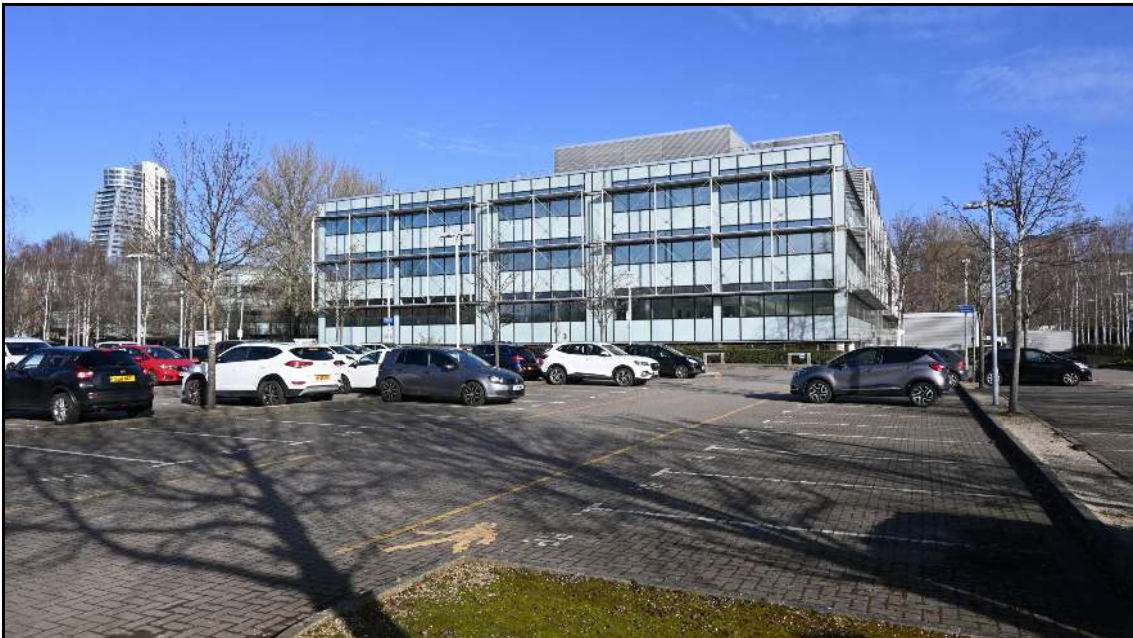
**Plate 5 Building 2 Southern elevation**
